**CULTURAL, STRUCTURAL &
ENVIRONMENTAL ASSESSMENTS**

THE WHEELER-HARRINGTON PROPERTY
West Concord, MA

February 2015

Prepared for the Town of Concord

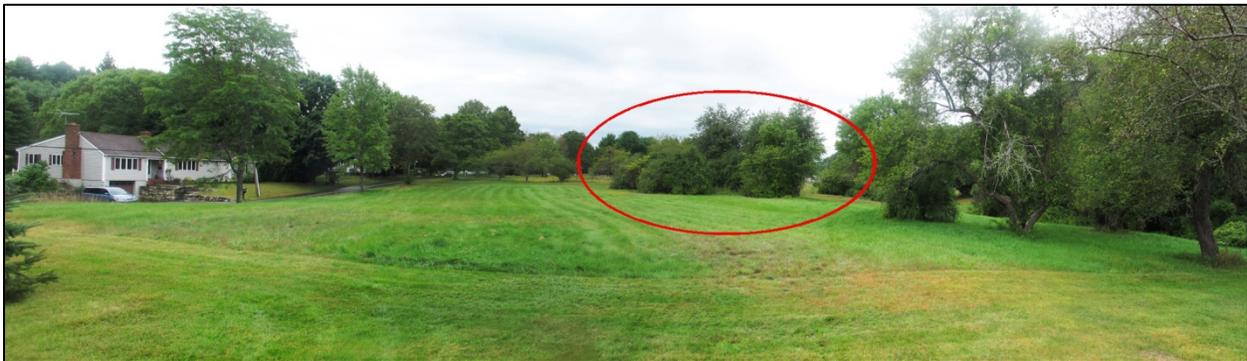
This will also be the case when the park is viewed looking west from the Wheeler-Harrington House. The offending copse of trees shown in Figure 16 limits the view across the Park to the agricultural land.

Figure 16: View west from residential parking lot.

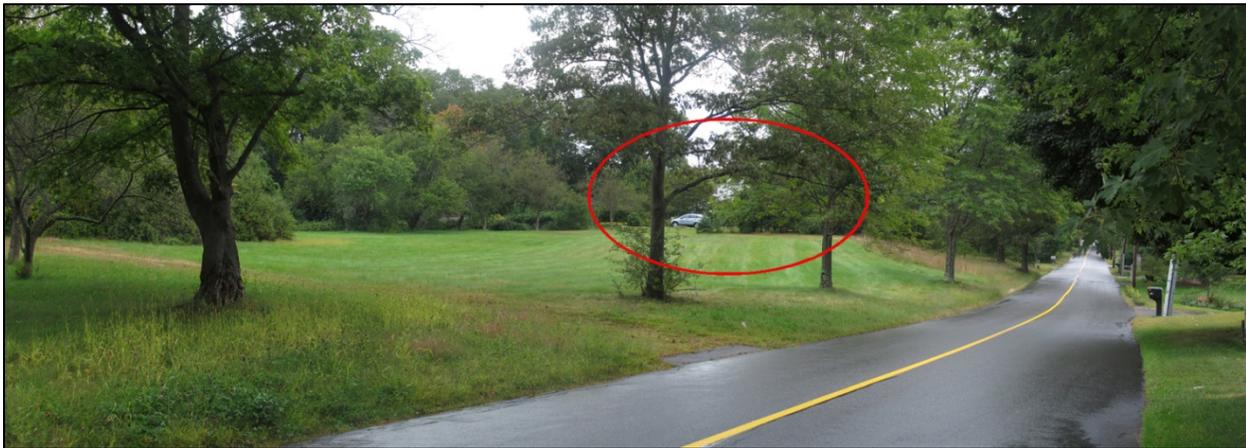
The windbreak at the residential driveway and parking area obscures an important view - from Harrington Avenue looking east-northeast across Harrington Park to the Wheeler-Harrington House. Clearing some vegetation at the windbreak and raising the canopy of the street trees along Harrington Avenue may be warranted to open up this view across Harrington Park. (Figure 27)

Figure 27: view of Wheeler-Harrington House obscured by vegetation

- a. Open up views of the Wheeler Harrington House from Harrington Avenue eastbound.
- b. Make the driveway entrance into Harrington Park more prominent and visible.
- c. Install way-finding signage as discussed in Recommendation 1.
- d. Remove understory shrubbery and weeds in all locations described in this Section.

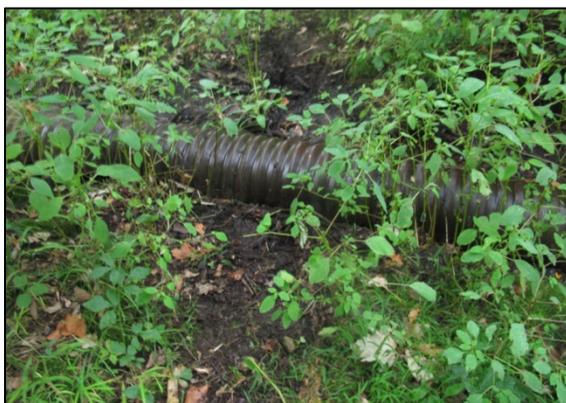
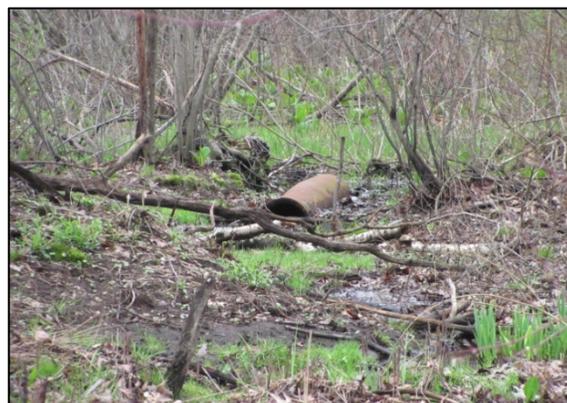
Peter Benes indicated the Harrington Spring feeds a small stream that flows to the Assabet River on the Harrington Park riverfront. The stream channel intersects the eastward trail and flows through a corrugated steel pipe (Figures 36 and 37).

Figures 36 and 37: The culvert from Harrington Spring on the riverfront trail easterly from Wheeler-Harrington

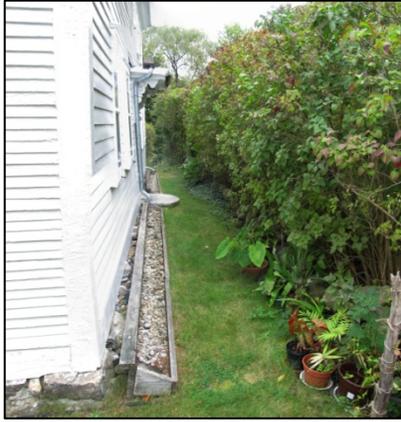
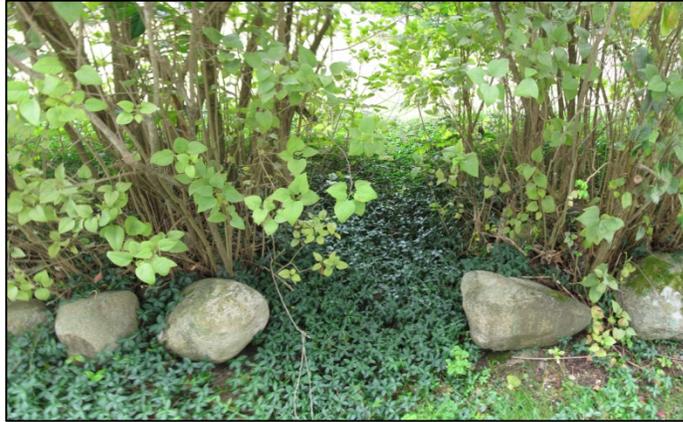
The front façade of the House is obscured by a lilac hedge bedded with a groundcover of *Vinca minor* and edged with a row of rounded stones. The grassed verge between hedge and clapboard face of the House is narrow. Peter Benes has constructed a simple, stone-lined wooden trough to serve as a ground-based gutter to collect roof runoff. Prior to the construction of the rain trough, the roof runoff infiltrated into the basement and caused some degree of basement flooding and damage to wooden sills. (See Historic Structure Assessment)

Figure 41: South Façade & Lilac Hedge Figure 42: Vinca Groundcover and Boulder Edge

- ii. Remove and discard the lilac hedge and Vinca minor groundcover.
 - iii. Remove the stone filled wood troughs that collect roof runoff. Replace with a flush French drain system, an excavated, stone lined and covered drainage trench with perforated pipe that connects to drywells set back from the south façade of the

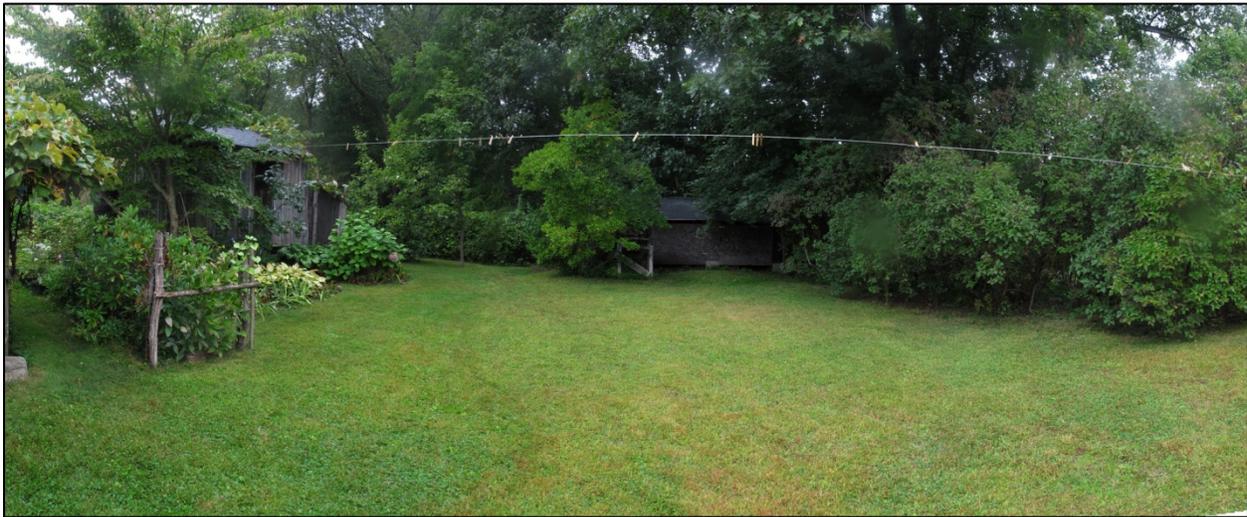
The outbuildings are contemporary, roughly built, service structures that house Peter Benes' yard equipment and supplies. Peter acknowledges the shed outbuildings were constructed as temporary structures and should be replaced with a barn structure.

Figure 47: North Yard

- iii. As a long-term goal for the property, eliminate the existing outbuildings before they degrade to the point of becoming hazardous. Replace with a barn of either historic vintage or a replica of a 18th or 19th century barn. Locate the barn between the existing and historic orchard of old apple trees and the parking area of the house. Situate in such a way that views westward to the open fields of Harrington Park are not obscured by the barn. Situate to ensure a full turning radius for a passenger vehicle at the top of the residential driveway and parking area. Accommodate the K-turning movements of a delivery truck. Maintain vehicle access route to the rear north yard of the Wheeler-Harrington House.

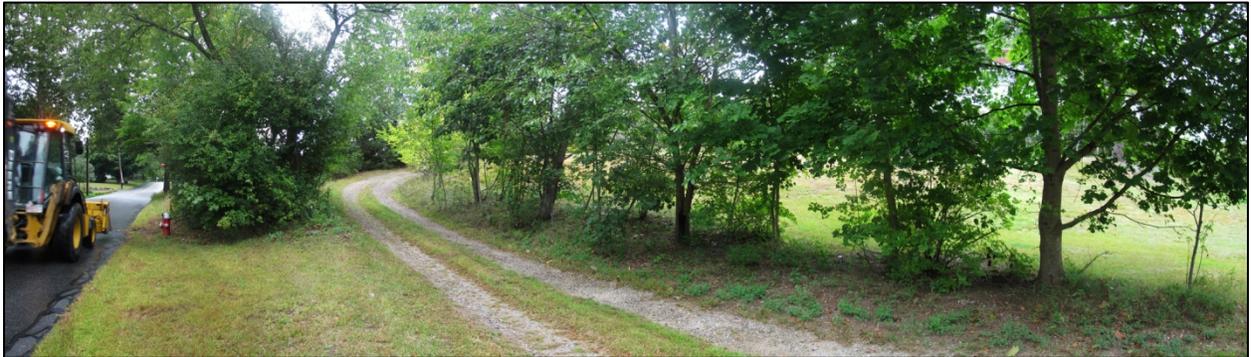
Volunteer trees and shrubbery flank the north edge of the drive at the bottom of the south lawn of the House. These trees and shrubs are invading weed species that obscure the view of the Wheeler-Harrington House from the road. On the south side of the drive is a volunteer black cherry tree surrounded by a scruffy accumulation of volunteer shrubbery.

Figure 50: Wheeler-Harrington House residential drive. Harrington Avenue looking west is on the left.

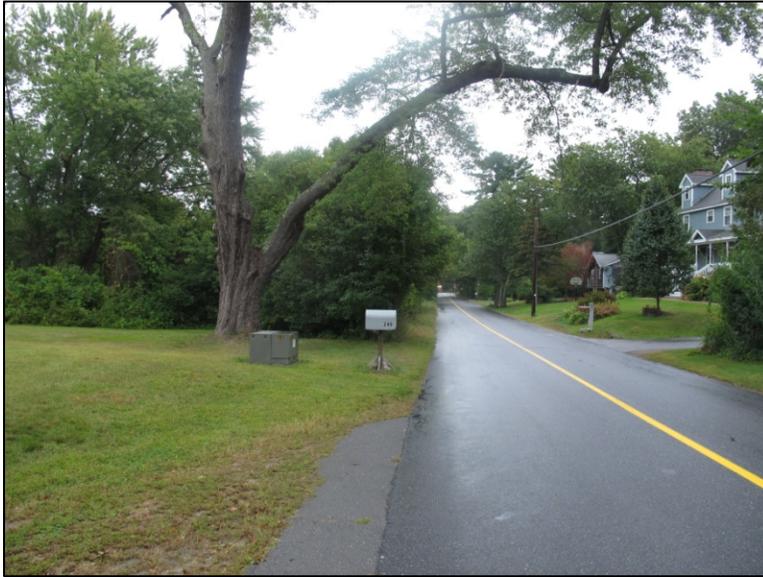
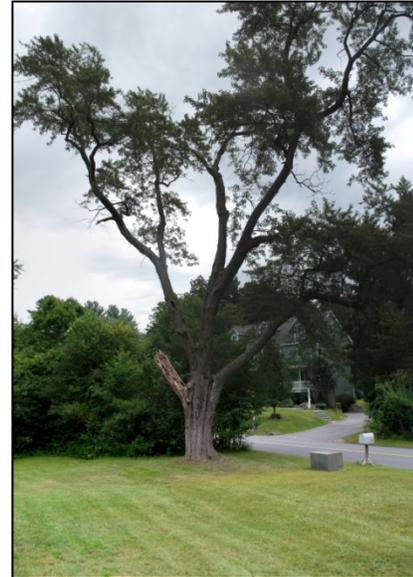
The sight line down Harrington Avenue to the east from the driveway throat is open. The large silver maple at the corner of the lawn (Figures 54 & 55) is a hazard tree. It has a large, heavy limb that stretches out over the roadway. It shows signs of internal decay throughout its principle stems and limbs. It is a risk to public health and safety.

Figures 54: Sight Line Harrington Ave eastward

Figure 55: Hazard Tree

- d. Immediately remove the hazard tree overhanging Harrington Avenue at the southeast corner of the front lawn. Replace with a new shade tree pulled back slightly from the edge of the roadway. See street trees below Harrington Park for appropriate setback.

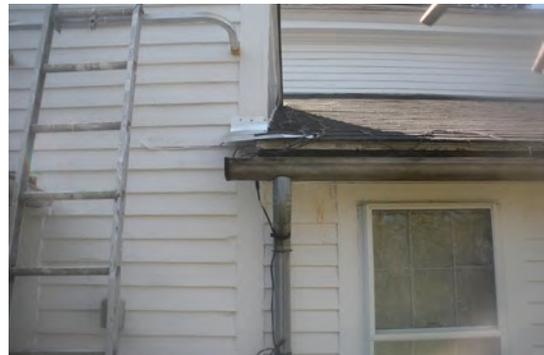
- Priority 2: A piece of sheet metal flashing is tacked to the east end of the wood gutter along the kitchen shed. This is protecting the northwest corner of the old kitchen ell where it meets the roof. The corner board and clapboards should be carefully removed, the old kitchen ell wall flashed up 8 inches with copper, and then the corner wrapped with counter flashing. Finally, the siding and corner boards should be reinstalled neatly cut to give 1-1/2 inches of clear space between the clapboard edge and the roofing material. Any raw wood should be primed and painted.

Sheet metal flashing tacked to wood gutter.

- Priority 1: Remove the layered sheet metal flashing and water catching trough. Remove roofing material and repair roof sheathing. Install new flat seam copper over felt and high temperature underlayment. Design with a shallow gutter and outlet to divert roof run-off to downspout.

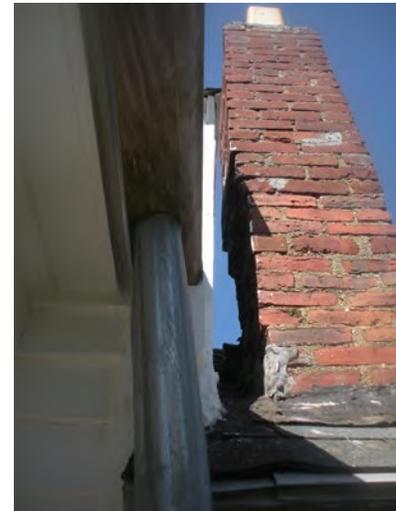
- Priority 2: The rear brick chimney mortar joints and cement cap wash are failing. The joints should be repointed with a moderately soft mortar and the wash at the top replaced with a durable mortar-cement wash.
- Priority 2: Flashing at the concrete block chimney and the rear brick chimney is liberally covered with roofing cement. The cement may have been a suitable stop gap but it conceals potential leak sources. The cement should be removed and the base flashing and counter flashing at the two chimneys replaced.
- Priority 3: It appears the concrete block chimney is capped and not used for venting. Consider removing the stack down to the basement. This will free up some space in the mudroom and eliminate a source of historic leaks.

The rear brick chimney has failed mortar joints.

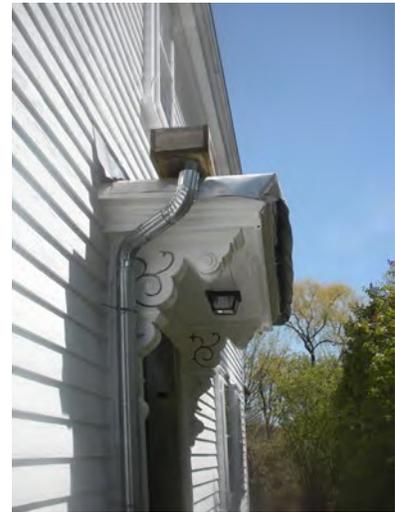
Wood trough over entry door hood.

- Priority 1: Remove trough from front door hood, incorporate gutter into entry hood re-roofing project, and install downspout on west side.
- Priority 2: The fascia board behind the wood gutter at the kitchen is looking warn. Remove the wooden gutter, replace the fascia (primed and painted front and back). Replace the wood gutter.

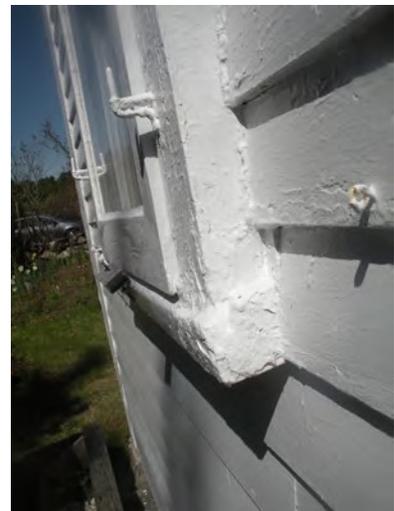
Heavy paint build-up at upper clapboards and window casing. Note shutter dogs.

- Priority 3: The façade will require repainting in five to seven years. Samples should be taken of paint layers to establish a paint history for dating purposes. Consideration of complete paint removal should be given in this or the next round of painting. This will allow exposure of wood to determine conditions and reveal detail that is obscured by the thick paint accumulation.
- Restoration Recommendation: Wood shutter reinstallation. (Not a requirement for preservation.) If elected, this work would achieve a 19th century appearance which is in keeping with the windows and ornament at the porch and the door hood.

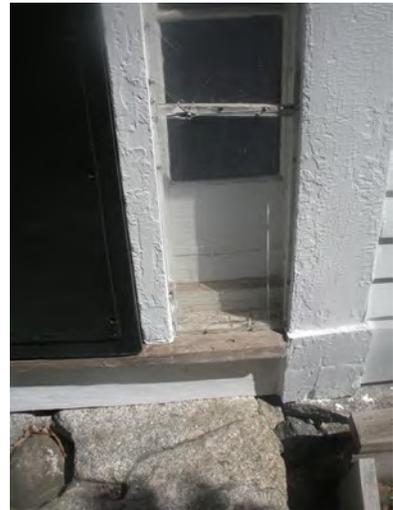
Sidelight at main entry.

- Priority 1: Remove the acrylic sheets at the front door side lites. Paint and reglaze side lites. Make new wood frames for protective glazing and install frames with clips for easy removal.
- Priority 2: The mortar wash around the basement window to the right of the main entry is cracked and failing. Chip out existing mortar and place new wash and repoint around opening.

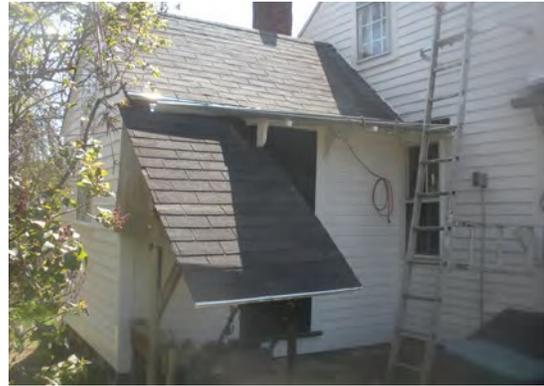
- Priority 2: The ground at the interior corner between the old sink room and the northeast kitchen addition gable takes on a lot of water. Discuss drainage options with the landscape architect and a civil engineer.
- Priority 2: Repoint the rubble foundations at the old sink room and the northeast kitchen addition.
- Priority 3: The elevation will require repainting in five to seven years. Samples should be taken of paint layers to establish a paint history for dating purposes. Consideration of complete paint removal should be given in this or the next round of painting. This will allow exposure of wood to determine conditions and reveal detail that is obscured by the thick paint accumulation.

Ground at corner of old sink room and kitchen addition is vulnerable to water.

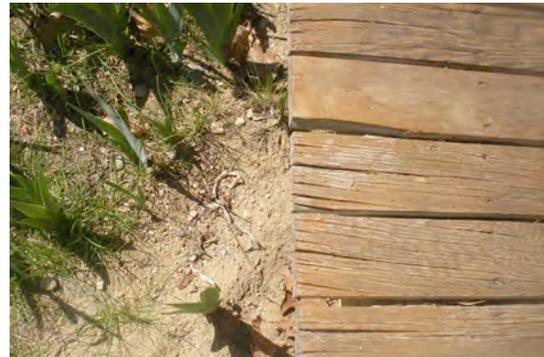
Wood boards at porch floor perimeter are worn.

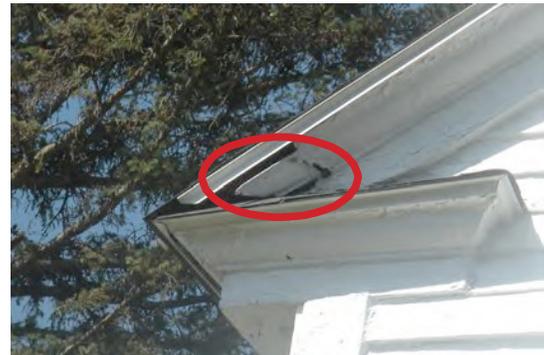
Broken rake trim at south gable return on main block.

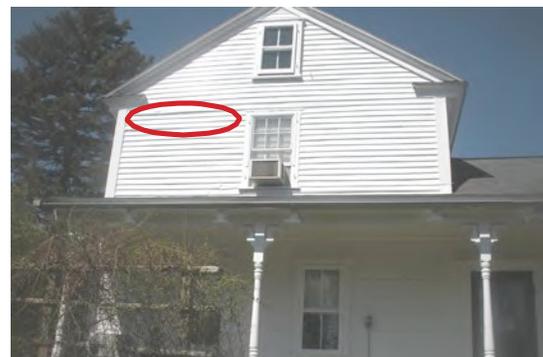
Porch at east elevation. Note early 6-over-6 window (with air conditioner), old skived and lapped clapboards above porch roof, and modified bottom rail at attic storm window. Bulging clapboards are circled.

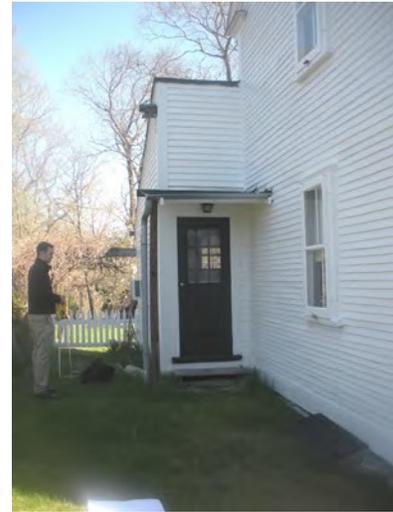
Grade at the west end of main block slopes slightly towards the foundation.

The Historic Structures Assessment addresses landscape conditions at the base of the west façade. The Assessment recommends adjusting the local grade at the base of the west elevation of the House to create a swale four feet out from the foundation. Regrading the landform to ensure a swaled diversion of stormwater away from the west façade would be disruptive of the west gardens and landform overall. See recommendations.

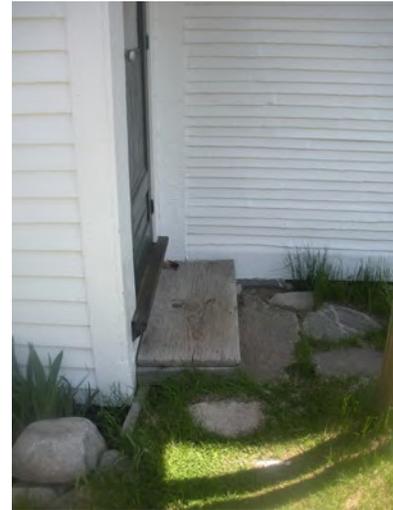
Grade at the stoop is higher than the lowest clapboard.

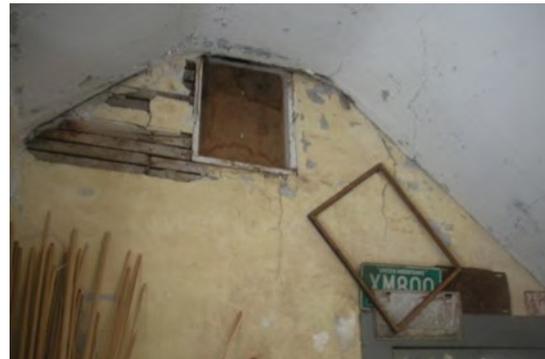
Damaged ceiling and wall plaster in the sink room.

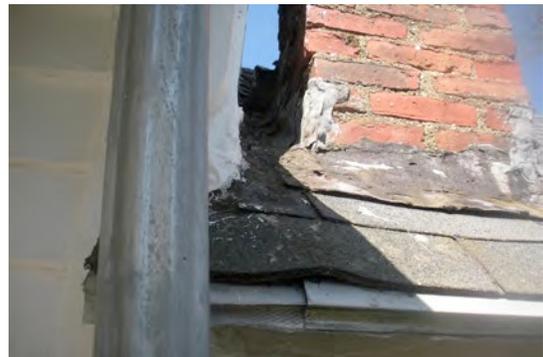
Eroded mortar joints at chimney at northeast kitchen addition.
