Project Name: 58 Monument Square: Roof Replacement and Structures Report

# HISTORIC ASSESSMENT

CORINTHIAN LODGE OF FREEMASONS  
CONCORD, MASSACHUSETTS

DECEMBER 2019

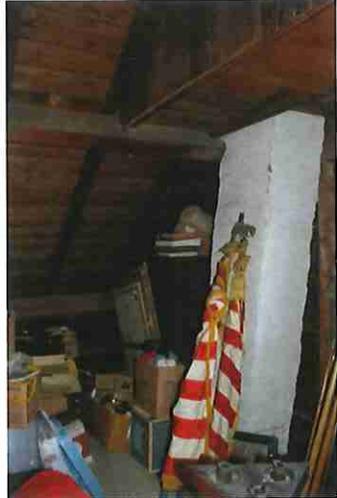
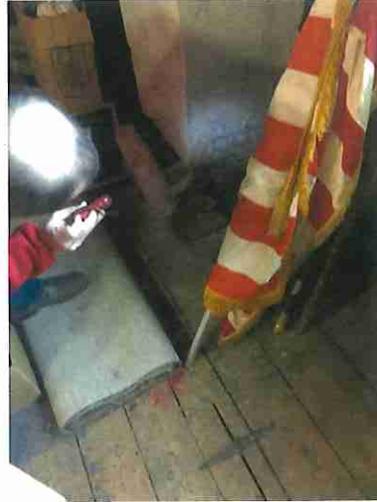
Above left: partial chimney at east gable wall slanting towards Monument Square  
Above right: base of partial chimney at east gable wall supported by loose masonry.

- Partial chimney at interior near east gable wall should be removed since there is considerable weight and the masonry is leaning.
- Active leaks were reported at the northeast roof hatch. Water in buckets was observed at the time of our visit. Both metal hatch covers should be reviewed during re-roofing. It is suggested the curbs be made taller, new flashing installed and crickets built on upslope side of hatch curbs. The metal hatch covering on the hatch covers should be examined and replaced if integrity is compromised. Replacement should be copper or lead-coated copper. The hatch and curb should be gasketed.

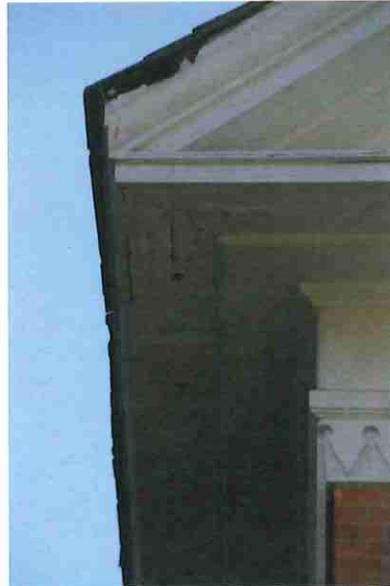
Above left: Paint failure at box cornice soffit at south-east corner. Rot at end of raking gable cornice. Above right: Rot at end of raking gable cornice at north-east corner.

- Evidence of water damage: rot at both south-east and north-east corner at end of raking gable cornices. Rotted molding should be replaced matching existing and re-painted.

- Paint failure and probable wood deterioration at box cornice soffit at south-east corner. Seven circular vents have been installed here might indicate a moisture problem. Investigate, repair and repaint. Review of sheathing, attachment of eave to building should occur during roof replacement.

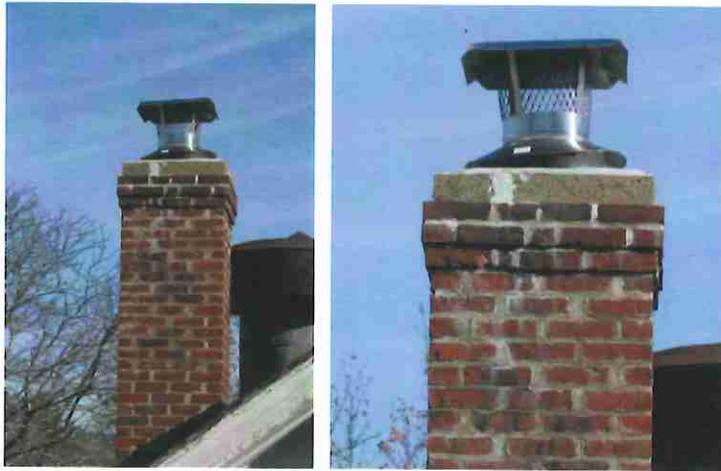
Above: North-west chimney mass above the roof

- North-west chimney mass above the roof only showed patches of mortar that might be recent. Base flashing and counter flashing are only partly observable under roofing tar on the south and west visible portions of the chimney. All flashing should be replaced when the roof work is done. All roofing tar should be removed. Copper, lead-coated copper or sheet lead flashing is recommended.

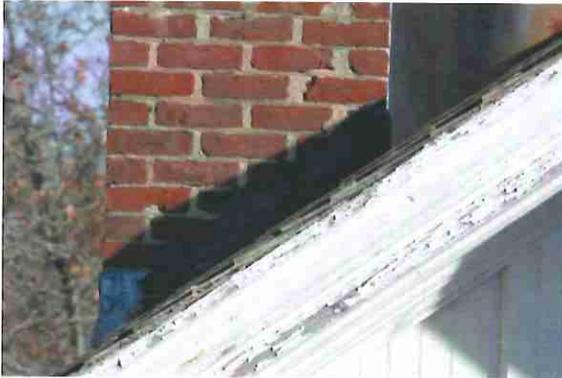
- Brick chimney set far back from façade so not visible from Monument Square.
- On the exterior we observed two layers of roofing: 12" wide x 18" long slate tiles with an 8" exposure and 16" long wood shingles with a 5" exposure. A metal ridge cap runs the entire length of ridge.

Above: Two layers of roofing material, slate over wood shingles.

- Extant roofing is worn and near end of service life. It is due for replacement. The wood shingles below the slate were examined at the rake ends. The wood fibers observed were extremely compromised. Removal of slate and shingles and installation of new, historically appropriate roofing over new roofing felt recommended. Wood shingle and slate were both used historically and would have historic precedent.

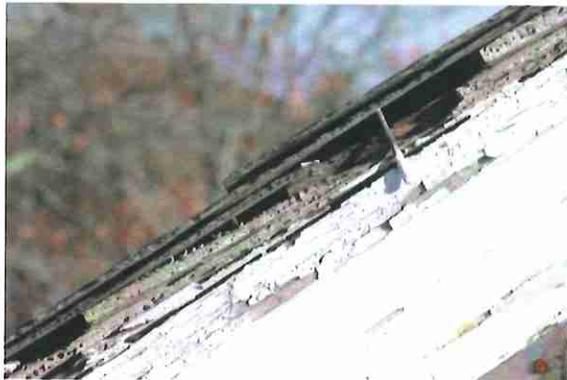
Above: Deteriorated wood fibers of the shingles.
