1.3: Ell South Facade and Main Block West Facade. The Additions to the ell are early-mid 20th century. First floor window frames on the main block are 19th or early 20th century

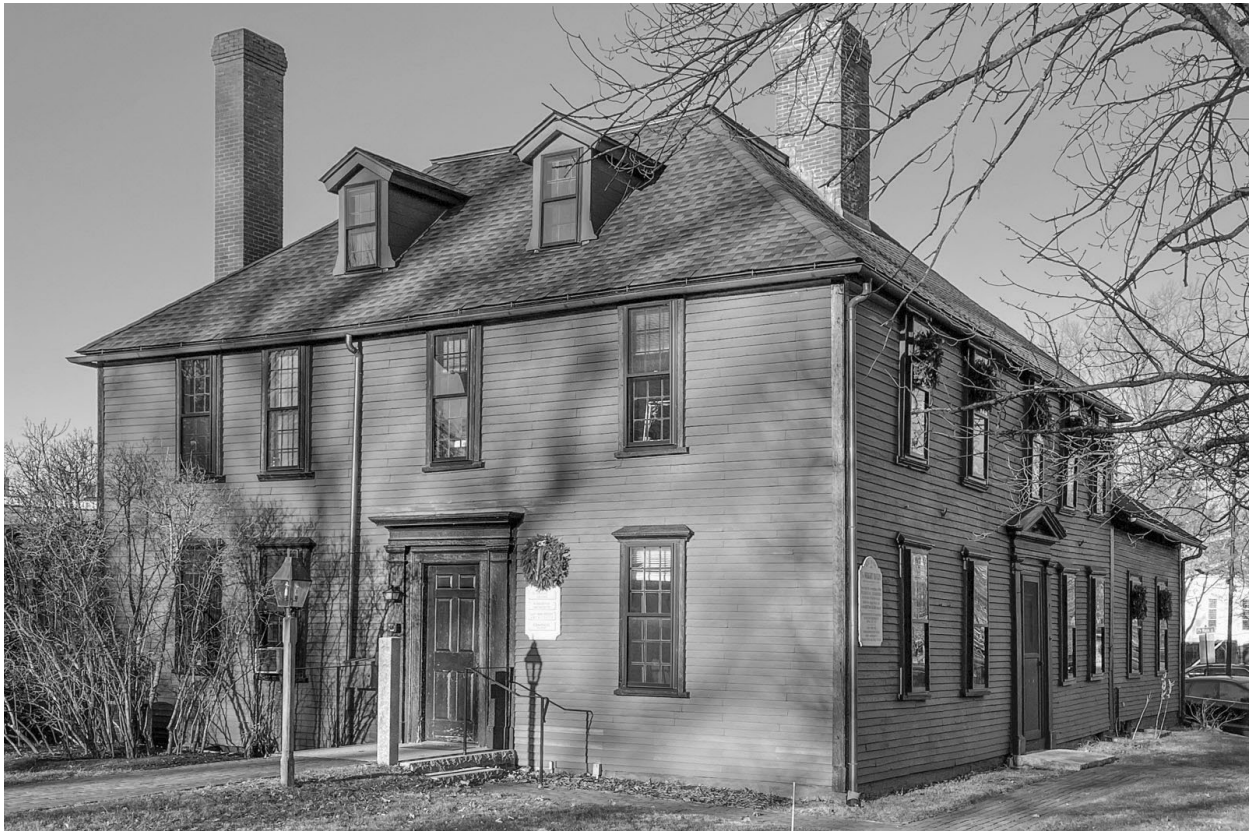
1.1: East and North Facades. Both facades retain their original or early entries, window frames, and corner boards. Original or early clapboards, usually with original wrought nails, remain in place on much of the main block from the first floor window sills up to the roof. Many of the clapboards below the window sills have been replaced in conjunction with sill repairs.

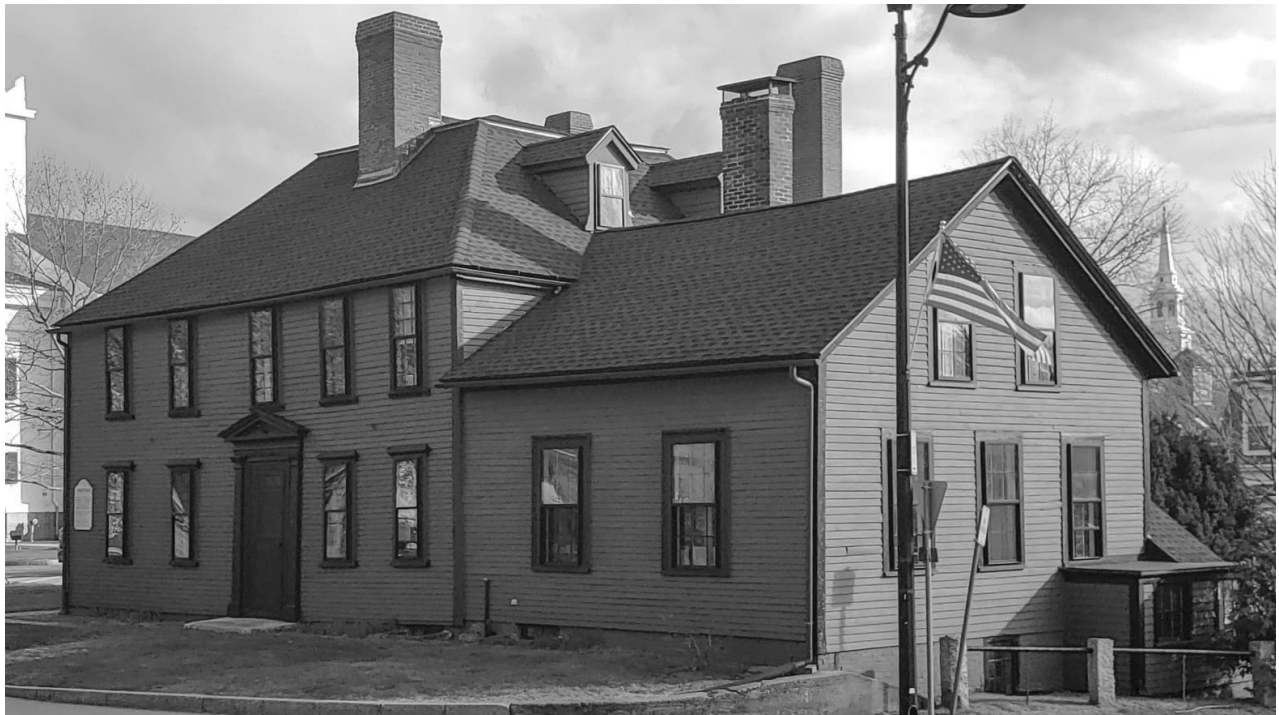
1.2: North and Ell West Facades. The ell was added in the later 18th century and has been altered considerably in the early-mid 20th century. Its current west facade is the result of its westernmost section in the early 20th century.

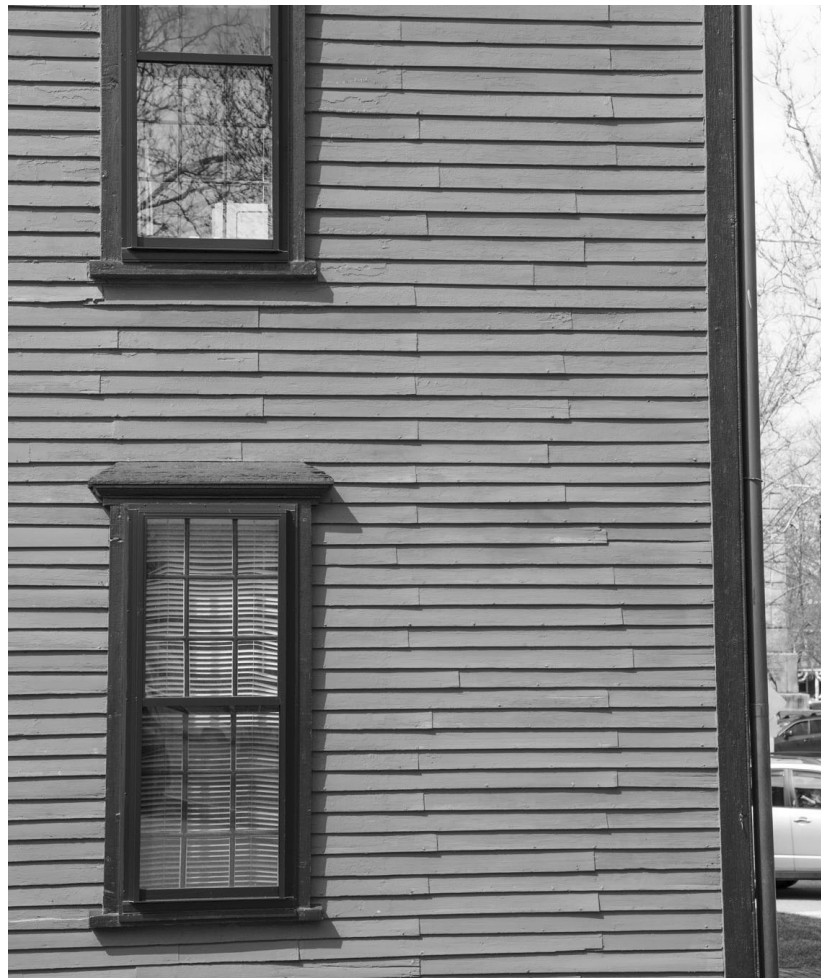
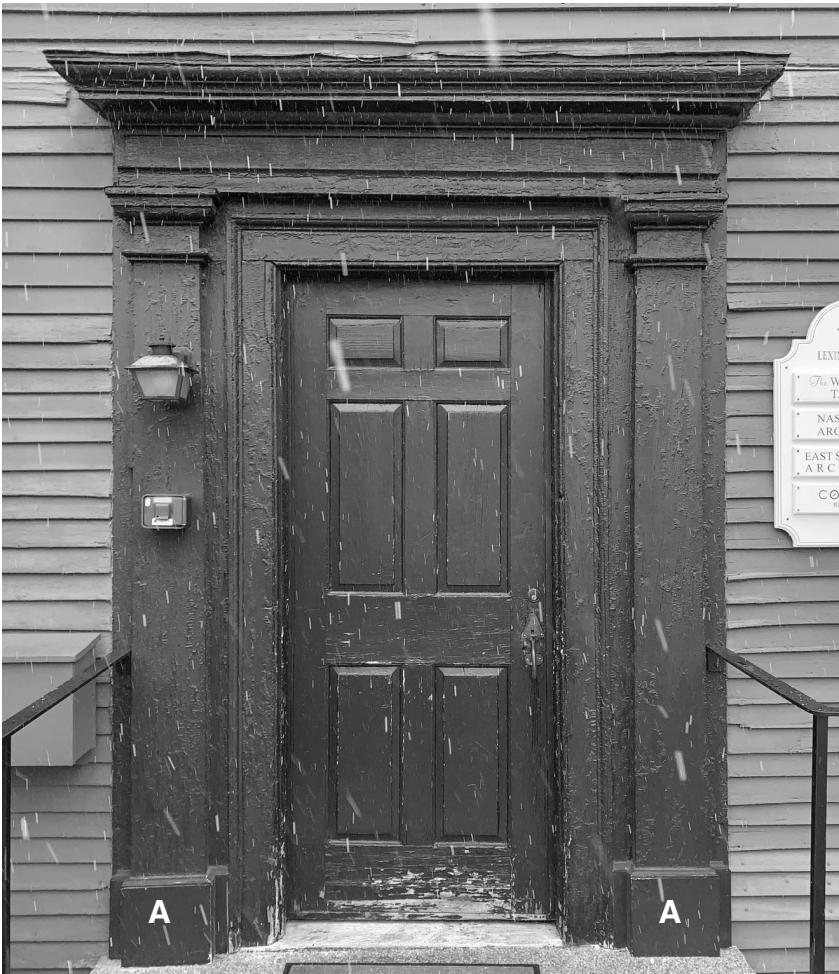
2.2: East Entry. Except for the pilaster bases (A), the entire frontis piece is original or early. The bases and their moldings are modern replacements of the originals.

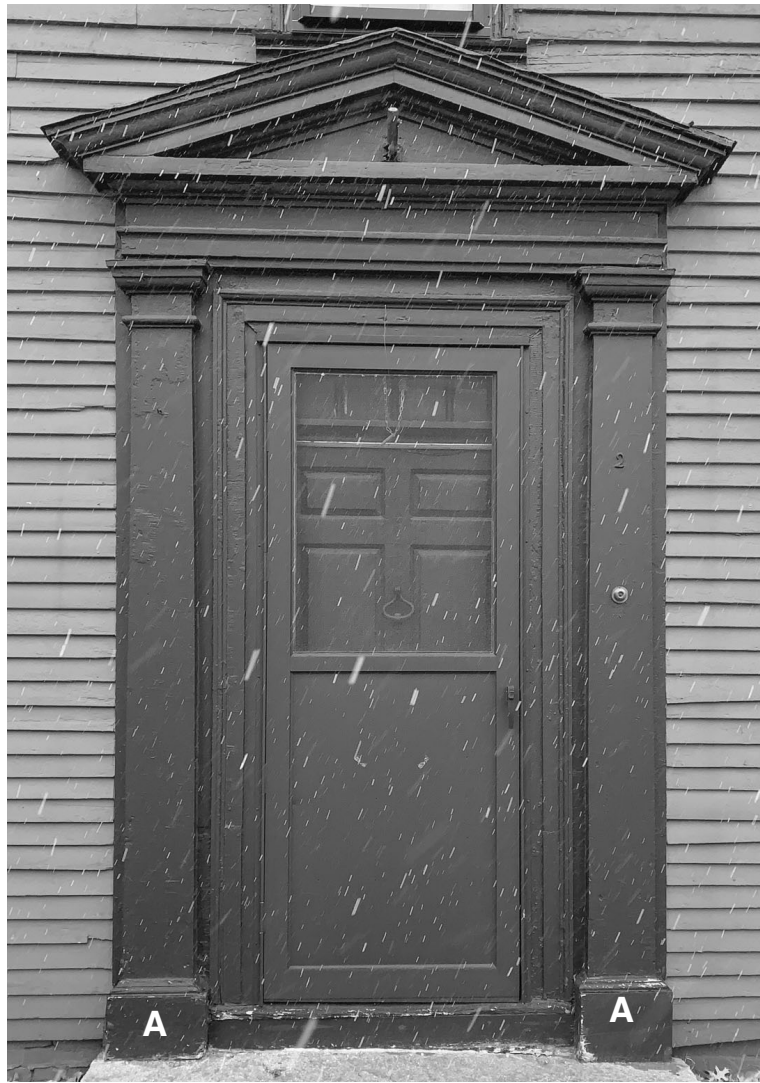
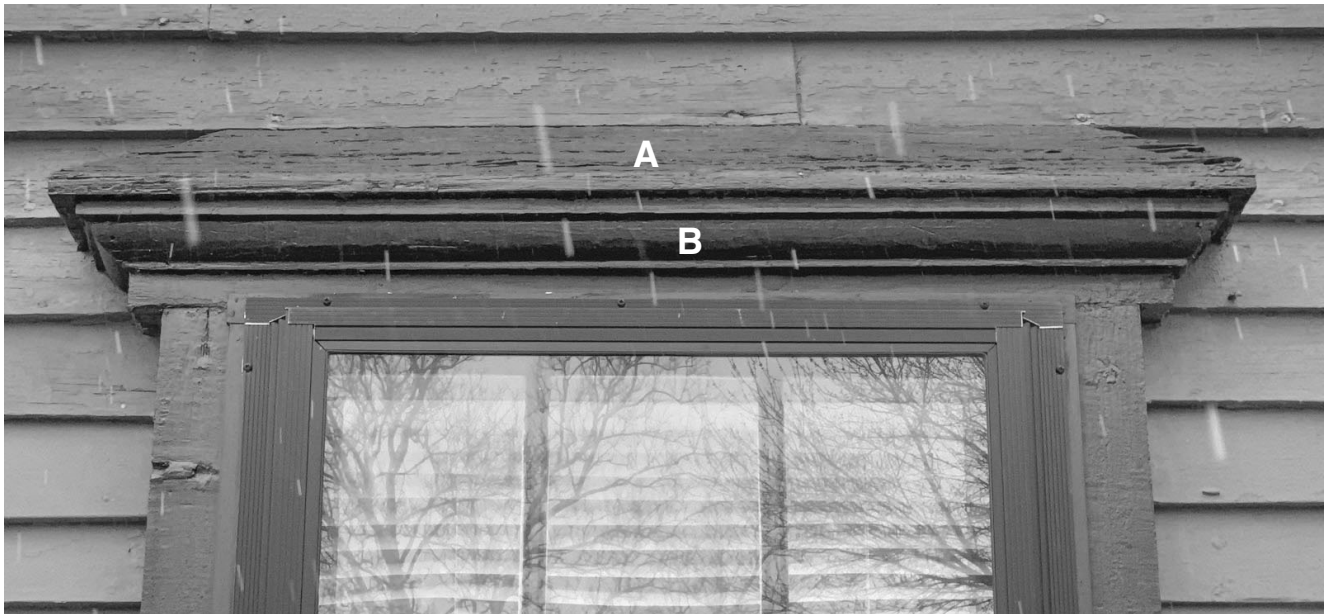
2.4: Window Frame and Head. The head of the window (A) is original or an accurate replacement of the original. "B" appears to be a replacement but is again accurate. The extent of replaced elements at each window varies, but all appear to be accurate. Preservation of the window frames is important.

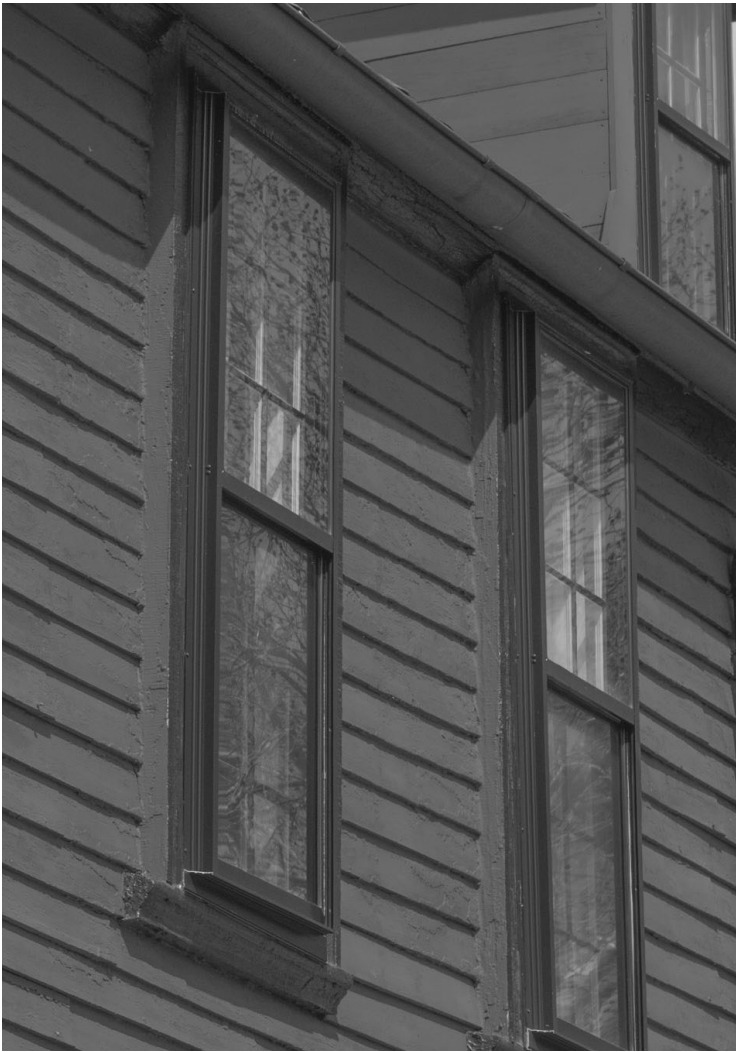
2.5: Window Frame. The original window frames project about 2" forward of the clapboards. They are a distinct type known as plank frames.

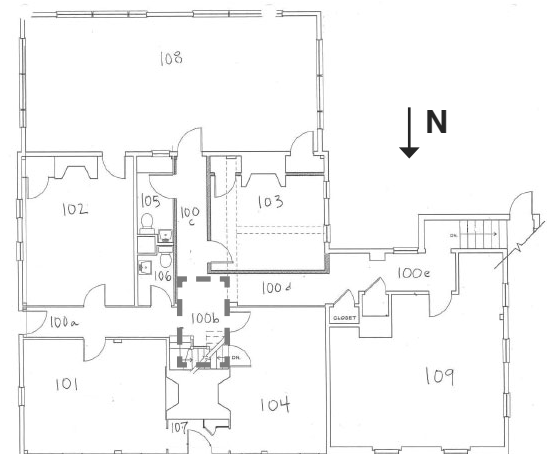
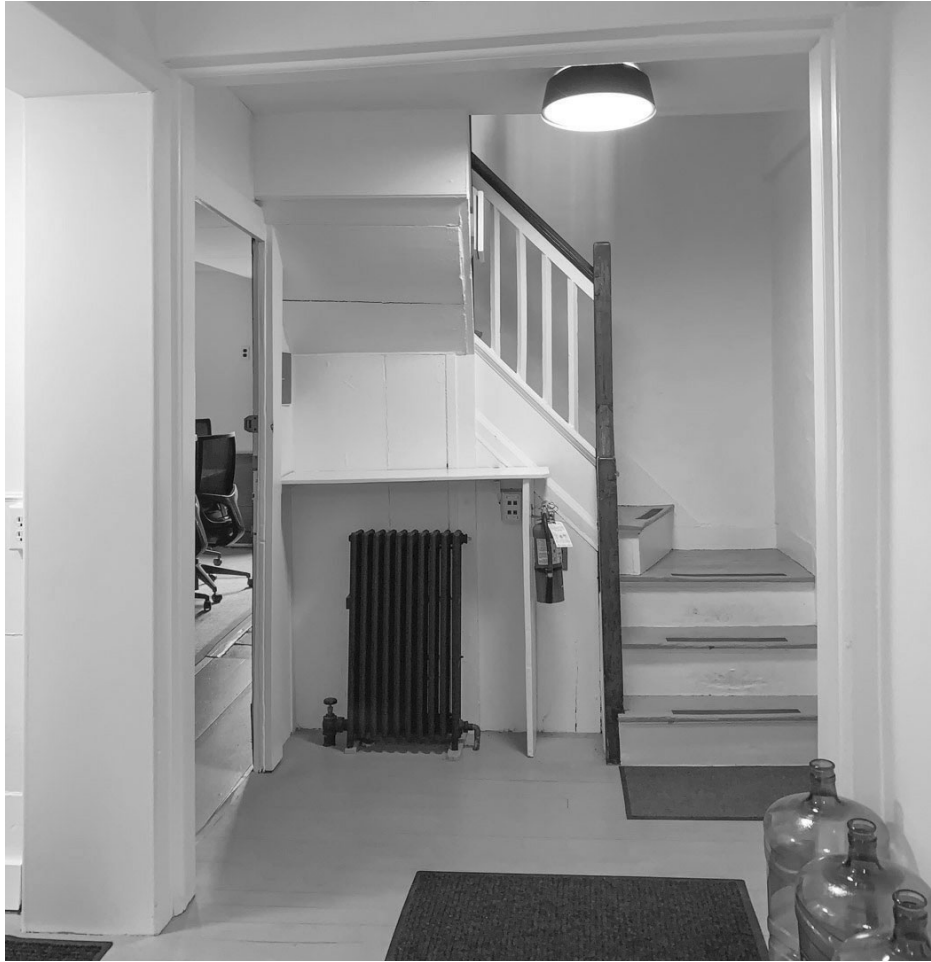
4.2: Room 100b - Stair Hall. All the woodwork forming the stair and the plaster wall beyond it is early, except that the treads of the stair are replacements.

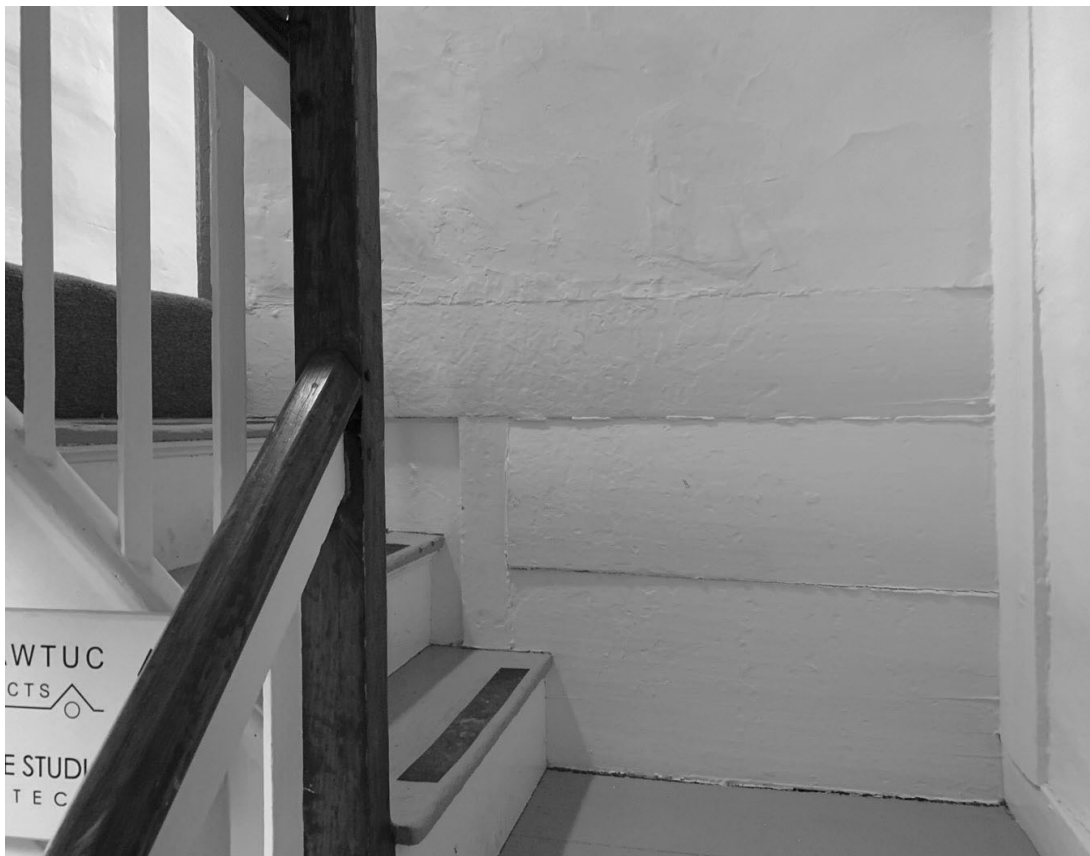
4.3: Room 100b - Stair Hall Detail. The wainscot on the back wall of the stairs is early.

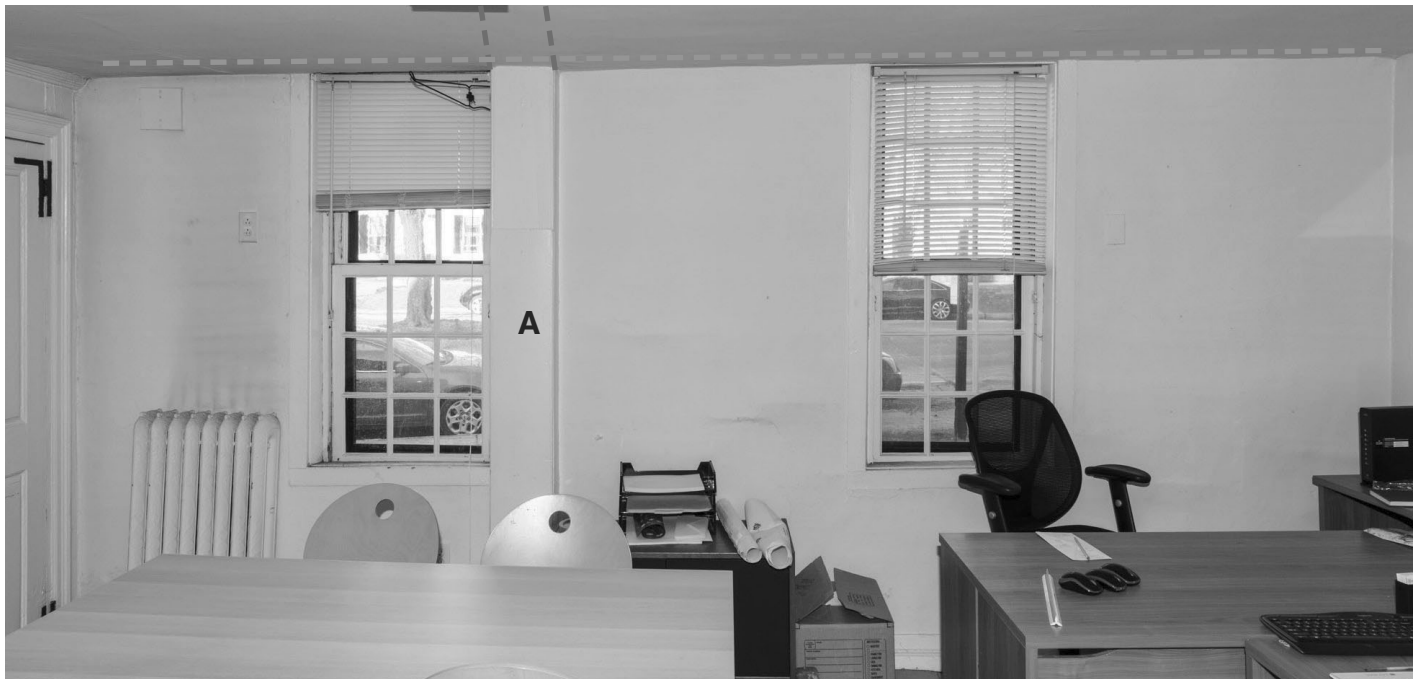
6.2: Room 101 - North Wall. The sash in both windows date to the 18th century, as do the spayed jambs of their frames. The flat casings are early. The heads of the window frames are original but are hidden by the 20th century ceiling plaster. The post casings are original except an early 20th century replacement of the lower section of one board. The wall plaster is early and should be retained. The original wall girt and its casings are likely present above the later plaster ceiling (dashed blue line). The original summer beam is likely present above the ceiling and extends to the post on the south wall (dashed red lines). The baseboard at the bottom of the wall is original.

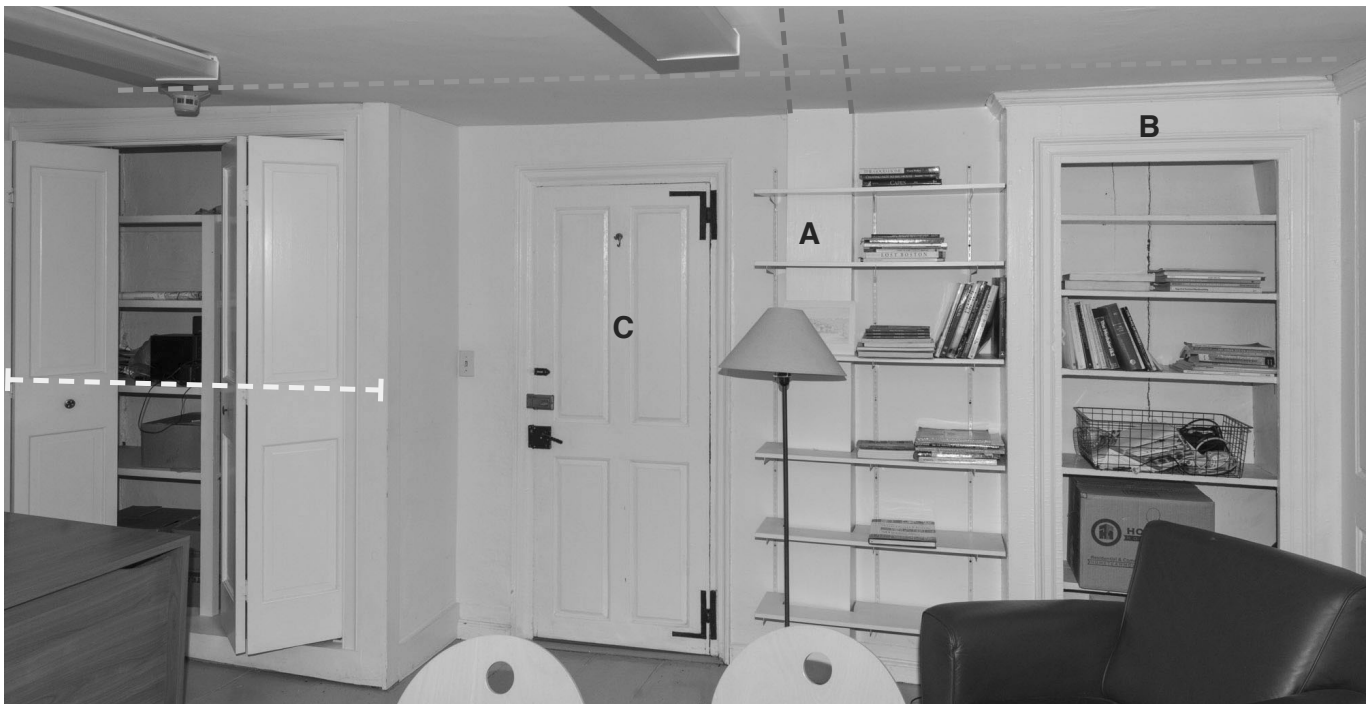
6.3: Room 101 - South Wall. The post "A" is original as is the cabinet "B" is early including its shelves and back boards. Its original crown molding was moved down when the ceiling was lowered. The door "C", its casings, and the baseboard are early. The cabinet on the left (yellow dashed line) is modern. The original southeast corner post and baseboard may be present behind it. The wall plaster is likely original. The shelving in front of post "A" is modern. The original summer beam (dashed red lines) and wall girt (dashed blue line) are likely present above the modern lowered ceiling.

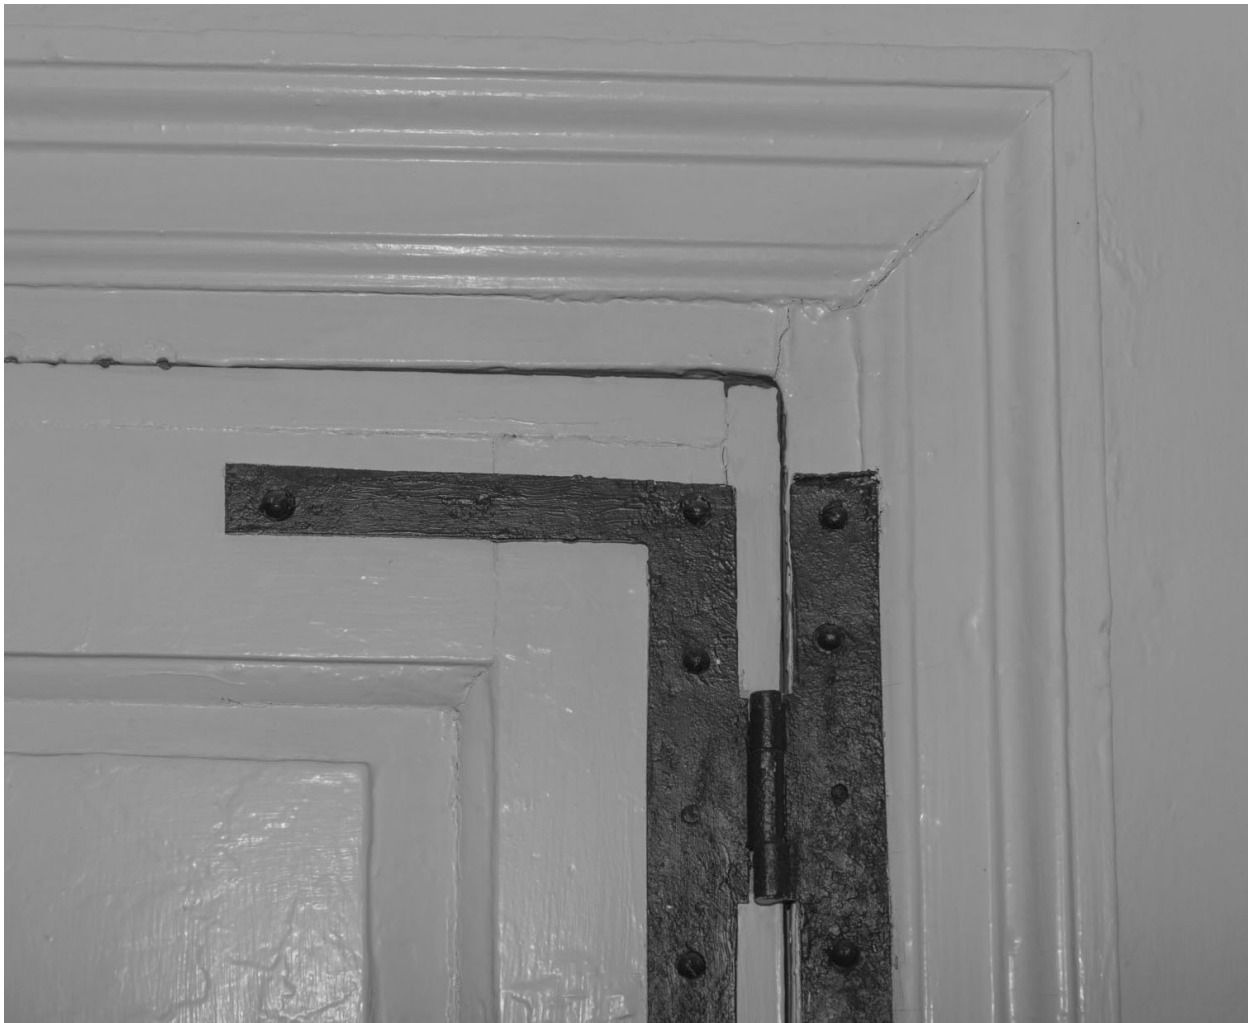
7.5: Room 101 - Door Hinges. The iron HL hinges on the doors are likely early 20th century reproductions that have been attached with modern screws, as they do not show the wear at their knuckles that would be typical for early hinges. While not original, the hinges should still be considered significant. In the period they would have been painted with the woodwork paint rather than being black. The ogee molded casings are typical of the original casings throughout the house.

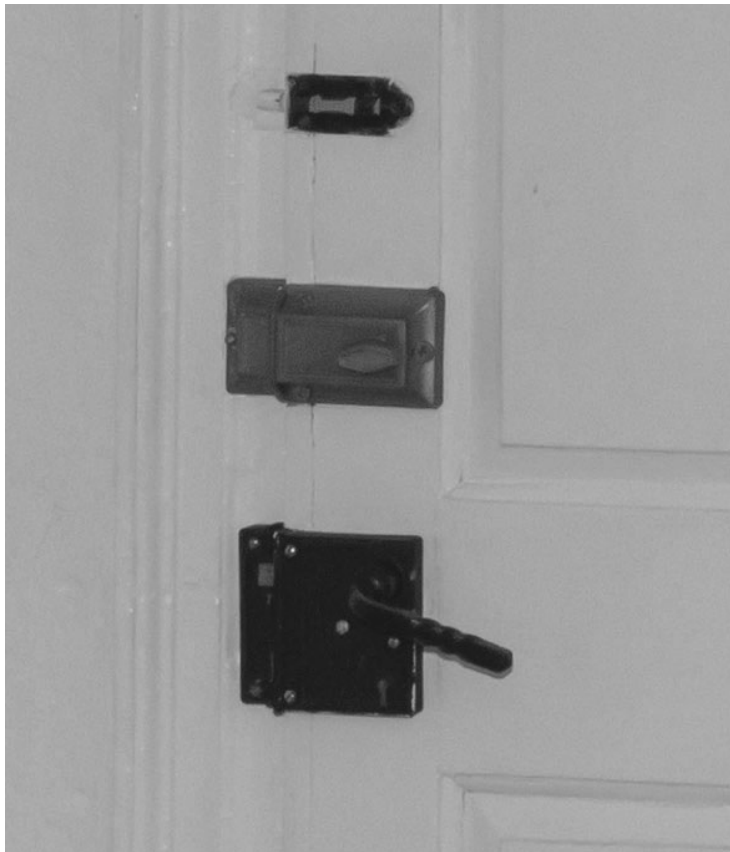
7.6: Room 101 - Door latches. The bottom latch is a mid 19th century latch that has had its original knob replaced with a modern iron lever in response to universal access codes. The middle latch is modern, and the upper siding may be ca. 1900.

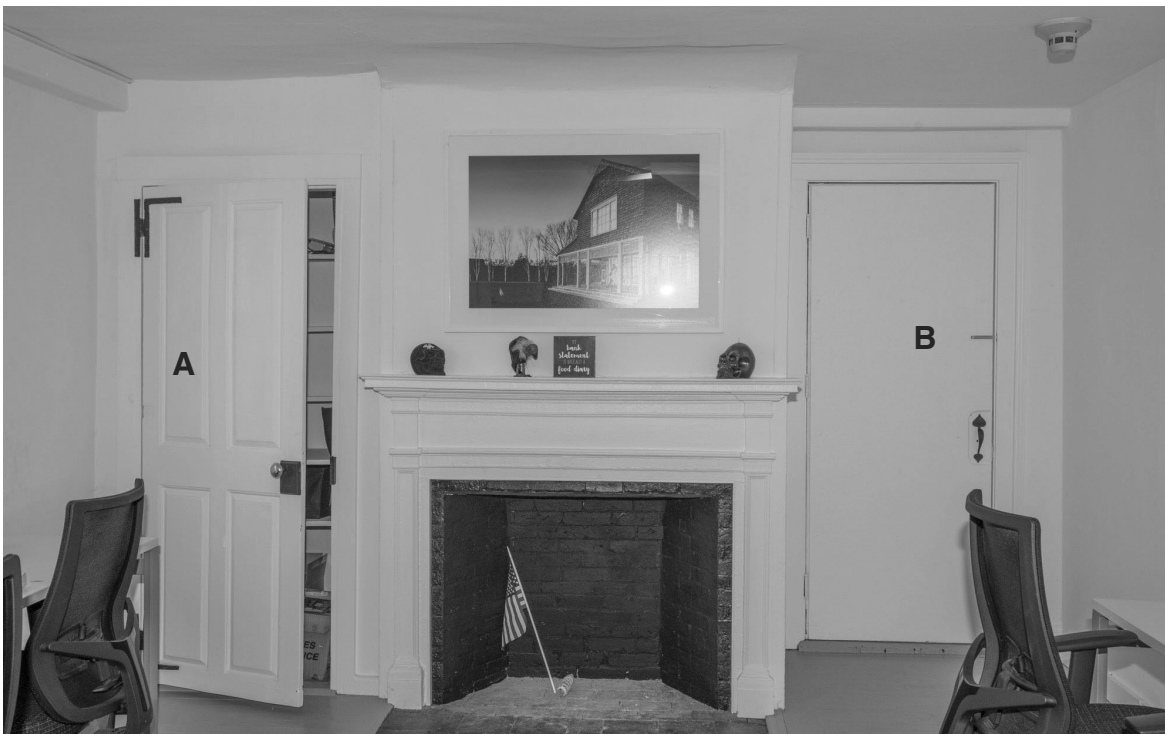
8.1: Room 102 - South Wall. The fireplace mantel and pilasters below it is a significant feature date to the Federal period (early 19th century). The curved material at the top of the chimney breast is likely an early brick half arch supporting the hearth of the fireplace above. Door "A" is a reused 18th century door installed in the early 20th century to create a shallow closet. Door "B" is a reused early 19th century door covered with modern insulation board. It has a modern reproduction latch. Its casings are modern.

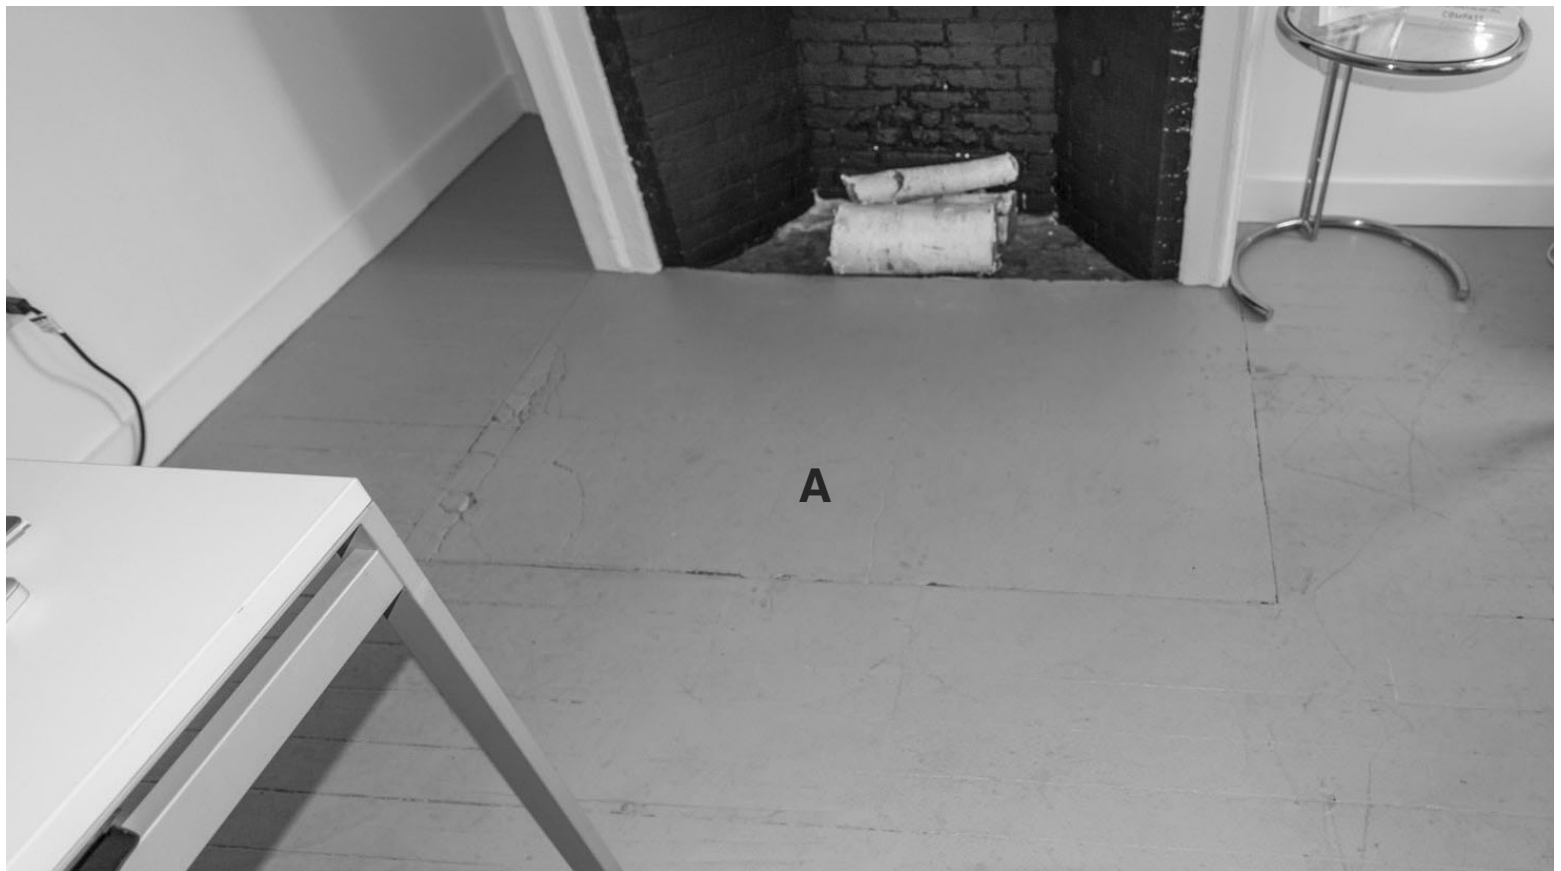
11.3: Room 103 - Floor and Fireplace Masonry. The floor is ca. 1900 narrow boards laid over the original pine floor. "A" marks the large area of concrete that replaced the original hearth in the early 20th century. It was probably installed as a base for a stove. The actual firebox of the fireplace is early, including the hearth brick that are within it.

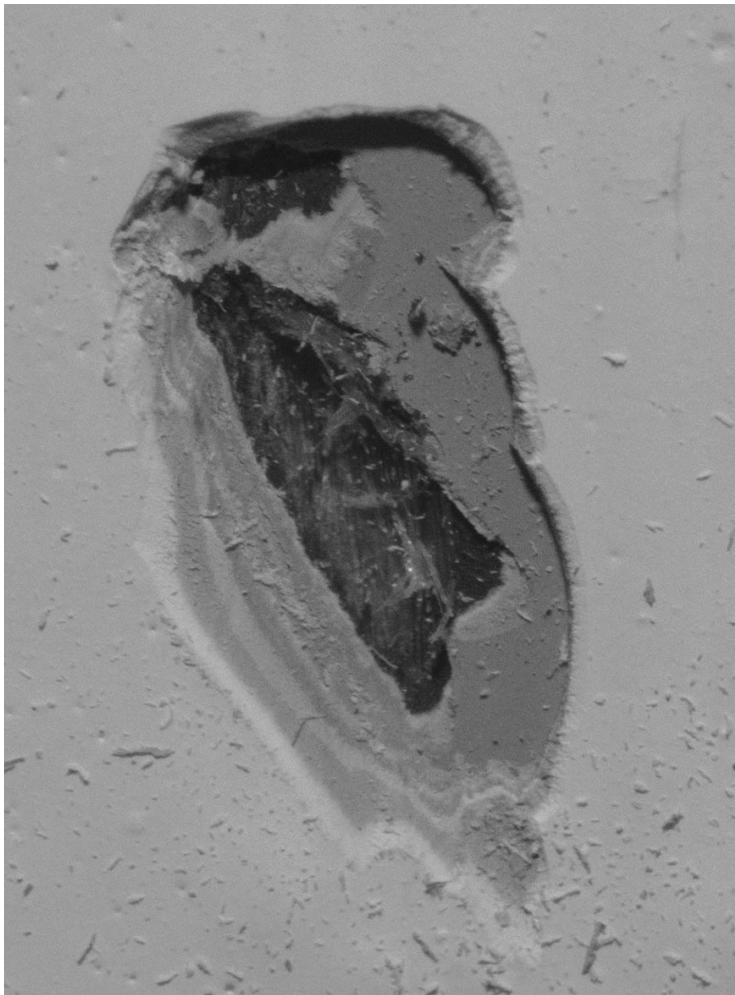
11.4: Room 103 - Paint Sample at "A". The cut into the paint at the woodwork marked "A" in the photo above shows relatively few layers.

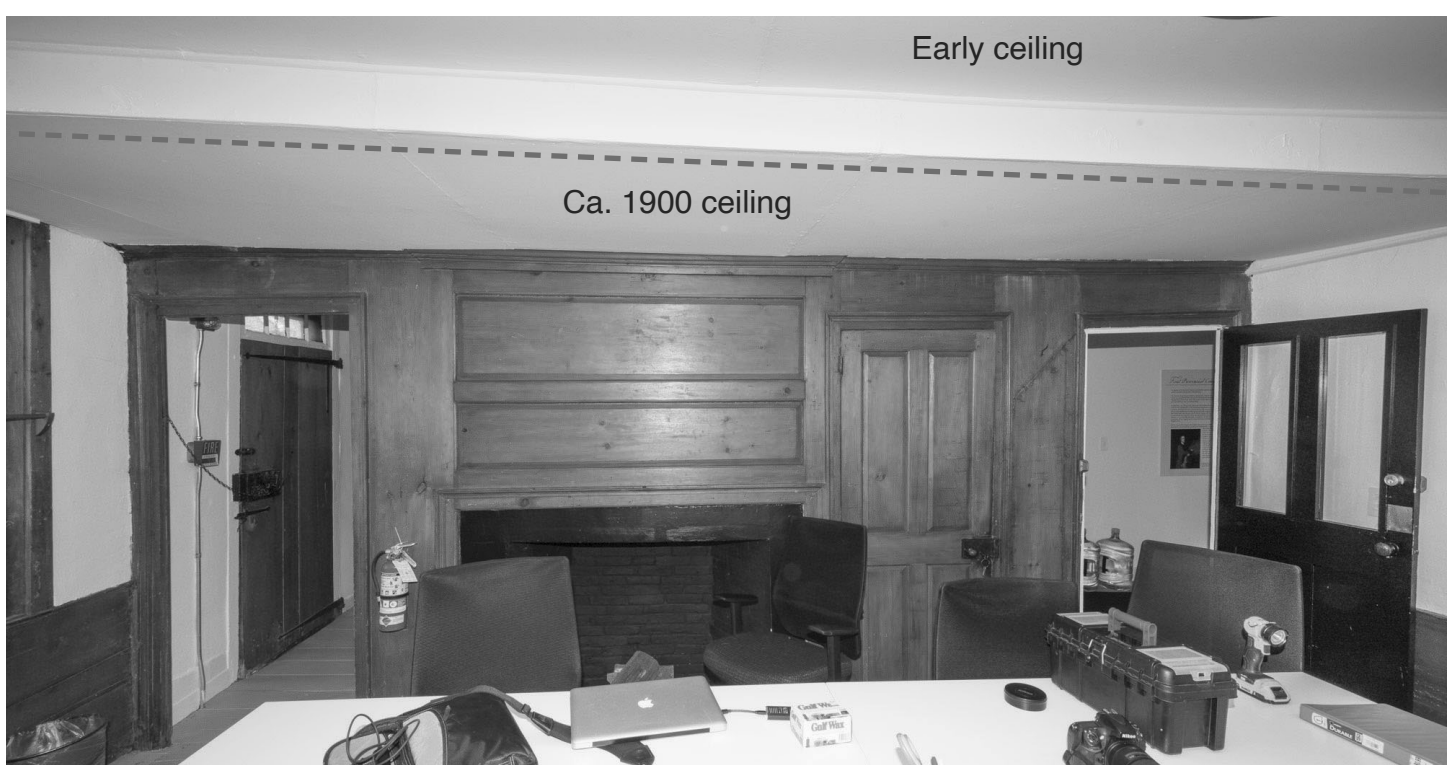
12.1: Room 104 - East Wall. The woodwork of this wall is early, but the removal of its paint makes the determination of past alterations, if any, problematic. The ceiling has been lowered in the eastern half of the room, presumably to conceal early 20th century structural repairs or plumbing. Its plaster is modern. The original north/south summer beam (dashed red line) may present in the edge of the step-down. The ceiling crown molding was moved down to its current position when the ceiling was lowered, and there also may be a ceiling girt concealed at the top of the wall. The door at the right is early 19th century but has had its upper panels replaced with glass.

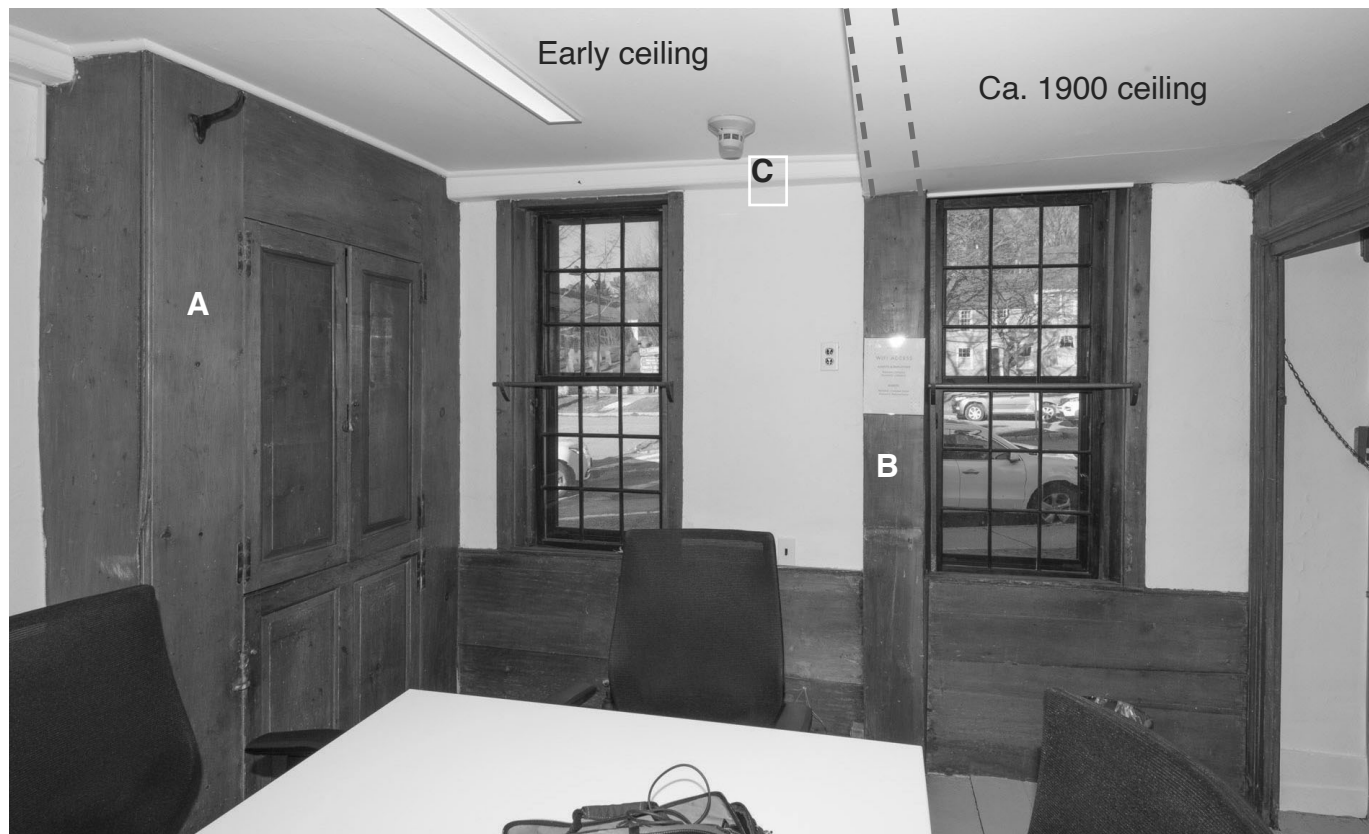
12.2: Room 104 - North Wall. The plaster on this wall is early, as the board wainscot and chair rail and the casing on the post at "B", the window casings, and the ceiling girt casing. The double red dashed line marks the presumed position of the original summer beam above the lowered ceiling. The early cupboard on the west wall is marked "A".

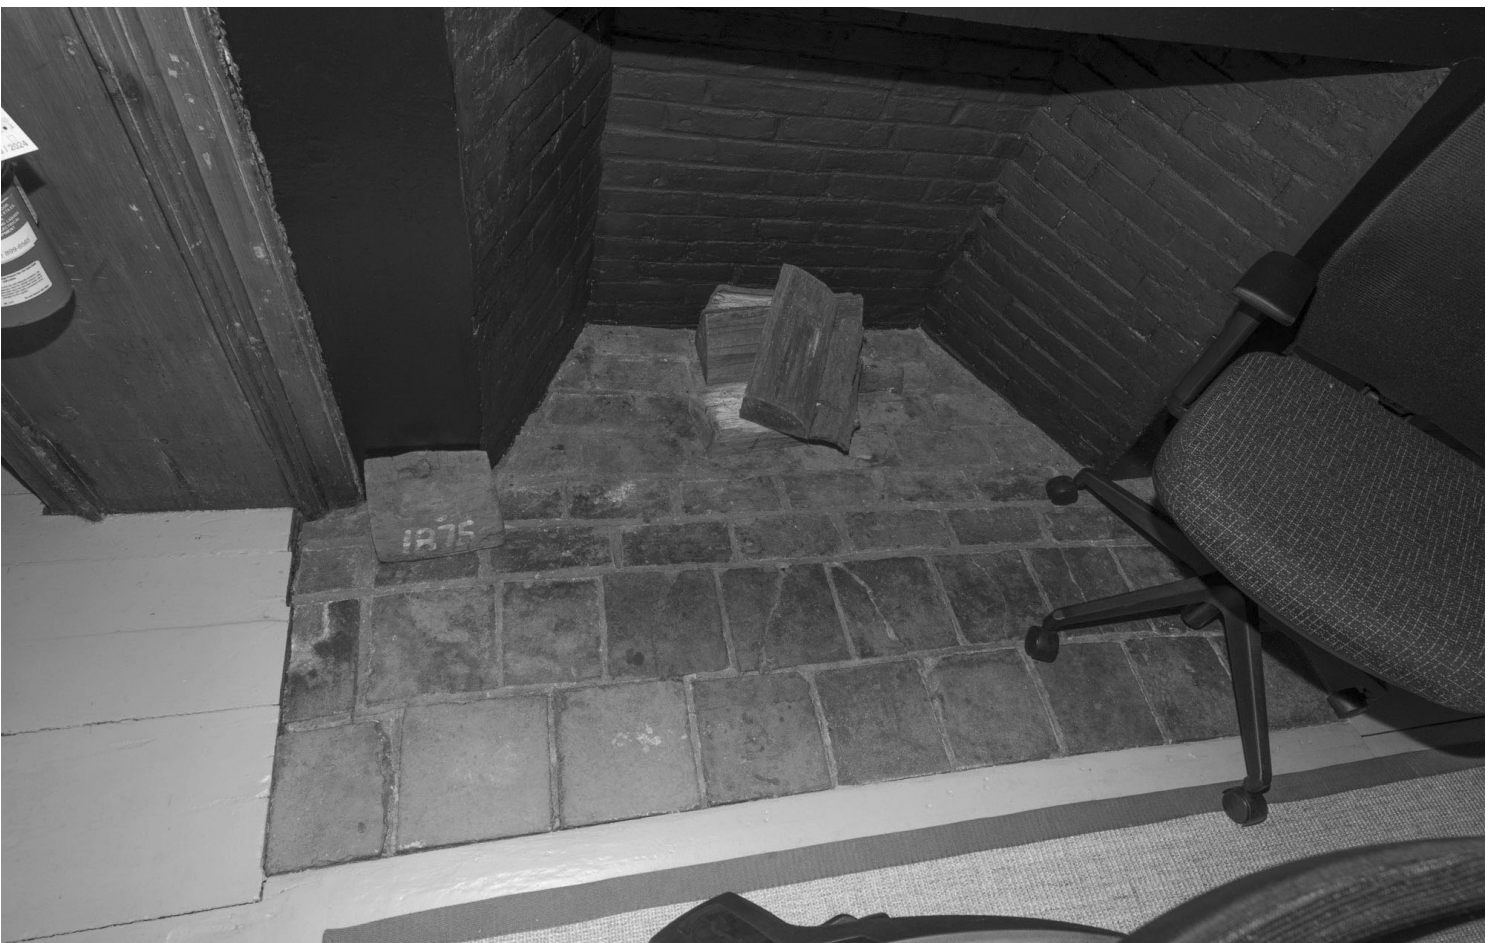
13.1: Room 104 - Fireplace Hearth. The square brick forming the hearth are early but have been relaid in mortar in the 20th century. The fireplace brickwork is early, although some of the brick forming the lower back has probably been rebuilt to replace burnt out brick.

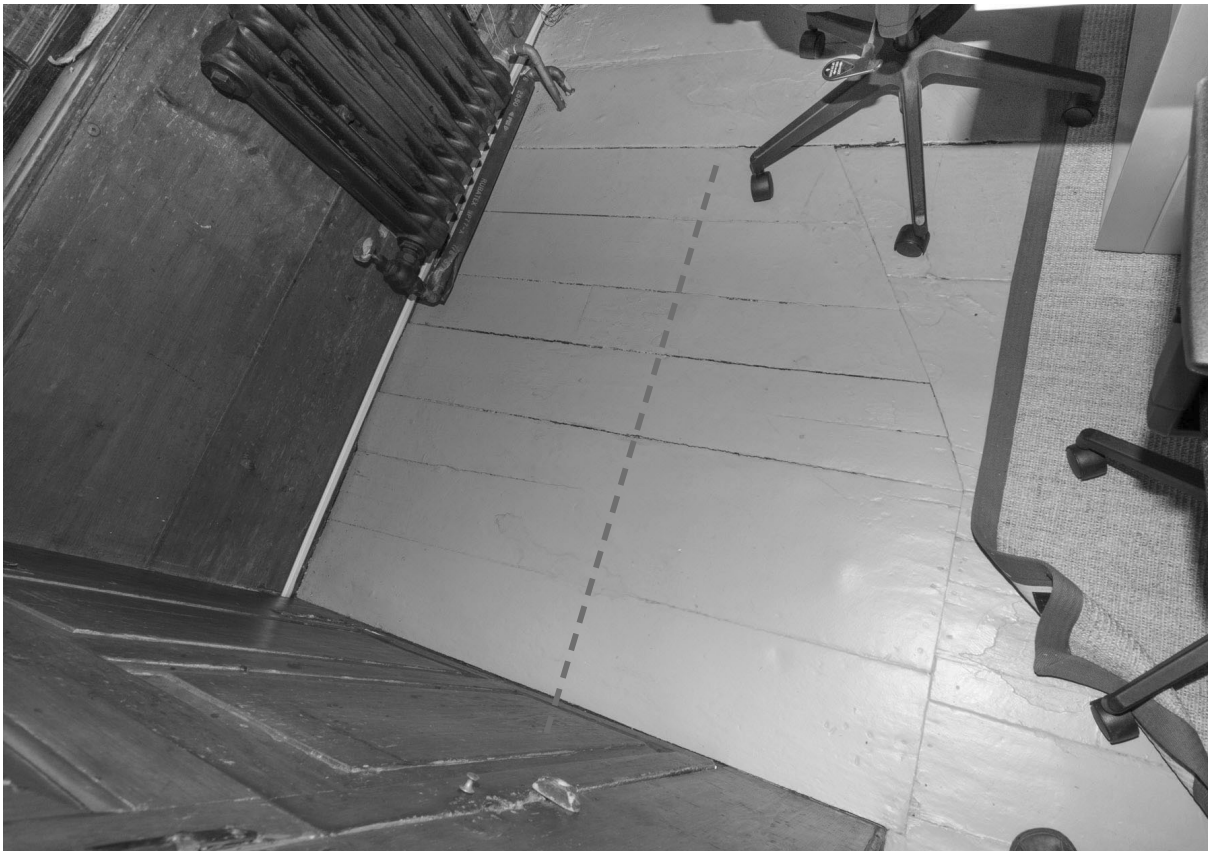
13.2: Room 104 - Floor Alteration. An area of floor boards has been patched in (red dashed line), perhaps relating to the former use of this room as a tap room. As original joists remain in place below the patch in the cellar ceiling, it does not indicate a past access to the cellar. This patch warrants careful preservation.

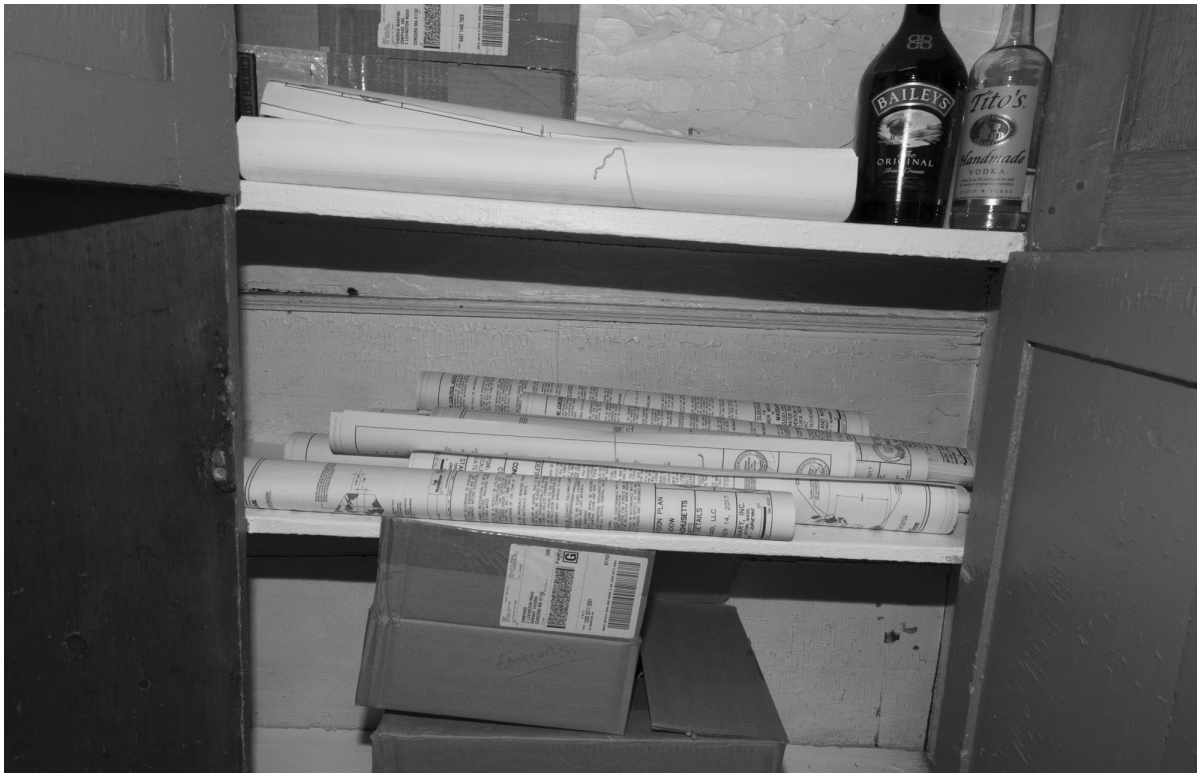
13.4: Room 104 - West Wall Cupboard. Early paint layers remains intact on the wainscot, chair rail, and wall plaster within the cupboard should be preserved in place. The shelving is also early. Although the doors show evidence of substantial modern repair and possible replacement of panels, they should be retained and preserved as part of the history of the building.

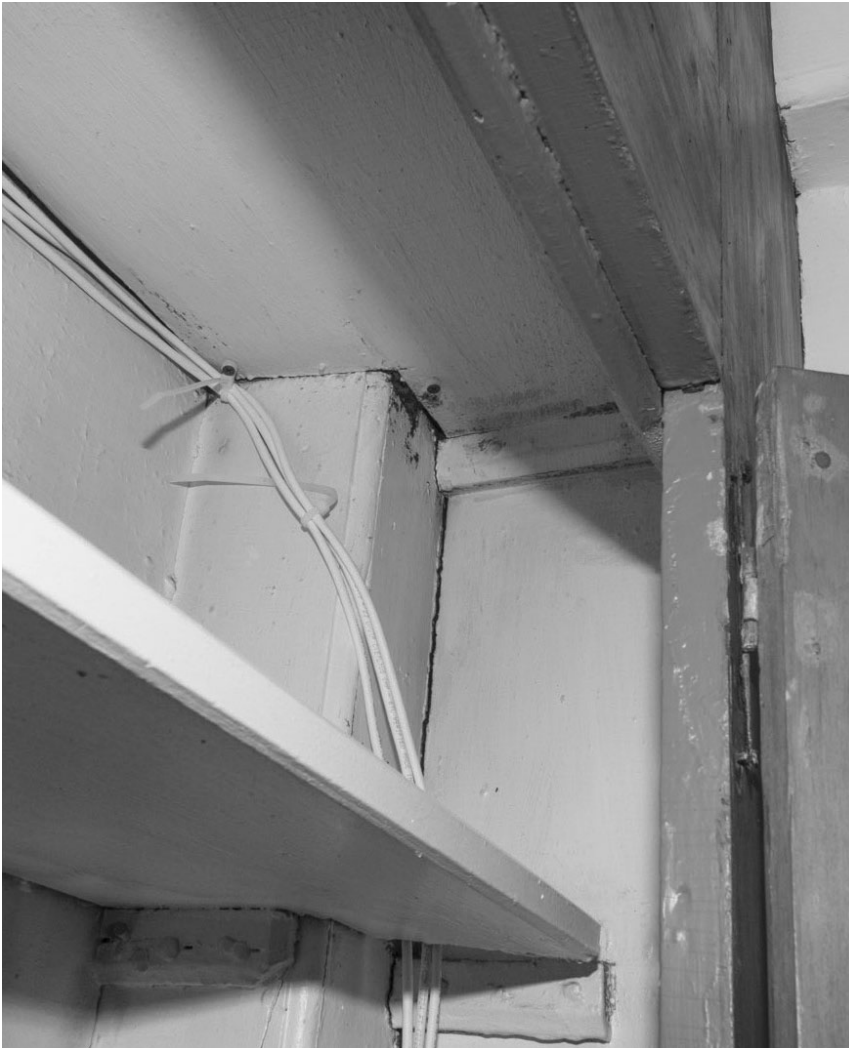
8.5: Room 104 - West Wall Cupboard. The north-west corner post with its early paint is present in the cupboard, and should be preserved.
