1.3: Ell South Facade and Main Block West Facade. The Additions to the ell are early-mid 20th century. First floor window frames on the main block are 19th or early 20th century

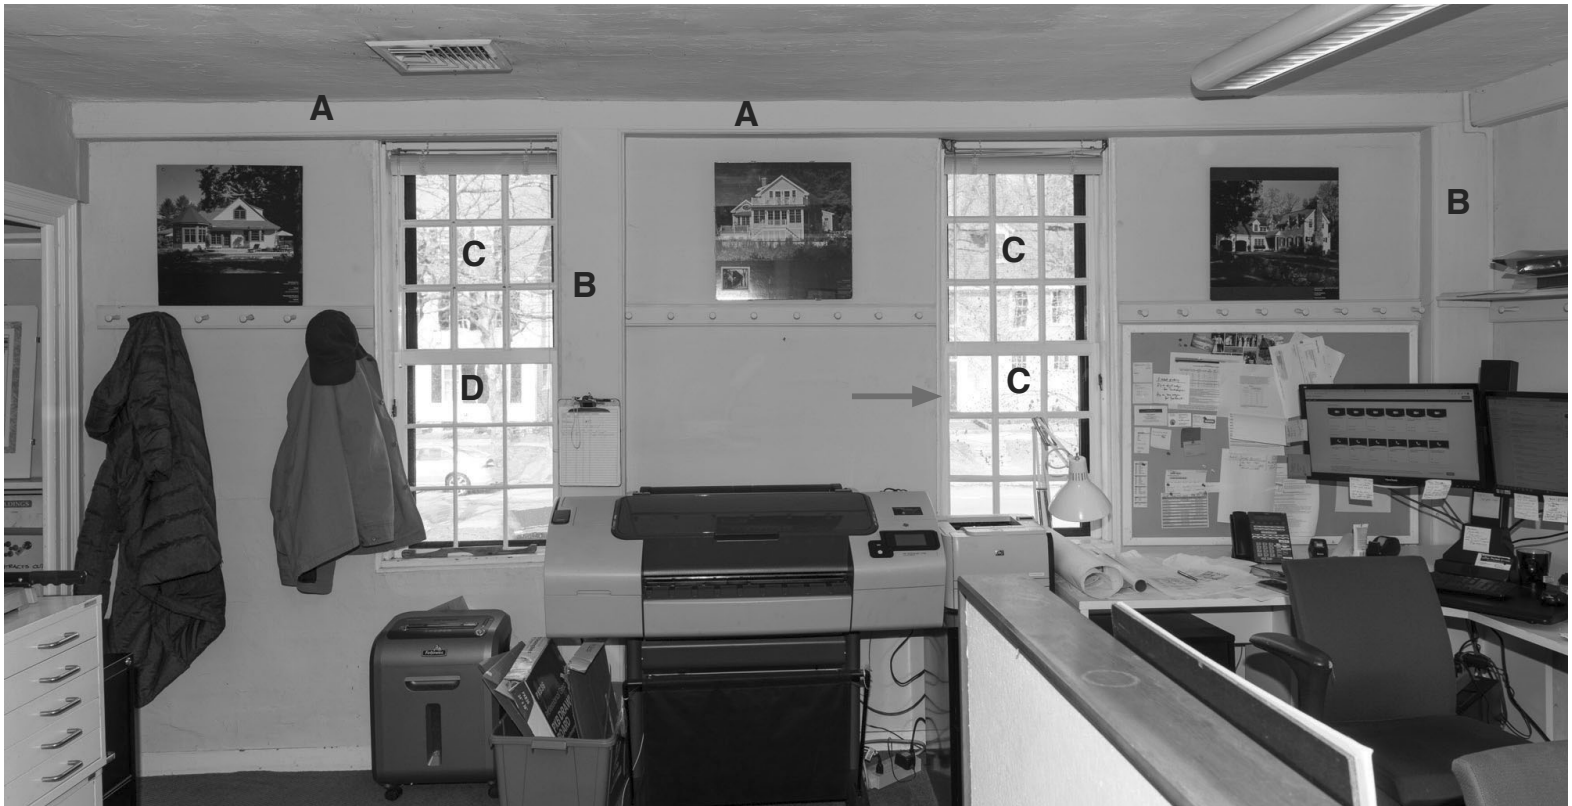
20.1: Room 201 - North Wall. The ceiling girt casings (A) are original, as are the post casings (B). The window jambs and sills are original plain boards with an ovolo molding on their edges at the plaster line (red arrow points to one). The window sash marked "C" are original. The lower sash "D" is an early 19th century replacement. The plaster on the walls is early. The peg boards are modern.

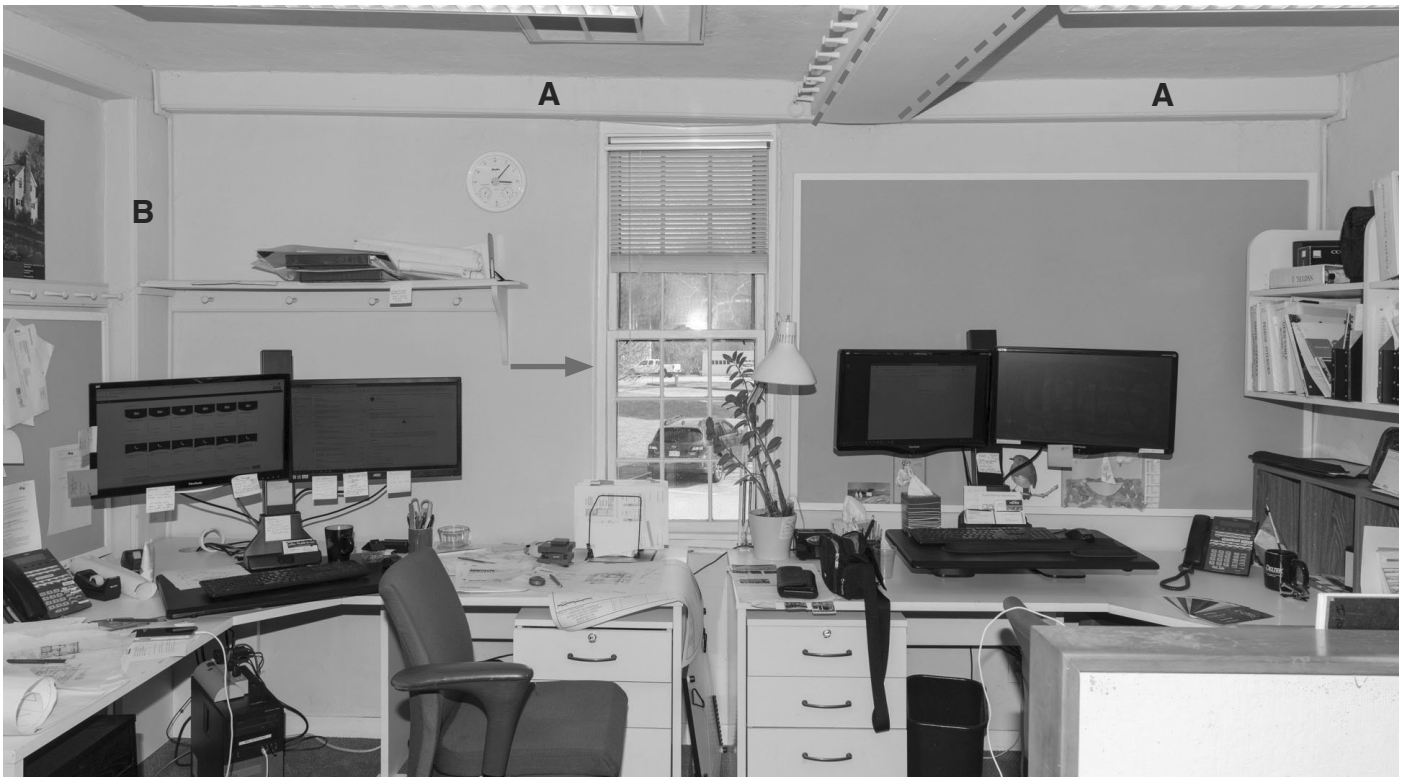
20.2: Room 201 - East Wall. The ceiling girt casings (A) are original, as is the post casing (B). The window jambs and sills are original plain boards with an ovolo molding on their edges at the plaster line (red arrow points to one). The window sash is 19th century. The casings on the summer beam casings (red dashed lines) are original. The peg board on the side is modern. The plaster on the walls is early.

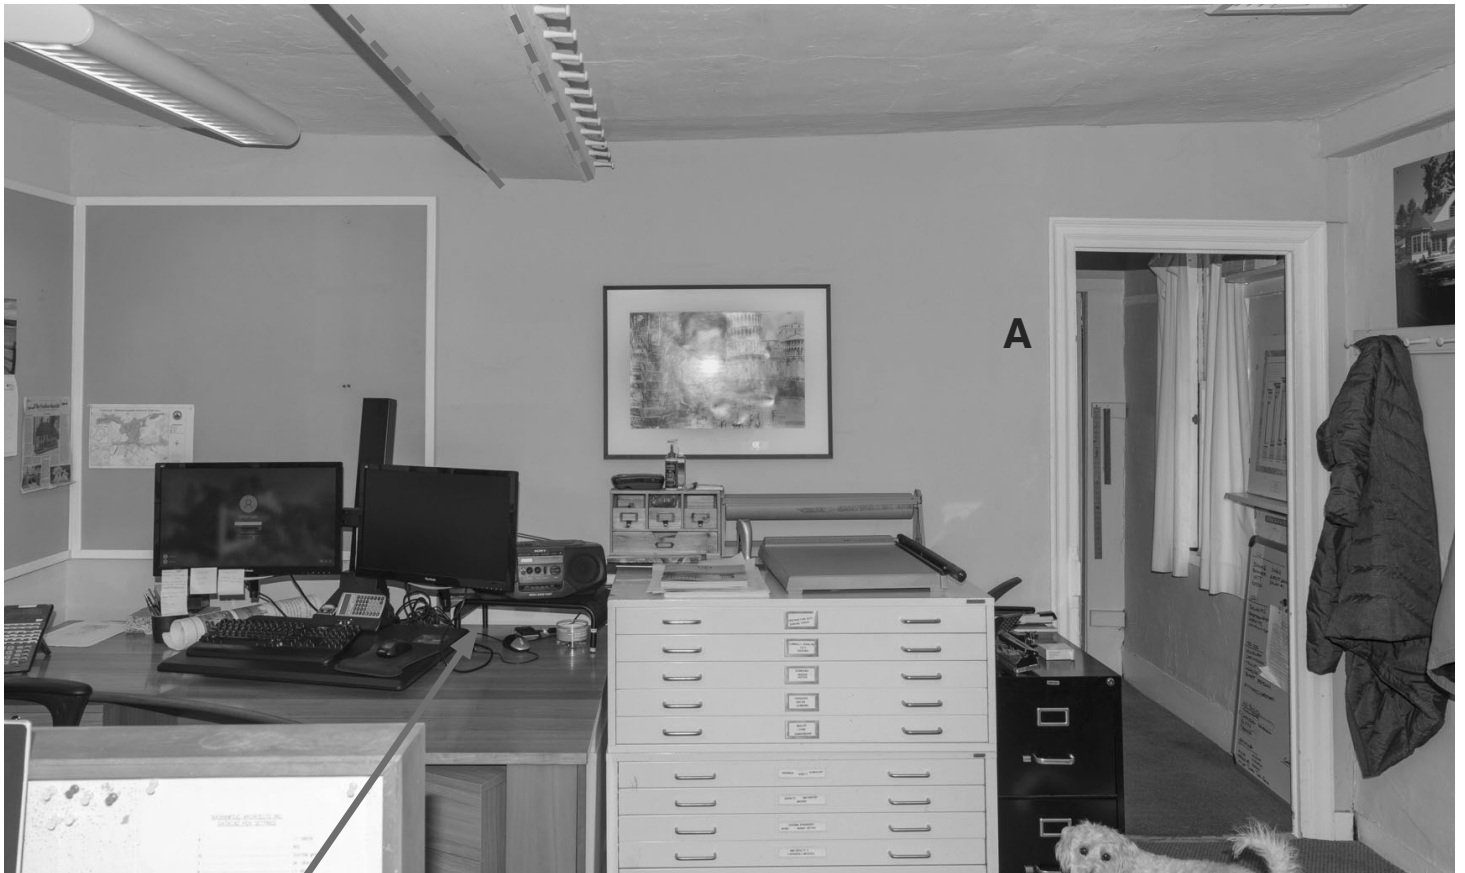
20.4: Room 201 - West Wall. The casings on the door opening at "A" are original or early, but its door is missing. The furniture covers the fireplace and its molded surround, which is original or early (red arrow). The wall plaster is early. The original summer beam and its casings are marked with the red dashed line.

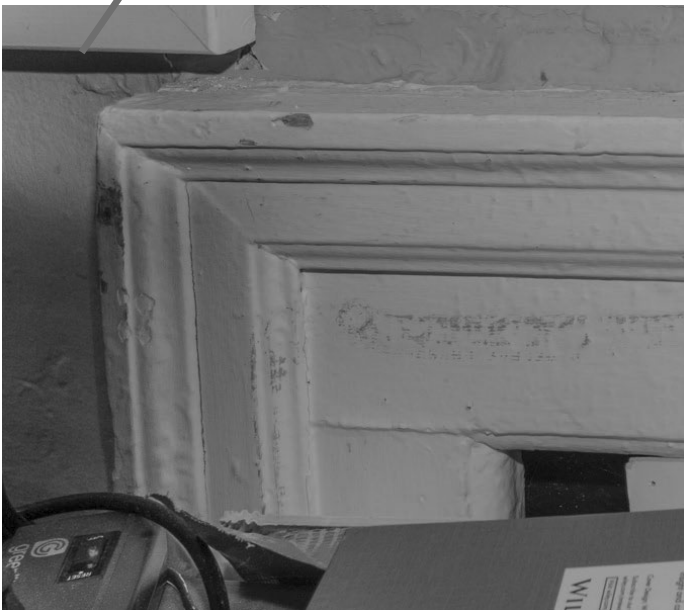
20.5: Room 201 - West Wall. Detail of the early fireplace surround.

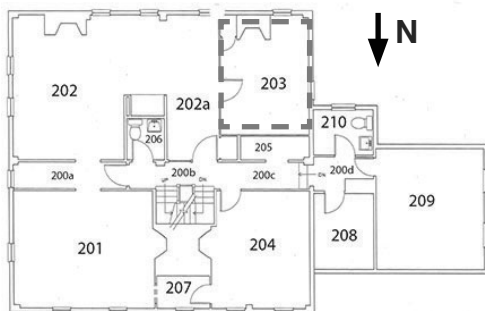
23.4: Room 203 - North Wall. This wall is completely modern, having been installed in the mid 20th century to create room 205.

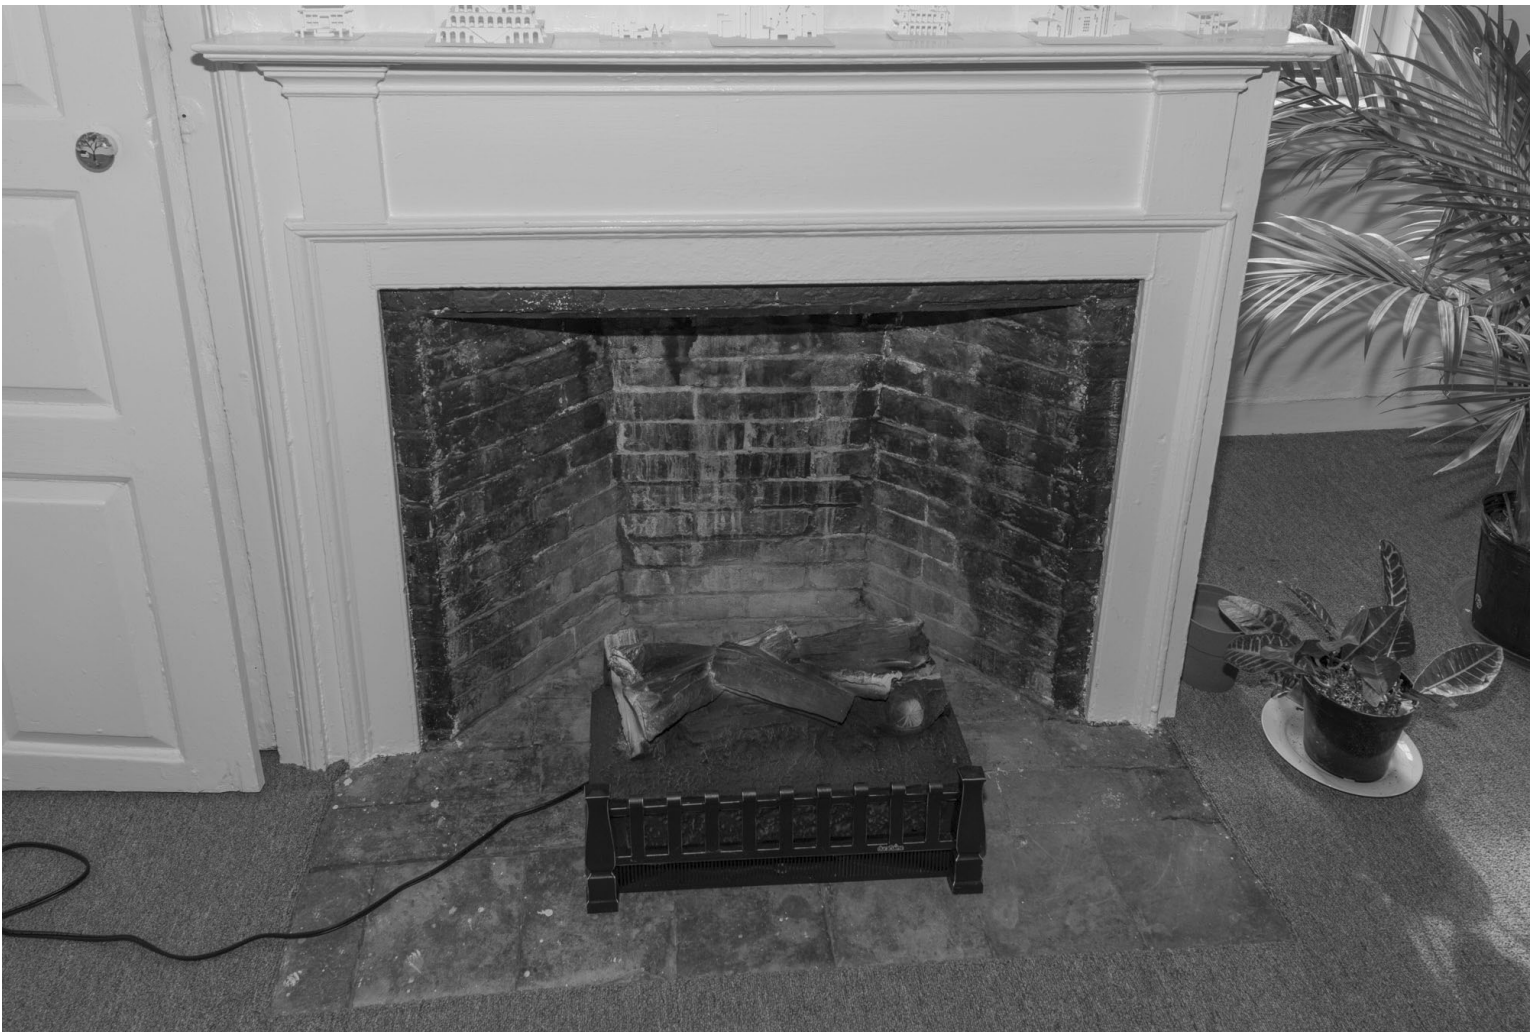
24.1: Room 203 - Fireplace. The hearth for this fireplace uses square bricks that have been set in sand with tight joints indicating it is original to ca. 1815 and has not been relaid. The firebox also appears to be largely original. The fireplace masonry in room 202 (16.1) also appears to be in similar original unaltered condition. The wood mantel is also original to ca. 1815.

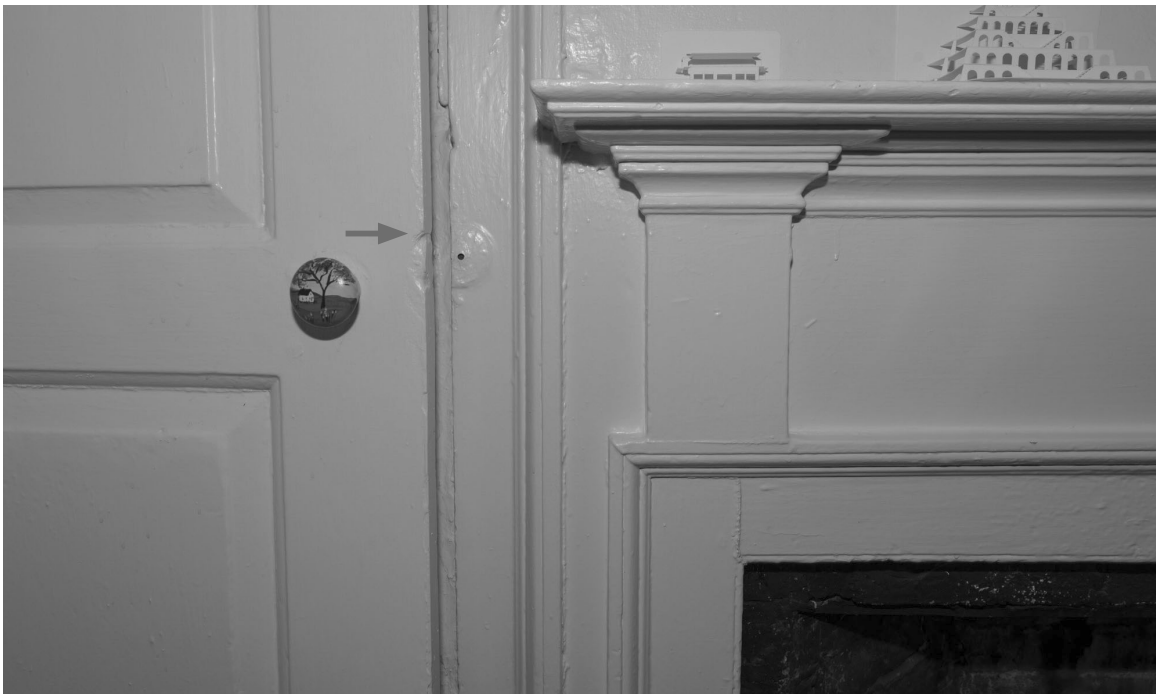
24.2: Room 203 - Fireplace. Detail of mantel showing its details that are original to ca. 1815. The arrow points to a paint shadow on the door and its casing from an early swivel holdfast. The door may be an earlier door that was reused in this position ca. 1815, as its bottom rail has been reduced in height (see 19.1). The door casing band molding matches the fireplace band molding.

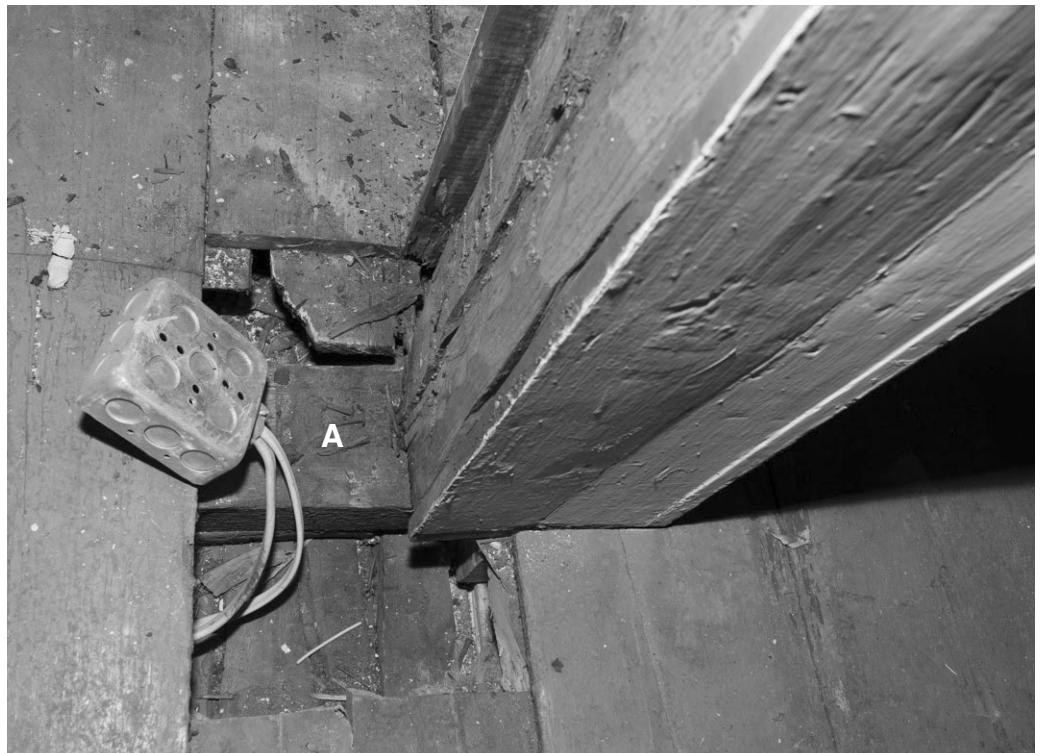
32.5: Room 304 - Base of Post. "A" marks the relatively light original board the post bears on.

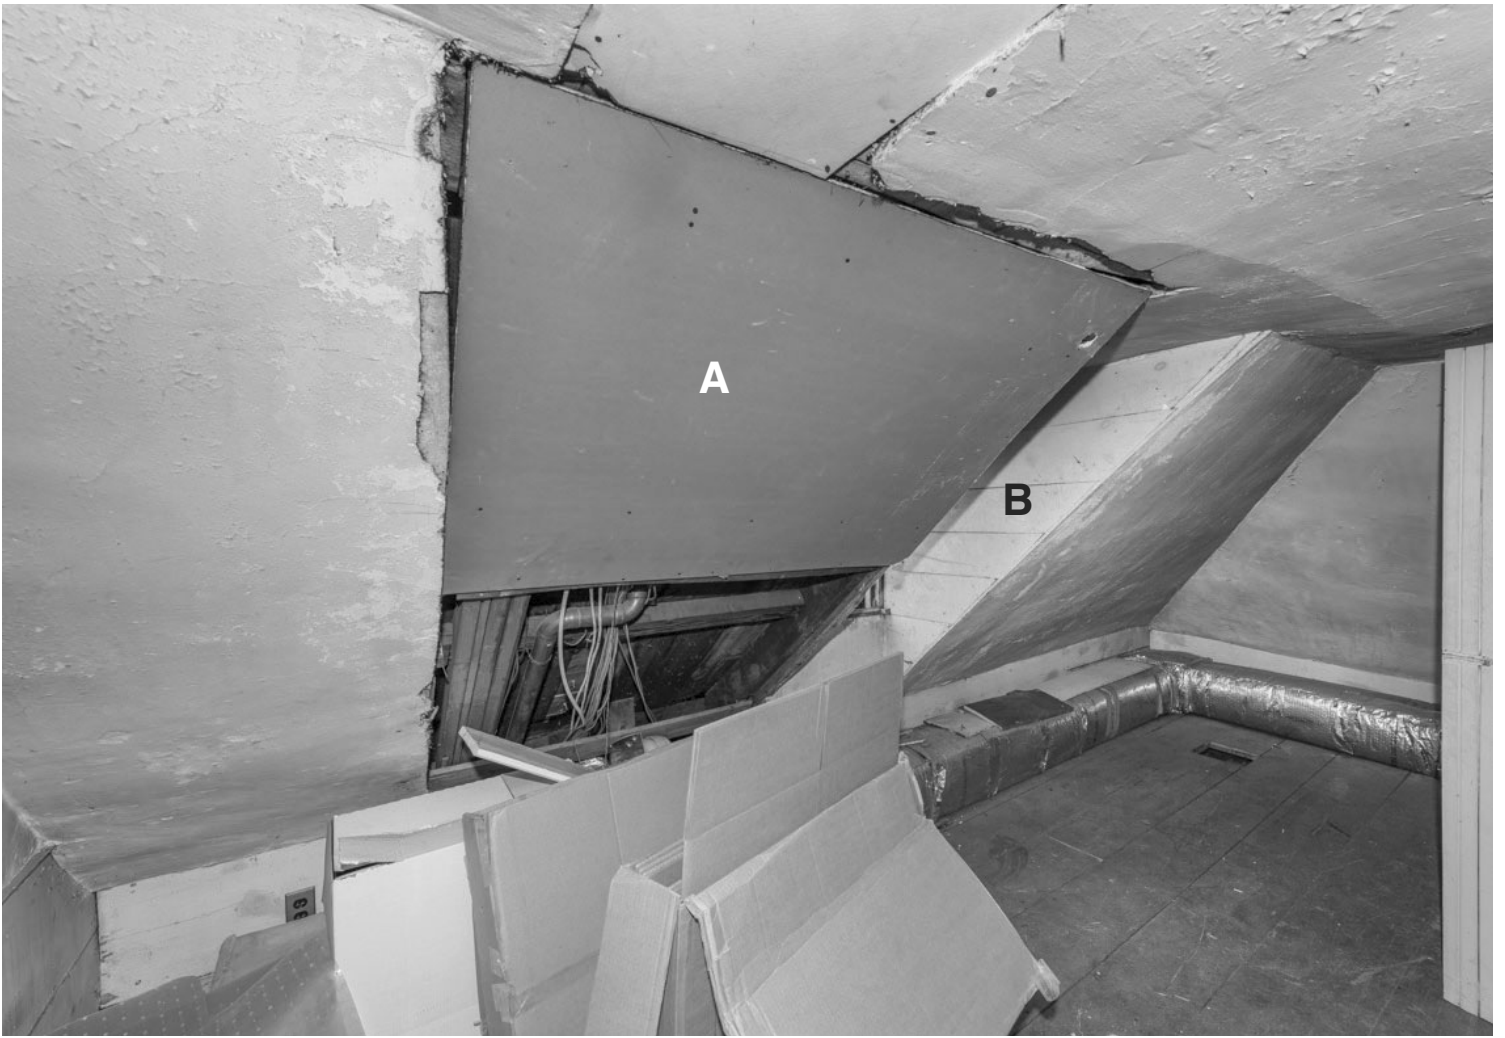
33.1: Room 305 - West wall. The original lath and plaster at "A" has been removed, apparently to install plumbing. The boards on the flank of the dormer at "B" are probably a relatively modern repair of failed original lath and plaster.

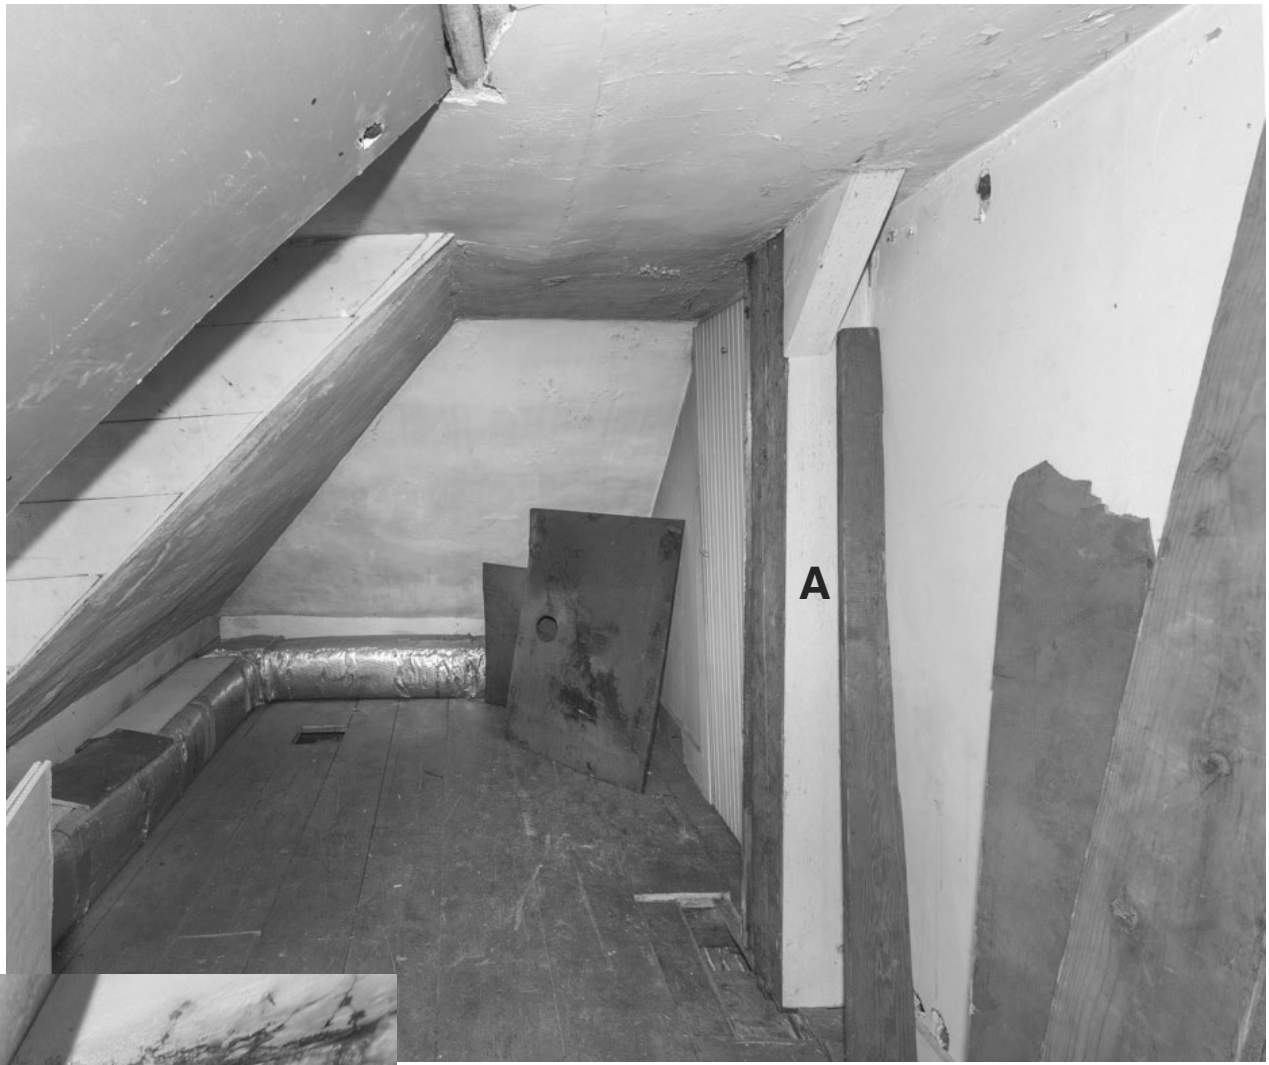
33.2: Room 305 - North wall (above). The east wall is on the right. "A" marks the attic framing post in this room.

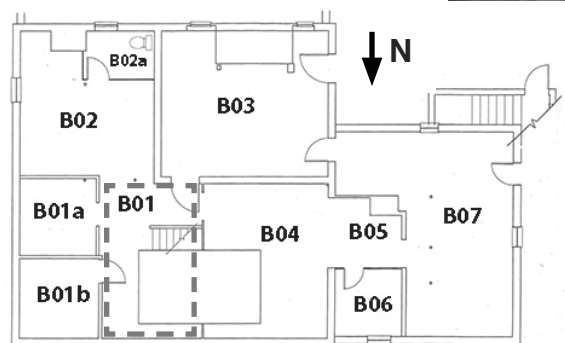
34.2: Room B01 - Looking Southwest. The door "A" is an early double faced door opening into B03 with old strap hinges, but may have been reworked later. Door "B" leads into bathroom B02a that was likely added ca. 1900. The parged brick wall at "C" likely dates to ca. 1815 when the fireplace in B03 was constructed.

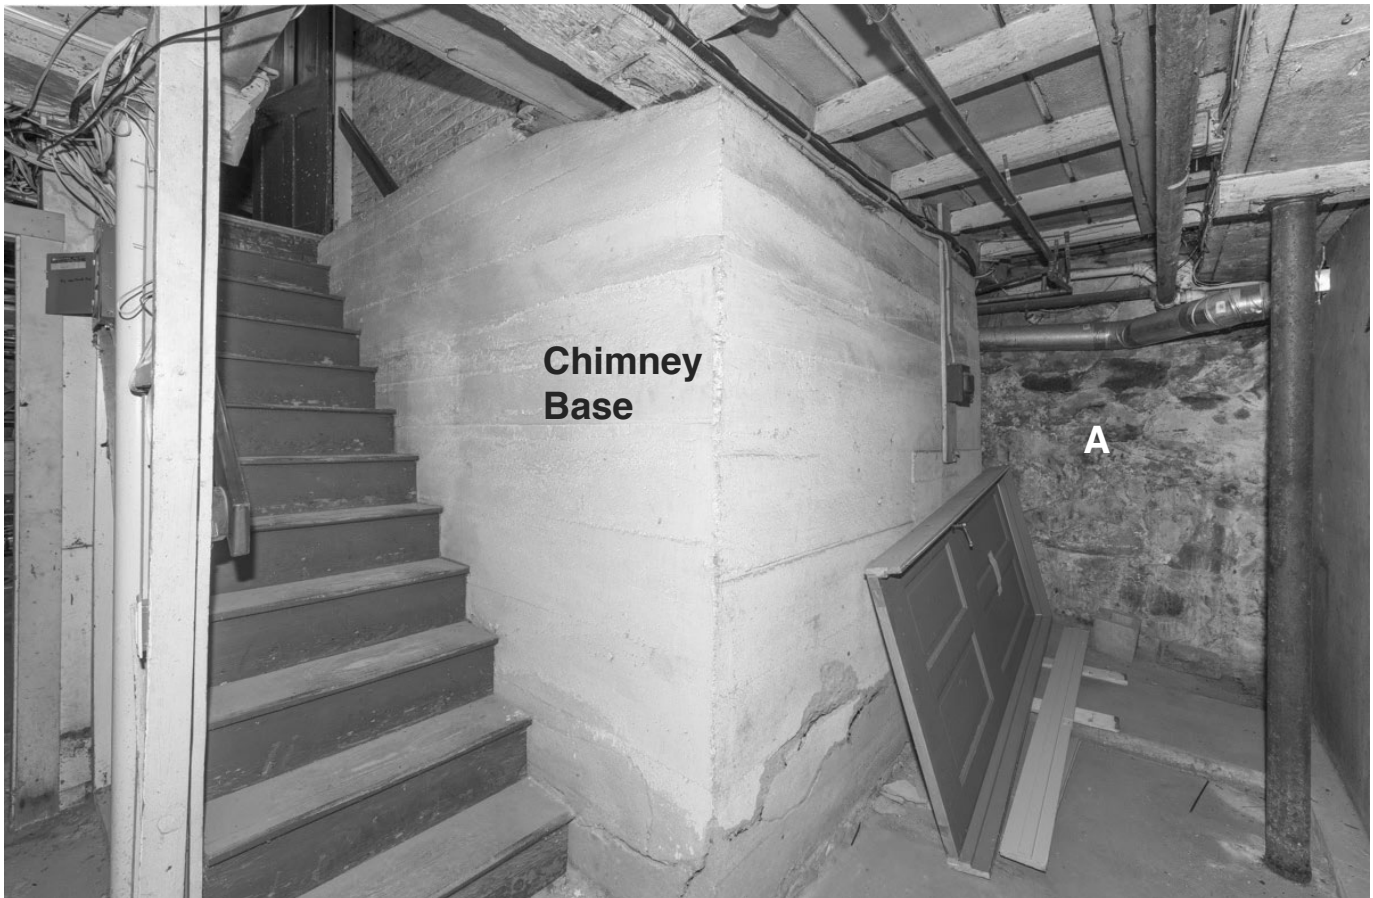
34.3: Room B01- Looking North. The base of the chimney serving rooms 101 and 104 is enclosed within cast in place concrete added in the mid-20th century, presumably to stabilize deterioration of the original masonry. "A" marks the original north foundation wall.

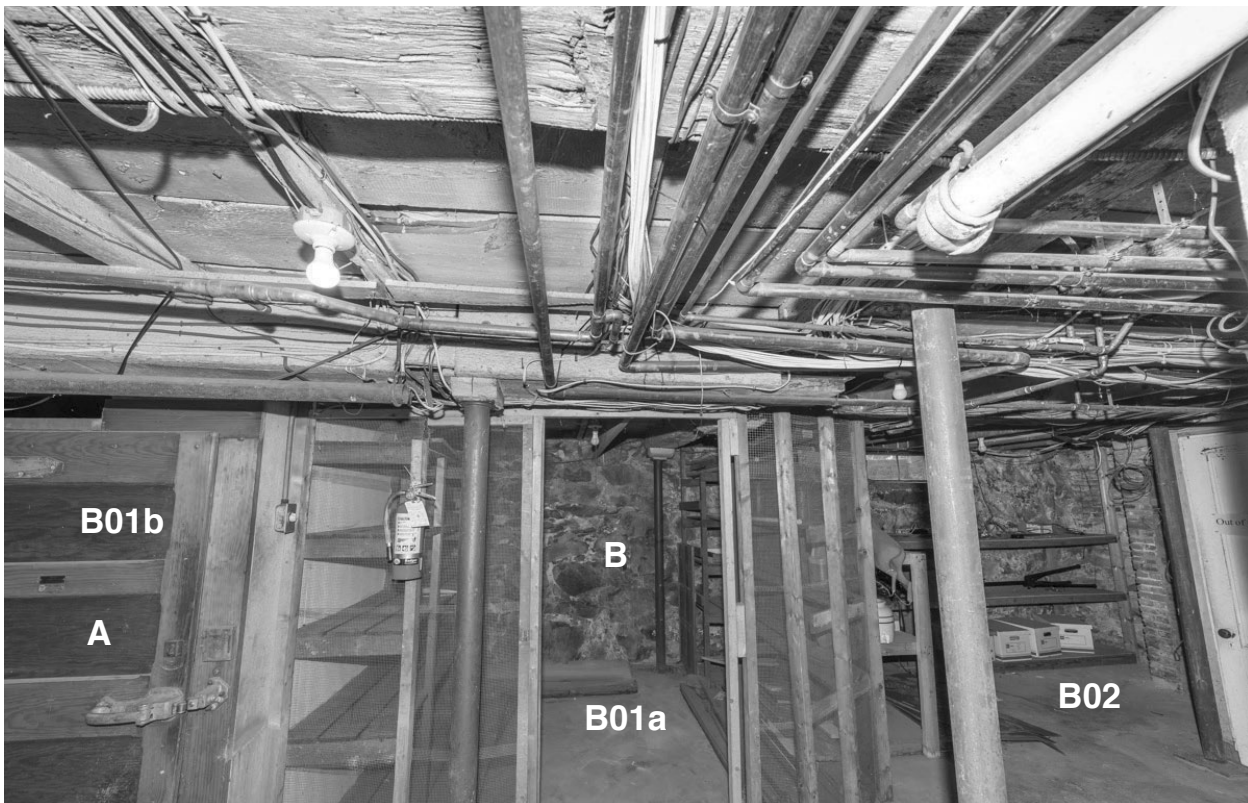
34.4: Room B01- Looking East. View taken from the foot of the cellar stairs. Room B02 is on the right. Room B02b with its door "A" is a cold storage room dating to the first half of the 20th century. B01a is likely mid-20th century. "B" marks the original east stone foundation of the house.

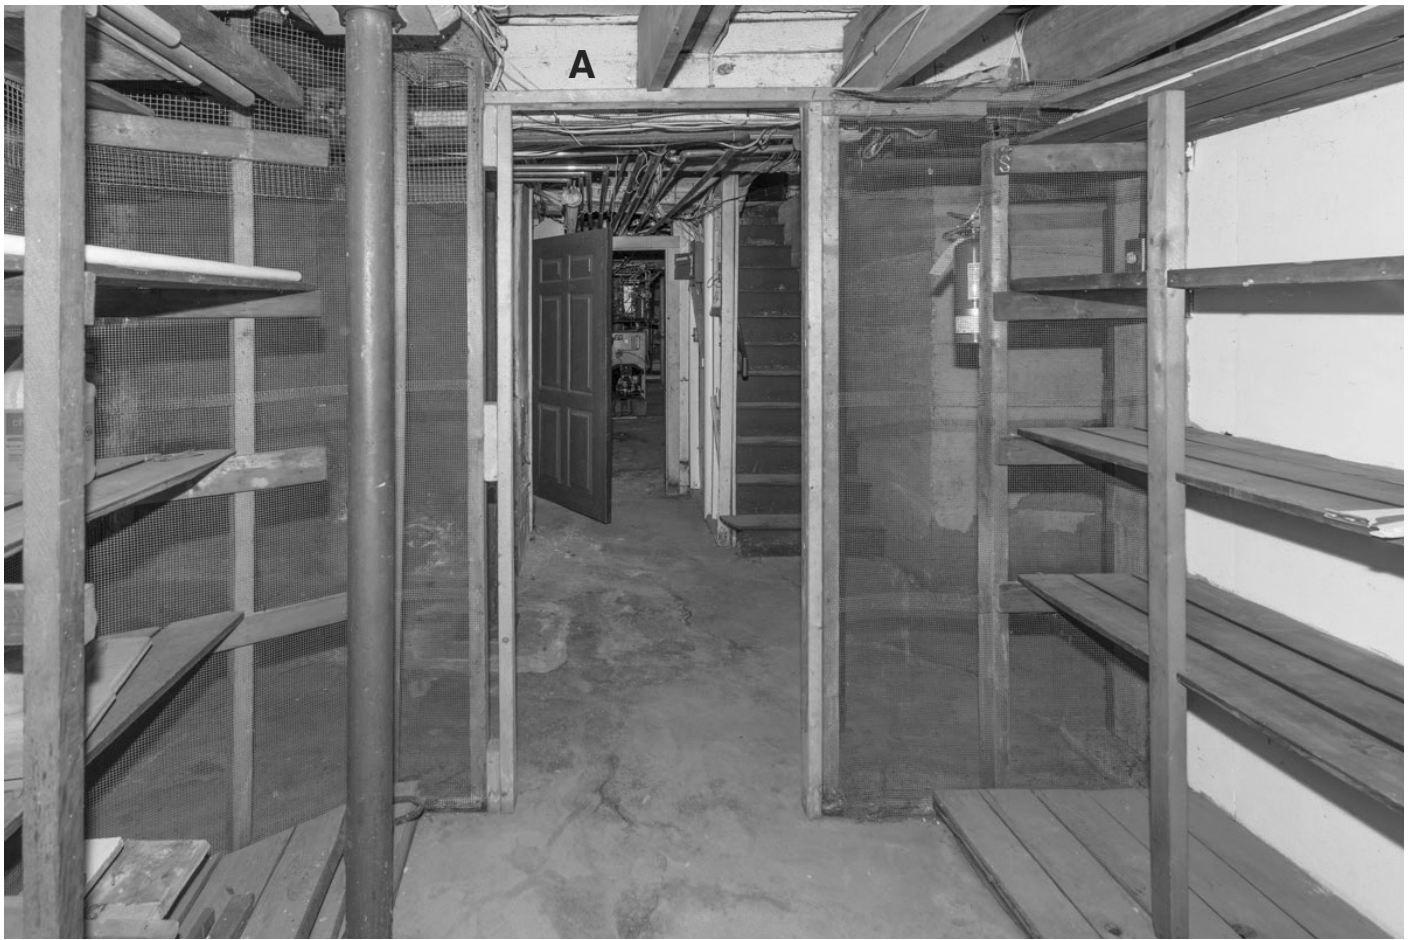
35.1: Room B01a- Looking West. This space was enclosed in the mid-20th century to provide secure storage for supplies for the tavern restaurant. The space beyond is room B01. "A" is the original summer beam for the floor of room 101 above.

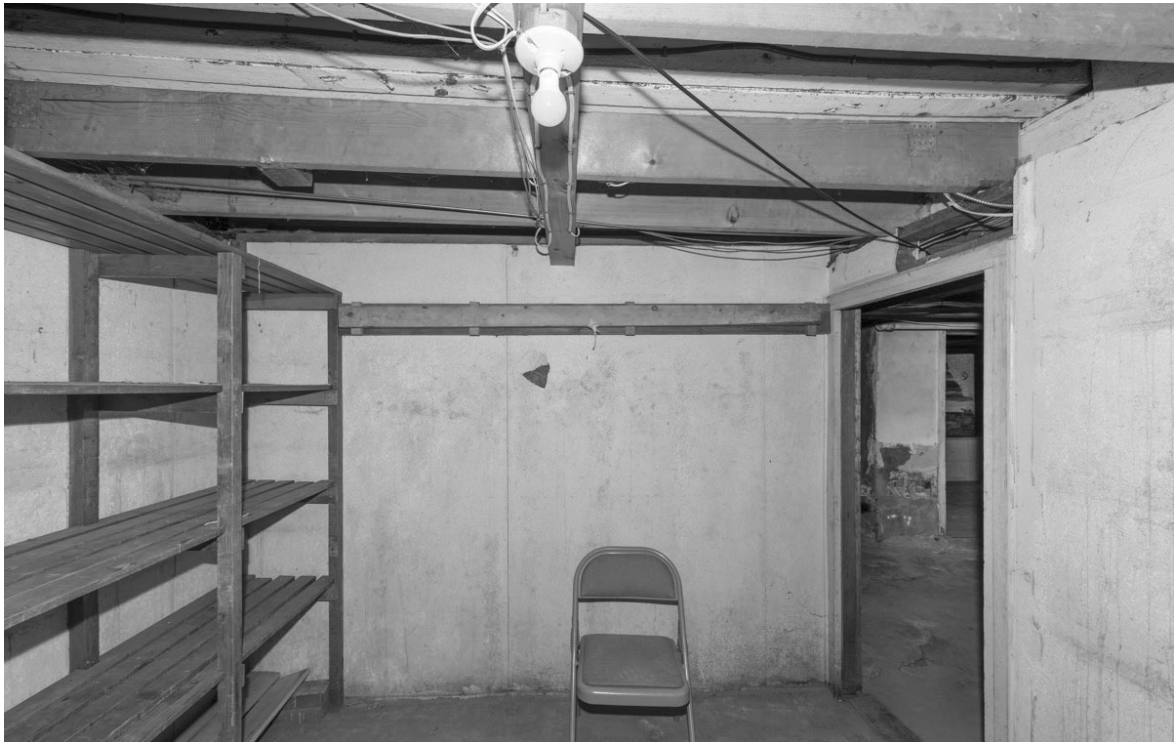
36.2: Room B01b - Looking South. This space was enclosed in the early-mid 20th century to provide cool storage for supplies for the tavern restaurant. Presumably the walls are insulated panels. The left handle wall panels cover the original foundation wall.

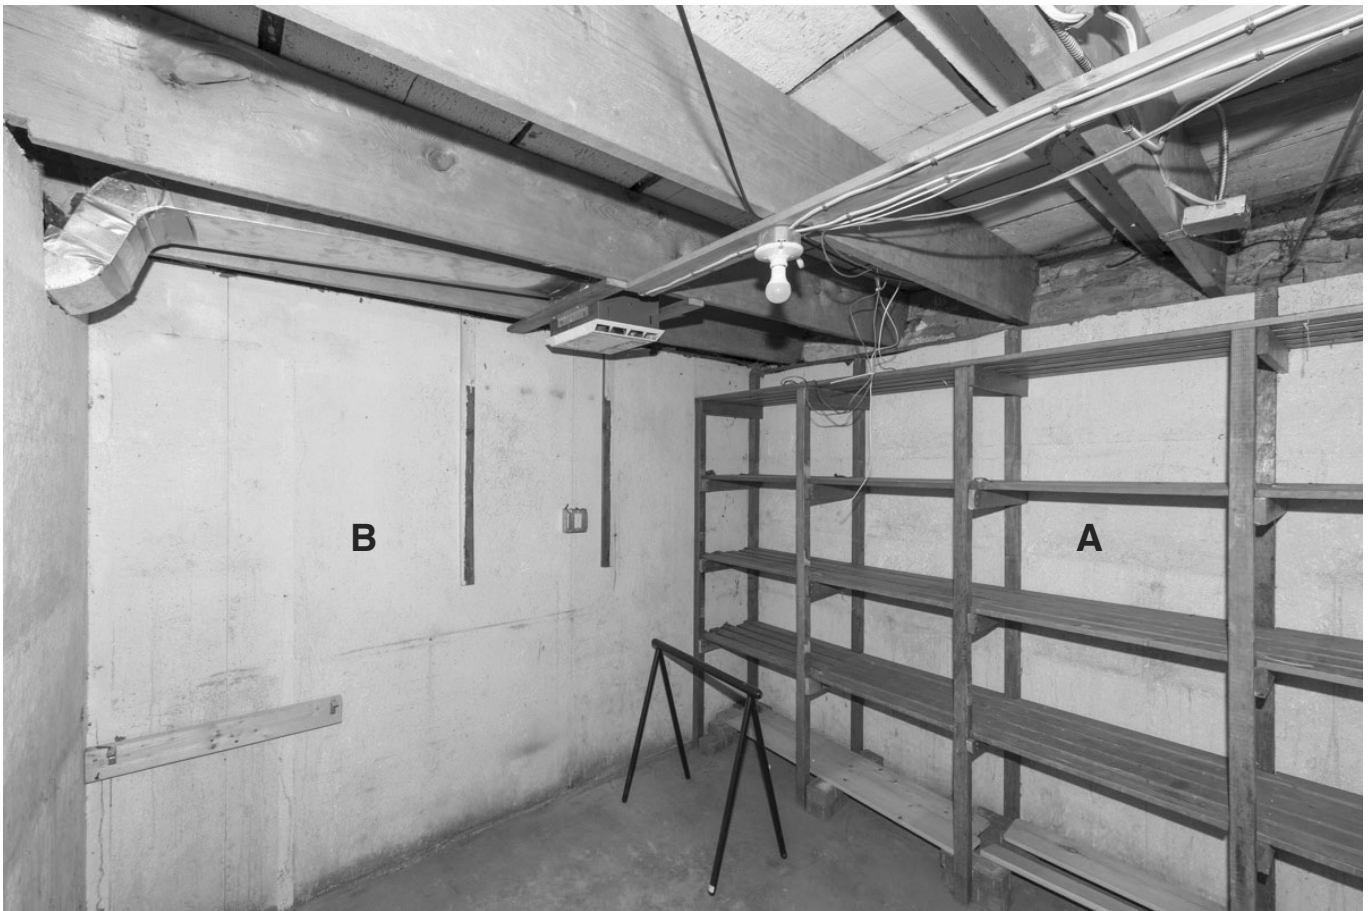
36.3: Room B01b - North and East Walls. The right hand wall panels (A) cover the original east foundation wall, and the wall panels at "B" cover the original north foundation wall.

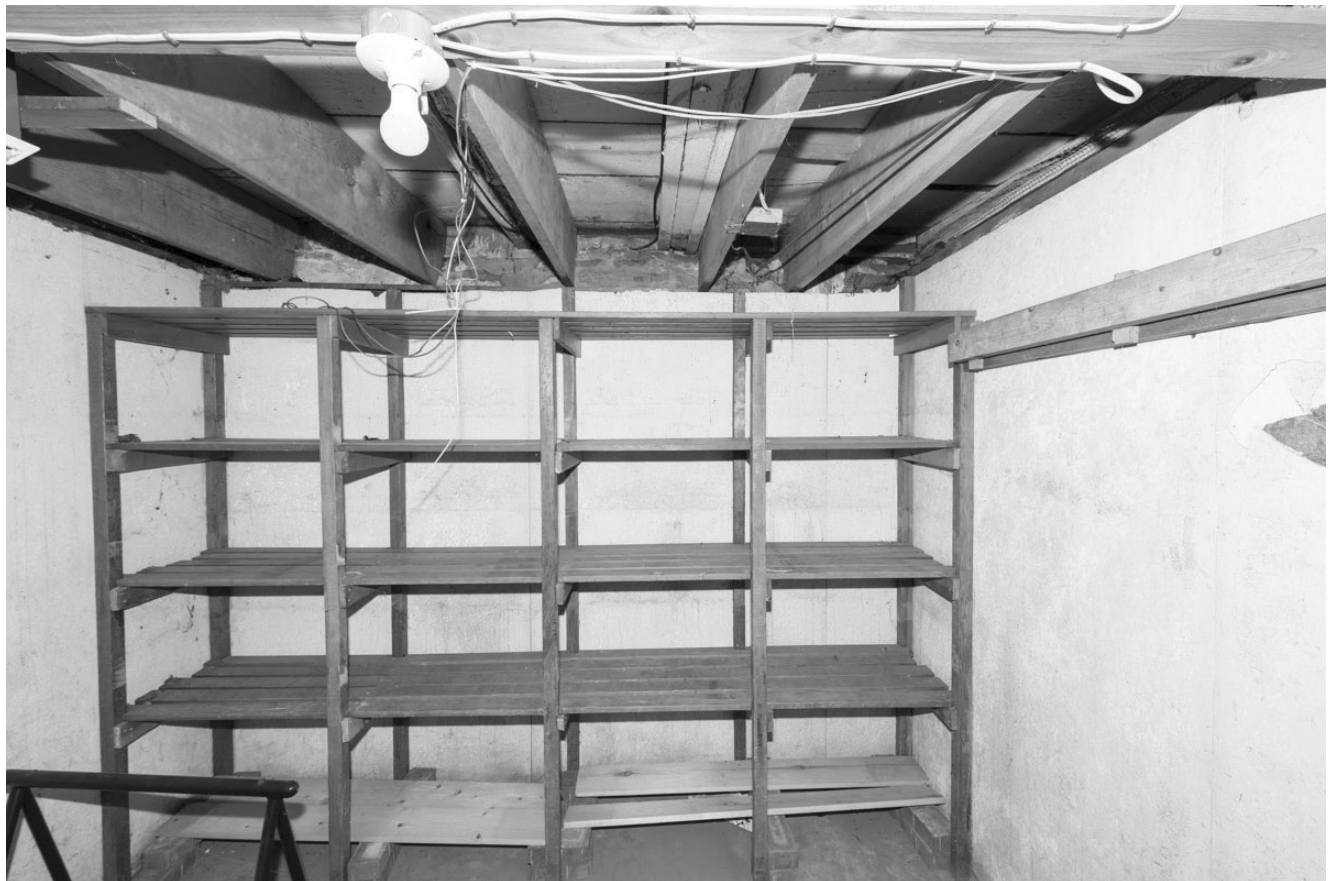
36.4: Room B01b - East Walls The wall panels cover the east foundation wall.

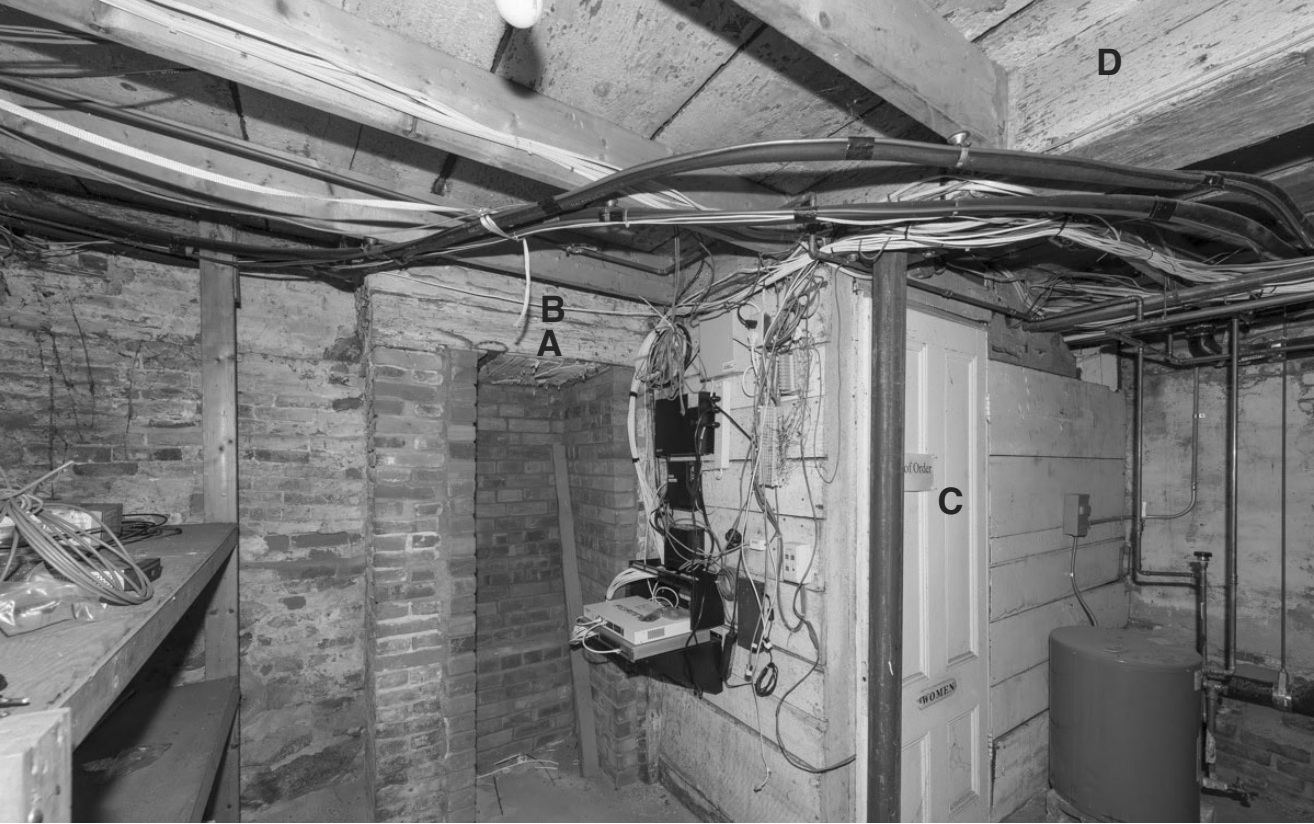
37.1: Room B02 - Looking South. "A" marks the base for the fireplace in room 102 that was added ca. 1815. "B" marks the south foundation wall which is brick rather than stone. The south wall was largely above grade until the sun room (room 108) added in 1923. "C" marks the door and board walls added ca. 1900 to enclose a bathroom.

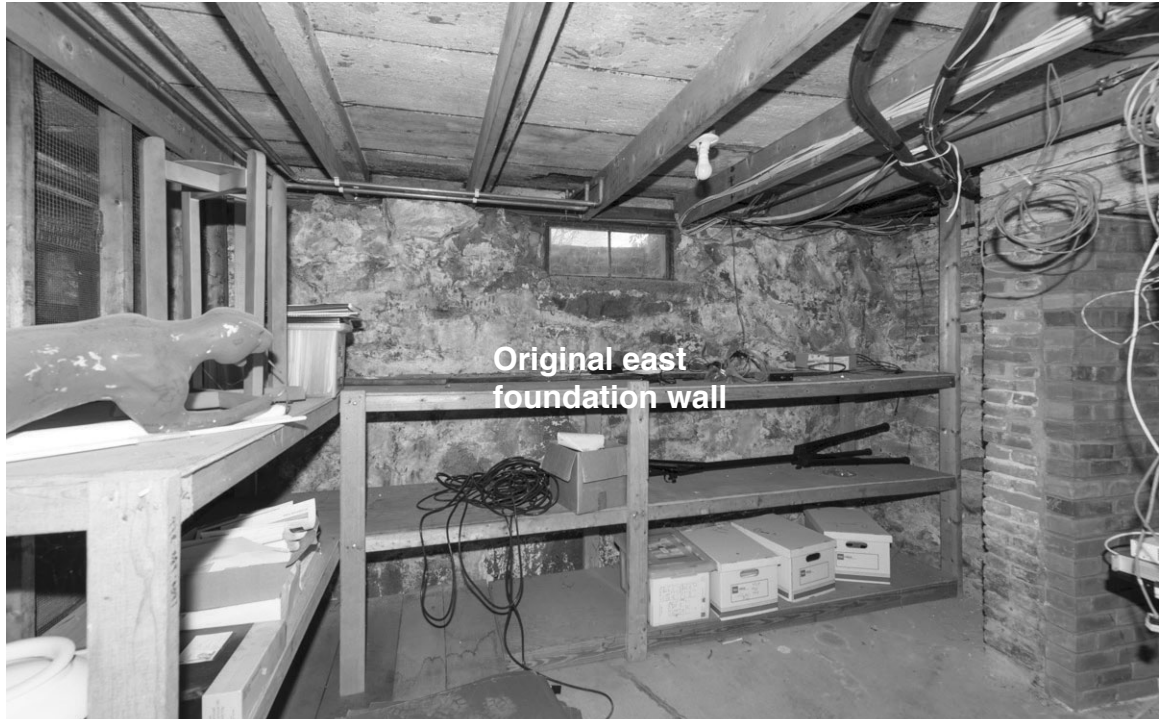
37.2: Room B02 - Looking East. The south wall of room B01a is on the extreme left.

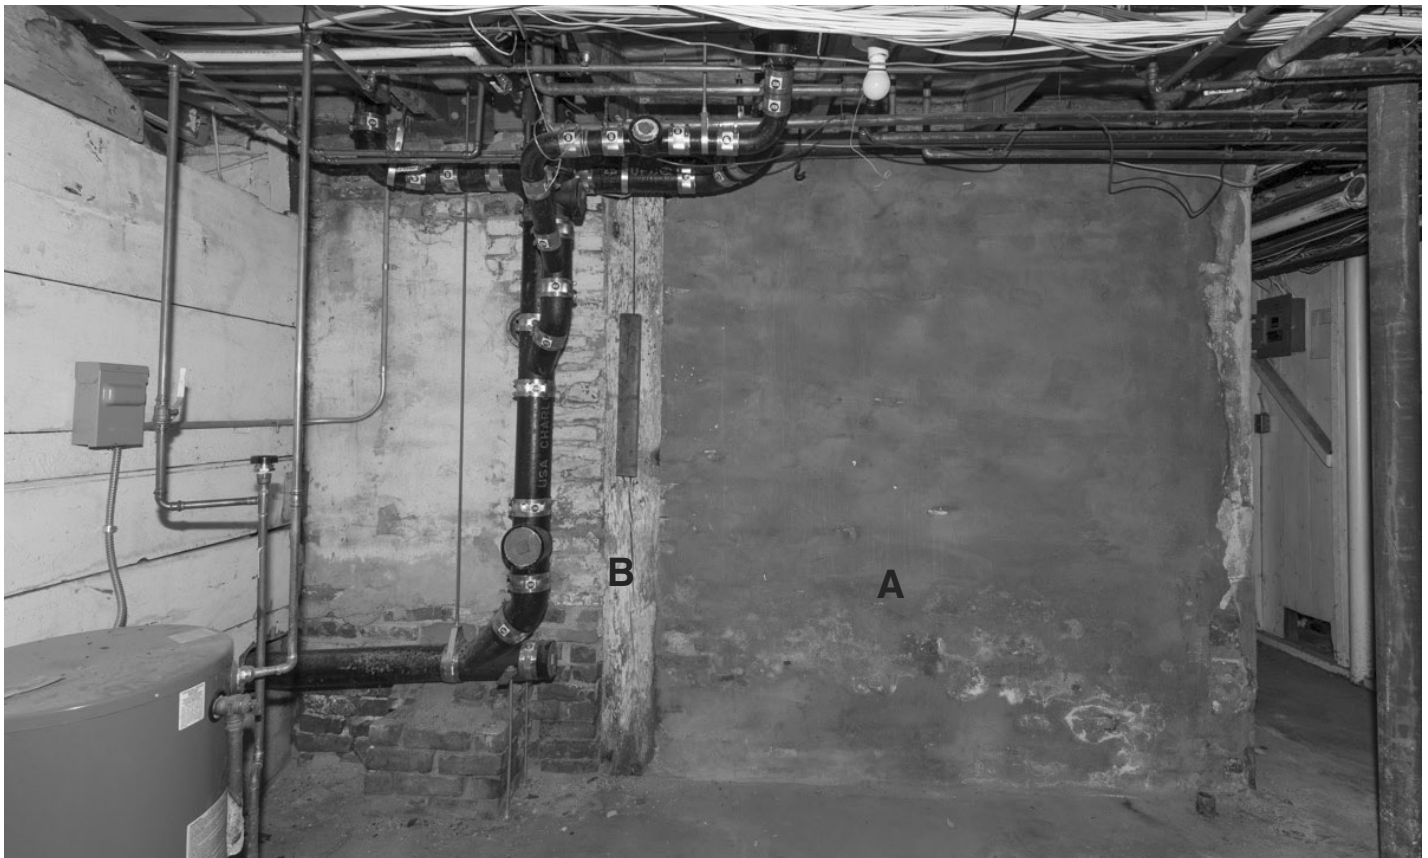
37.3: Room B02 - Looking West. This wall (A) forms the partition between this space and B03 housing the fireplace and large bake oven added ca. 1815. It has been parged in the 20th century to cover spalling brick, but the brick wall was installed ca. 1815 to enclose the new kitchen. The wall is capped with an early wood beam and is under the original portion of the east wall of passage 100c above (see photo 10.3). The post at “B” appears to be early but its function is not clear; perhaps it provided support for the beam prior 1815.

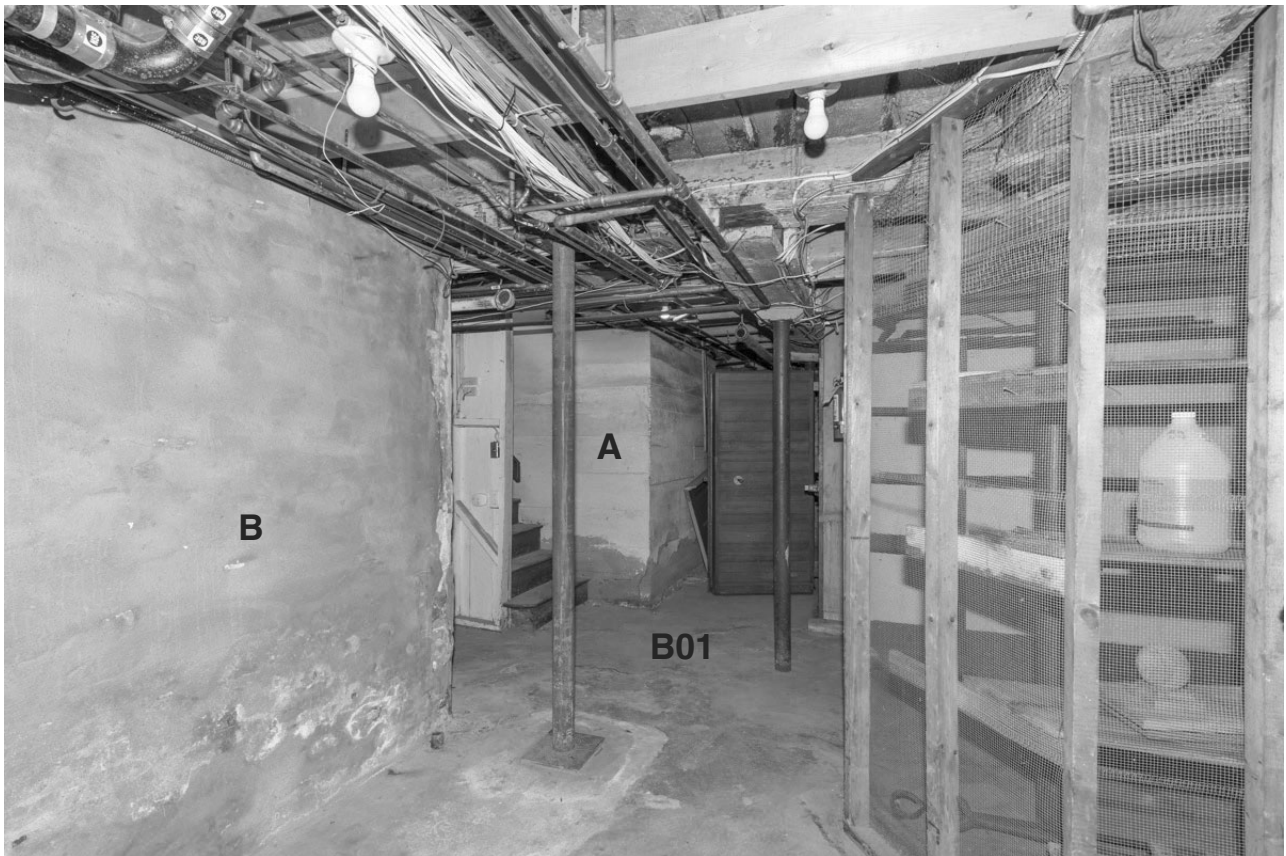
37.4: Room B02 - Looking North into B01. “A” marks the chimney base. “B” is the brick wall in photo 35.3 with modern parging..
