1.3: Ell South Facade and Main Block West Facade. The Additions to the ell are early-mid 20th century. First floor window frames on the main block are 19th or early 20th century

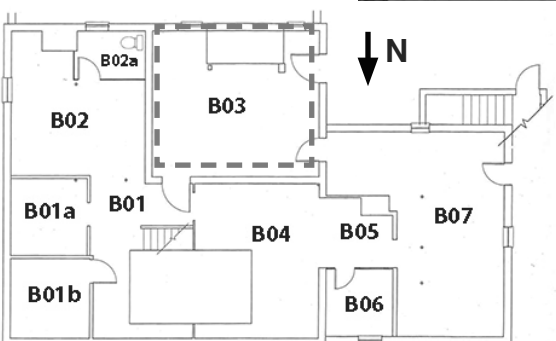
39.2: Room B03 - West Wall. The door at "A" is early. Its bottom rail has been reduced in height, probably to fit to modern changes in the grade at the landing outside. Its hardware is period in character, but its age is not known. The door at "B" is early but probably reused in this location as both its stiles have been widened. Its hardware is probably modern reproductions. The sash is 19th or 20th century. The arrow points to the early beam that is covered by the modern casing. Like the south wall this wall is probably brick rather than stone.

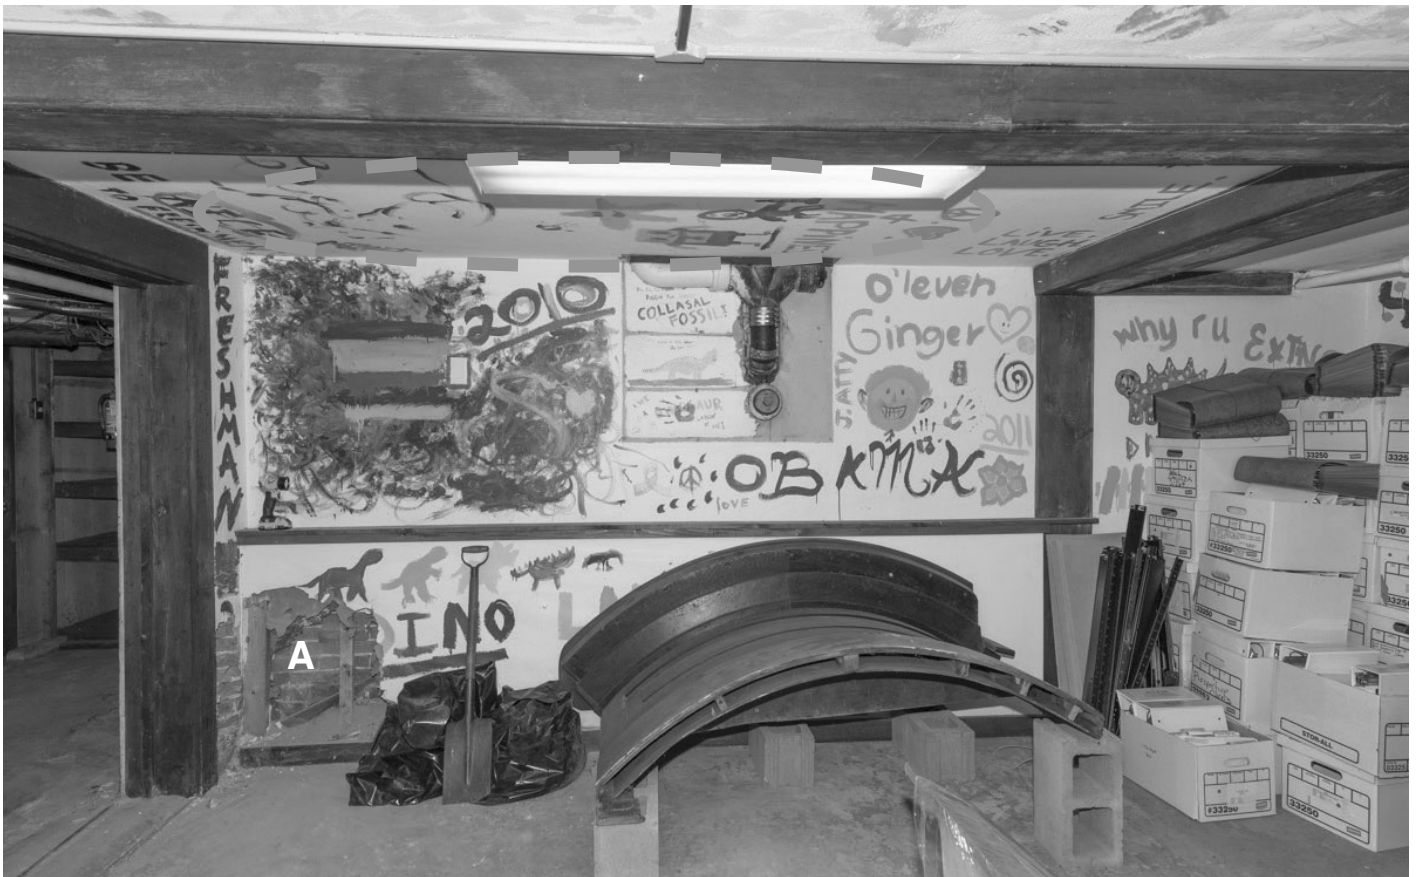
39.3: Room B03 - East Wall. This wall is the kitchen side of the ca. 1815 brick wall marked "A" in photo 37.3. The plaster covering the brick is modern, as is the woodwork forming the doorway and all the wood casings. As visible at "A", chronic rising damp has been causing the brick to spall. The area of the ceiling marked with the blue dashed circle is over framing that may have evidence for the location of the original chimney that was replaced ca. 1815 with the current south wall chimneys. This area is directly below room 100c in photo 5.1.

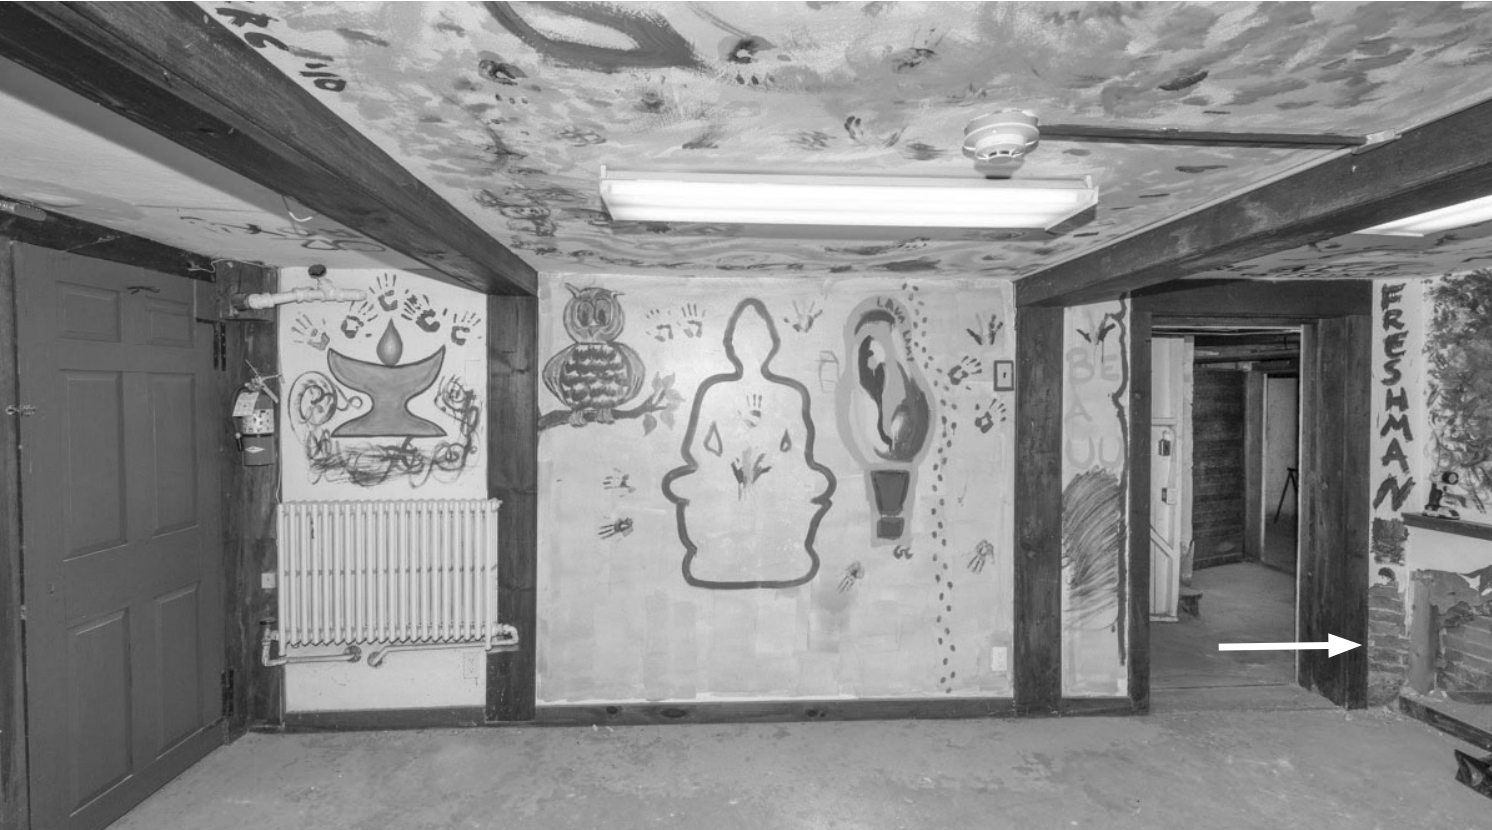
39.4: Room B03 - North Wall. This wall is modern cement block finished with modern plaster on wire lath like the east wall. The north return of the east wall is brick (arrow). It is likely that this wall was originally constructed ca.1815 with brick that deteriorated and was replaced in the 20th century with the current cement block.

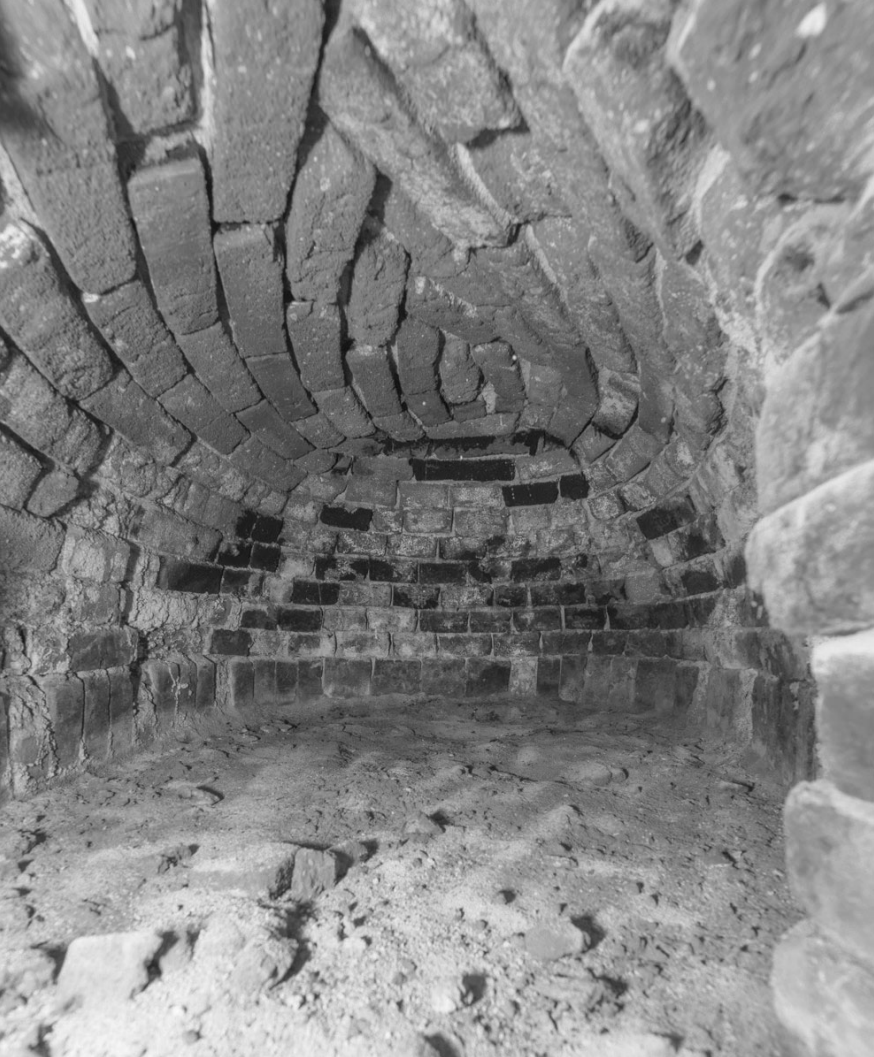
40.1: Room B03 - Bake Oven. This oven is unusually large supporting the concept that it was built for commercial use by the tavern and/or bakery. That the base brick is a soldier coarse is typical for its ca. 1815 date (18th century ovens usually have header brick as a base).

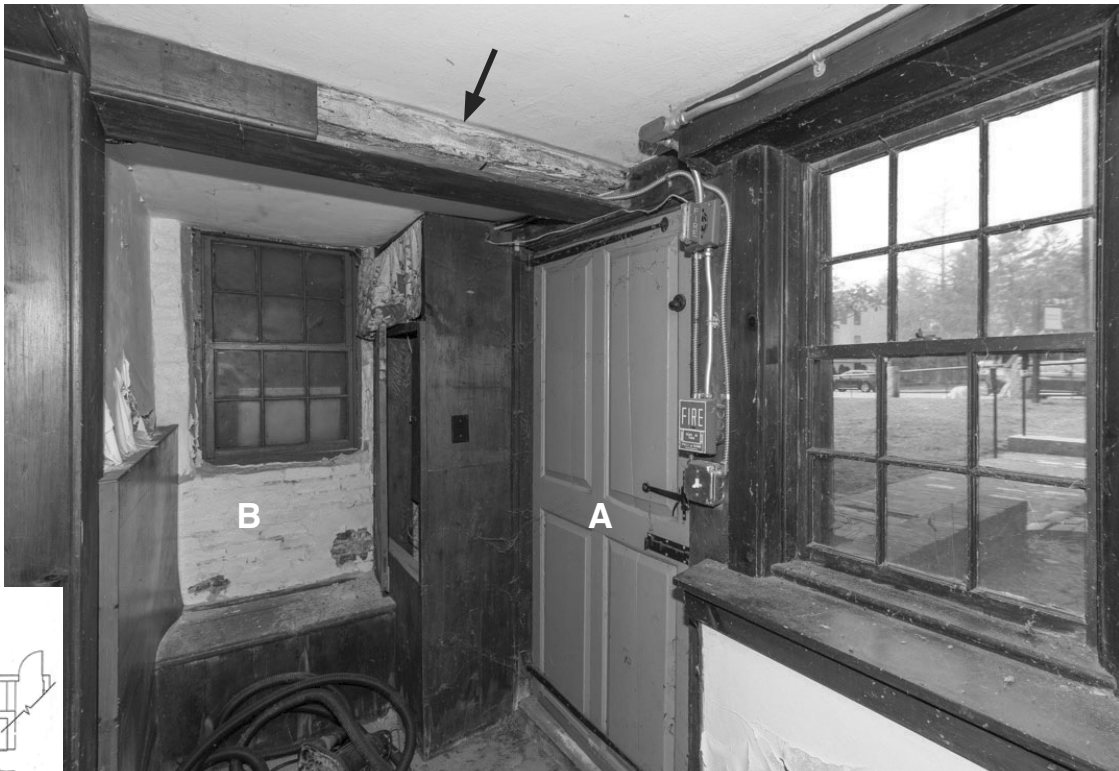
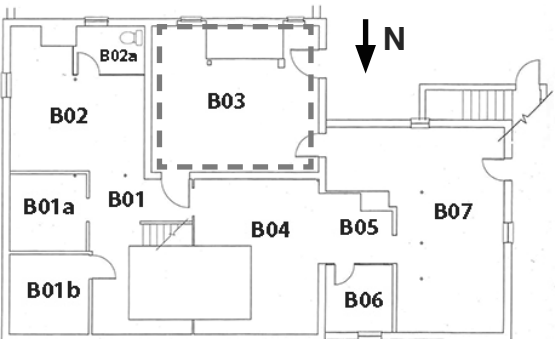
40.2: Room B03 - Southwest Corner. The arrow points to the early white washed beam that covered with the modern casing. As this space was used historically, all the principal framing members were probably exposed and whitewashed. The early door at "A" is discussed above in 37.1. As in room B02, the south wall is early brick indicating much of it was originally above grade.

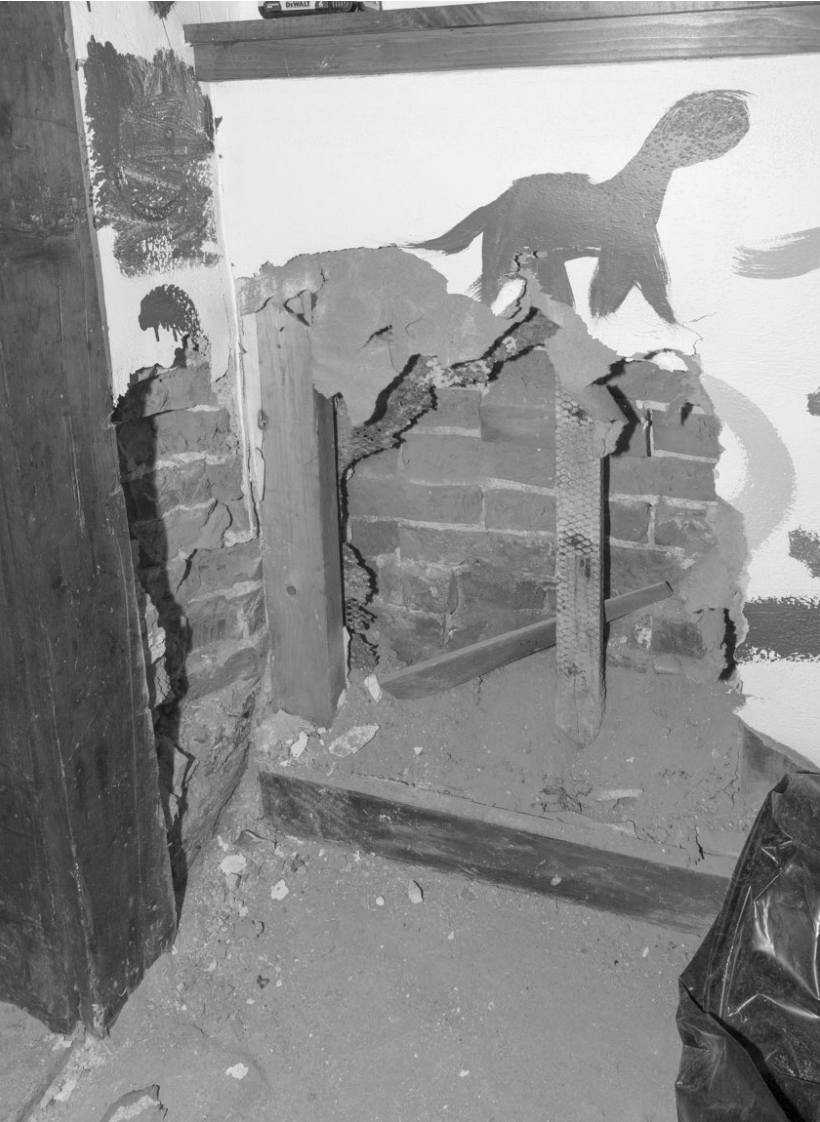
40.3: Room B03 - Northeast Corner. Detail showing the heavily spalled condition of the brick due chronic rising damp that is now covered with plaster on wire lath and sheet rock. The extent of this condition is not currently known.

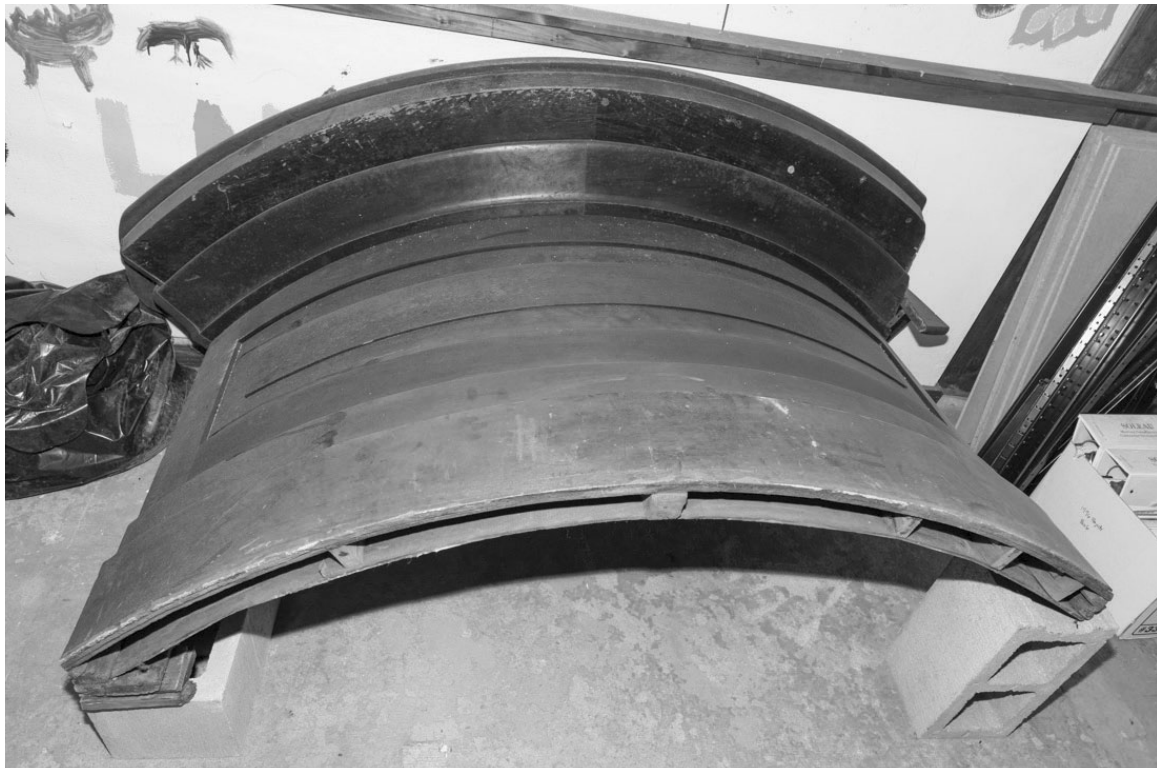
40.4: Room B03 - Tap Room Bar. This was built in the early 20th century when it was used to reproduce the traditional function of room 104 as the “tap Room”, as shown in postcards from that period. Its construction detailing is modern. It has historical value as an illustrative component of the past colonial revival interpretation of the building.

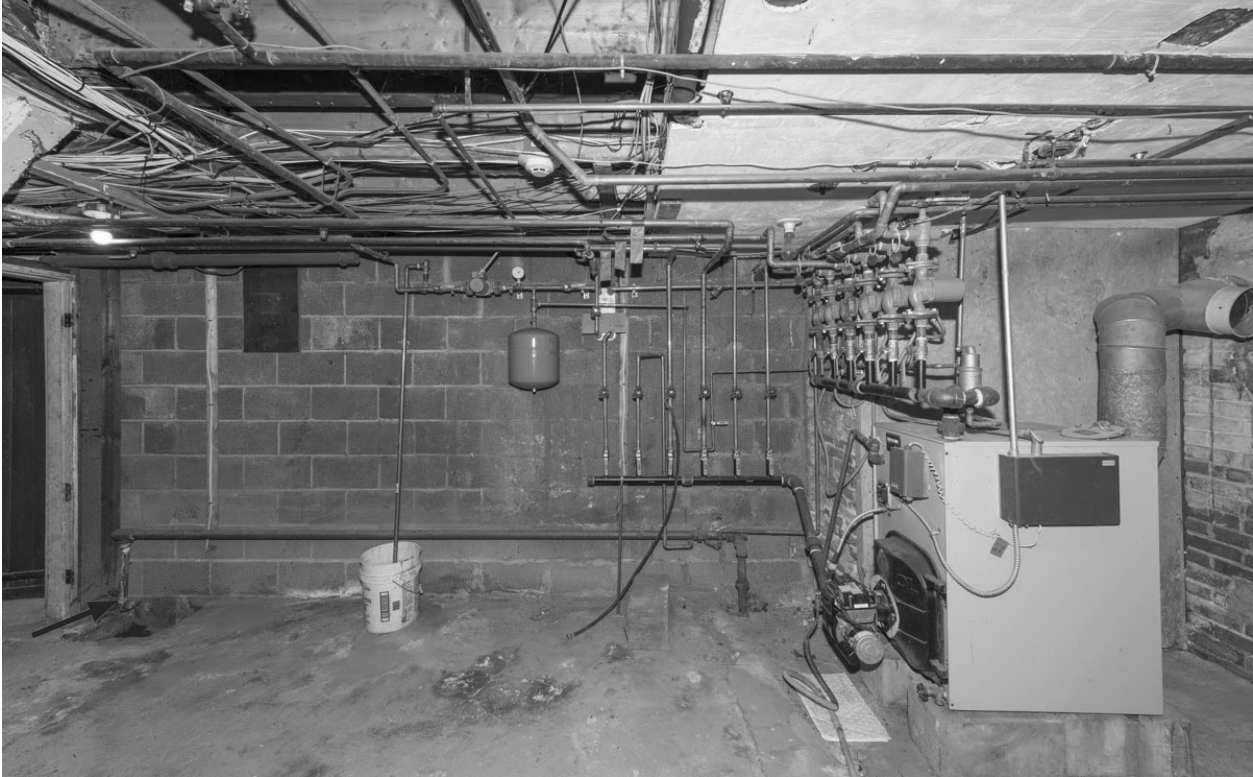
41.1: Room B04 - South Wall. This other side of this wall north wall of kitchen B03. The wall is mid-20th century cement block, but probably replaced the ca. 1815 brick north wall of the B03. The door frame at the extreme left opens into B01. The arrow points to a short section of brick wall that was probably part of the original west wall of the building prior to the addition of the west ell in the late 18th century.

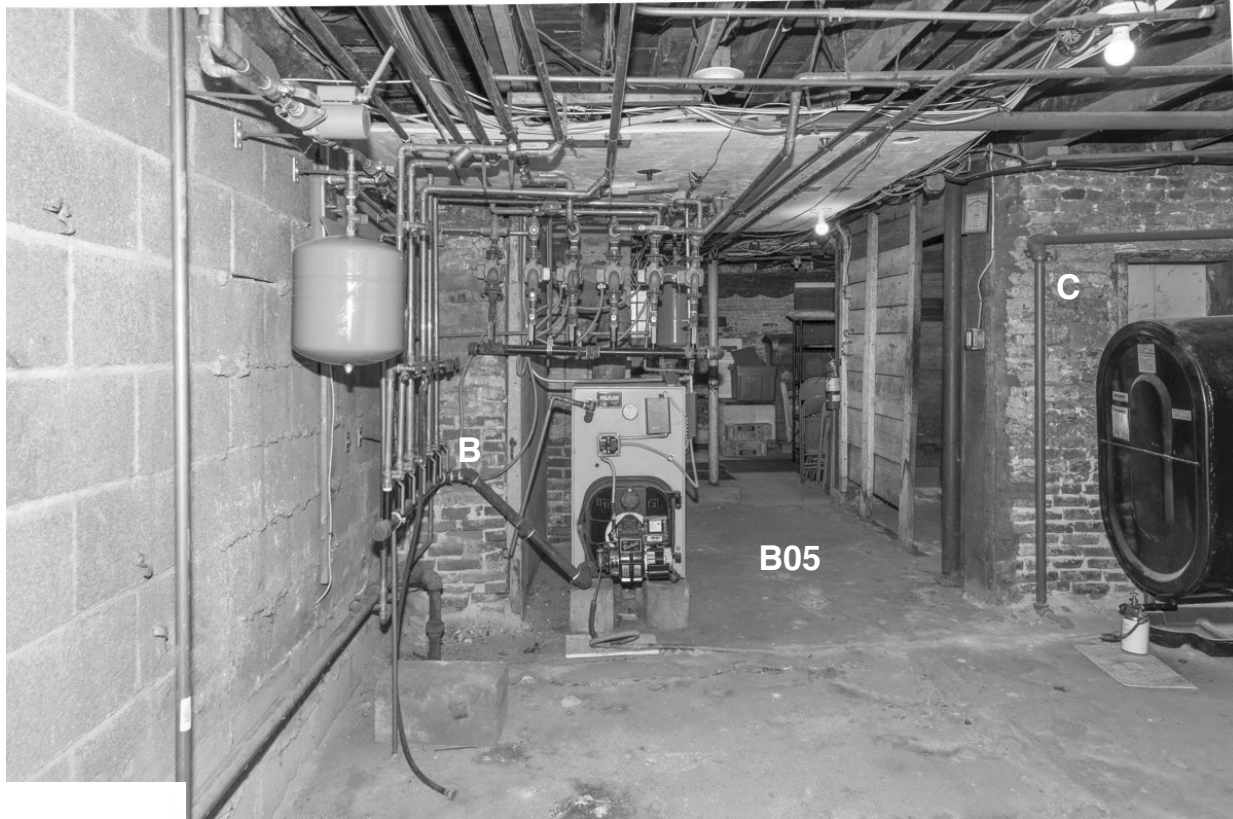
41.2: Room B04 - Looking West. "B" and "C" mark the remaining portions of the original west exterior wall of the building prior to the construction of the west ell in the late 18th century. The middle section was removed to provide access to the new ell cellar (Rooms B05 & B06), although it is not known when the removal was done.

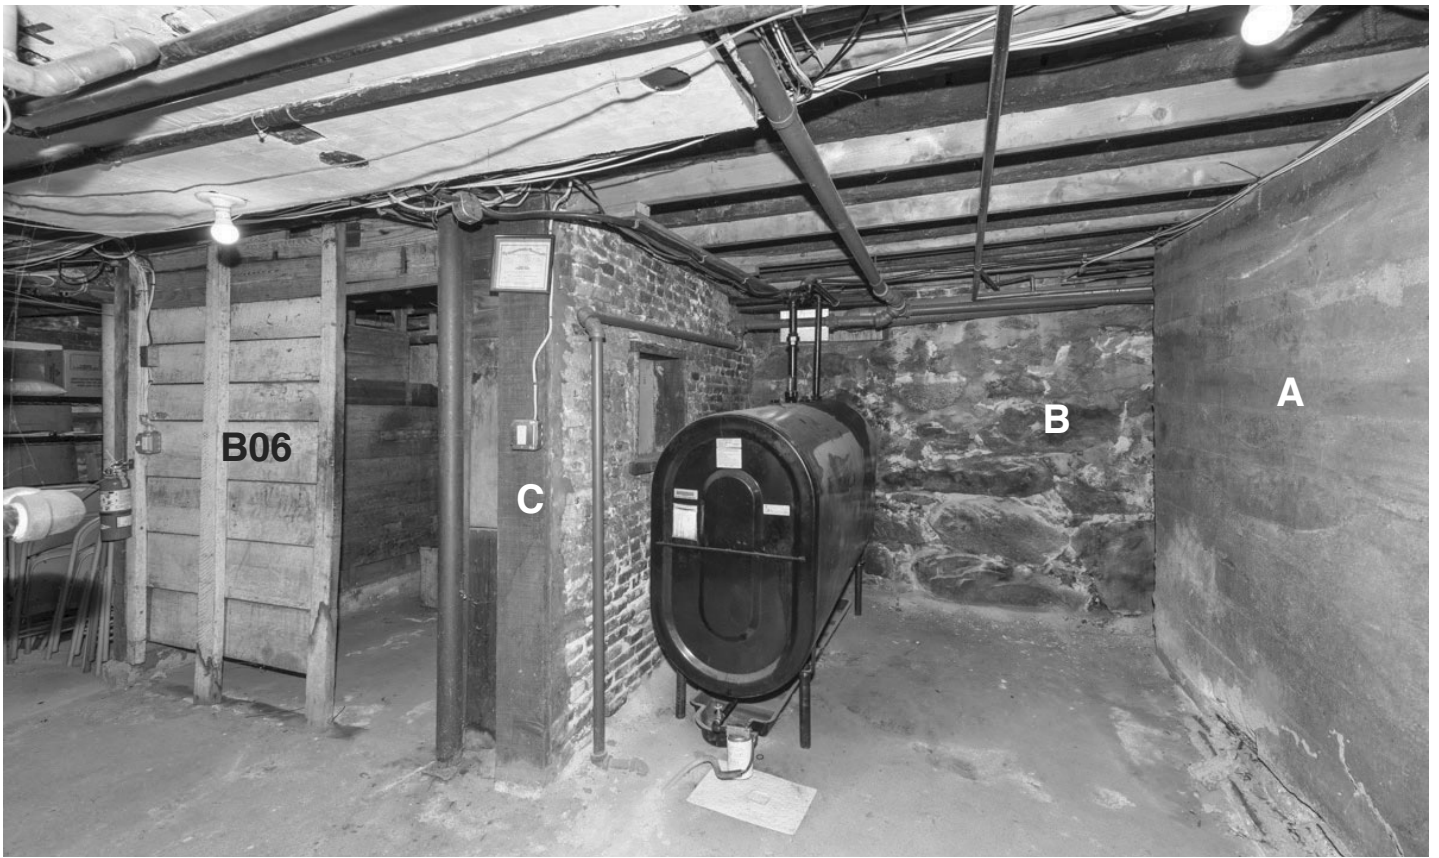
41.3: Room B04 - Looking North. "A" is the west side of the main chimney base. The edge of the Tap Room (Room 104) hearth is above "A". "B" is the original north foundation wall. "C" is the remaining of the original west foundation brick wall and marks the where the ell was attached to the main building. Room B06 is entirely within the ell.

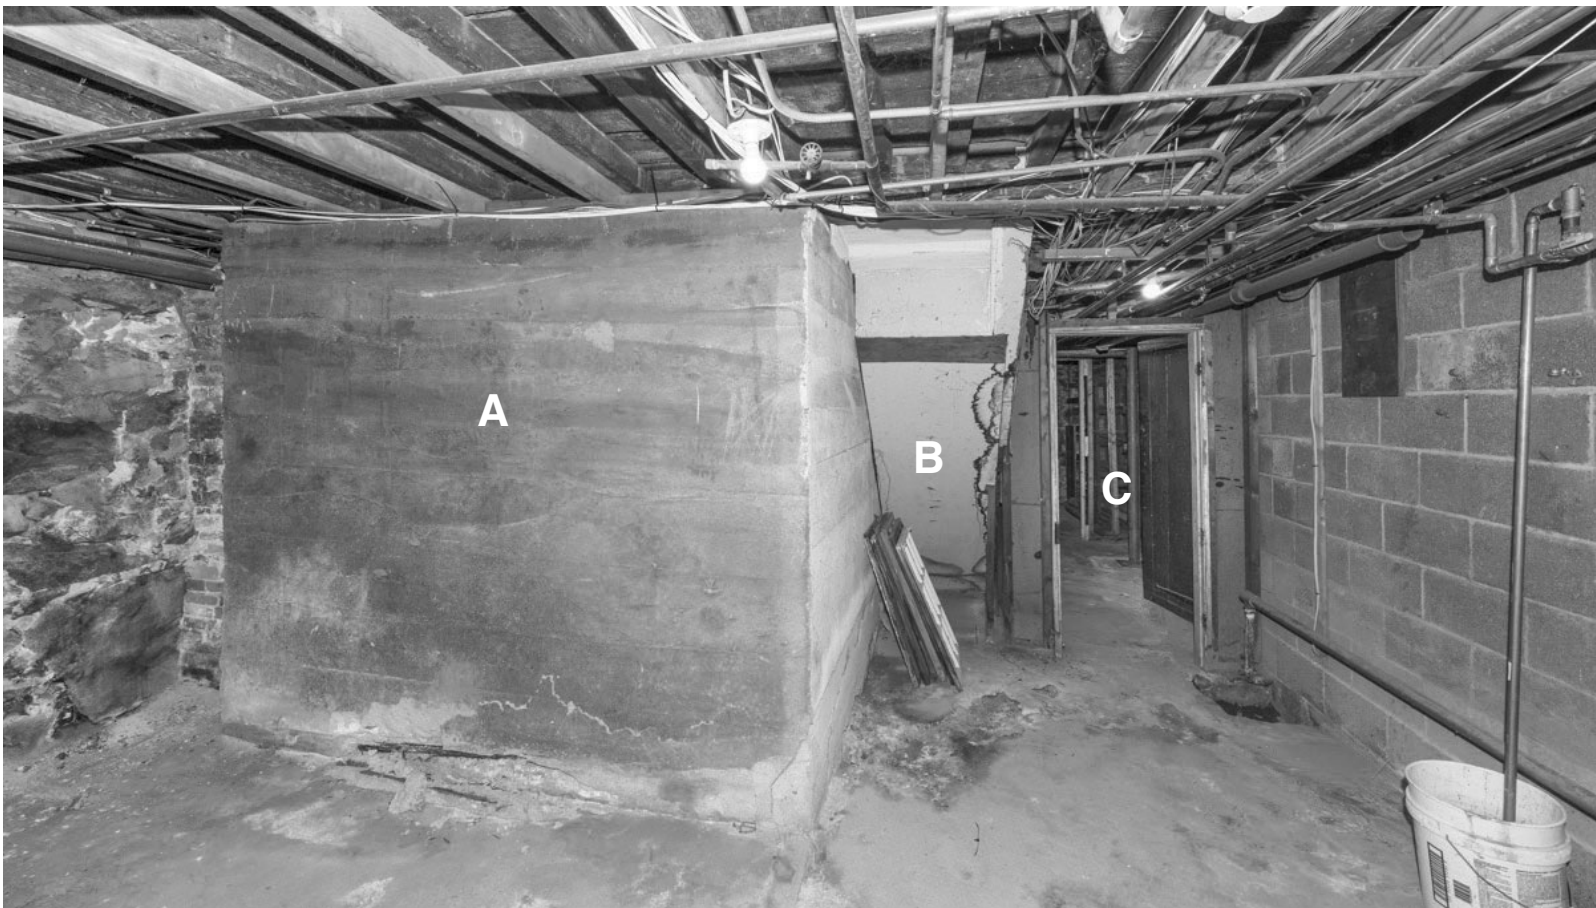
41.4: Room B04 - Looking East. "A" is the west side of the main chimney base. "B" is the back side of the stairs up to room 104. "C" beyond the door opening is room B01.

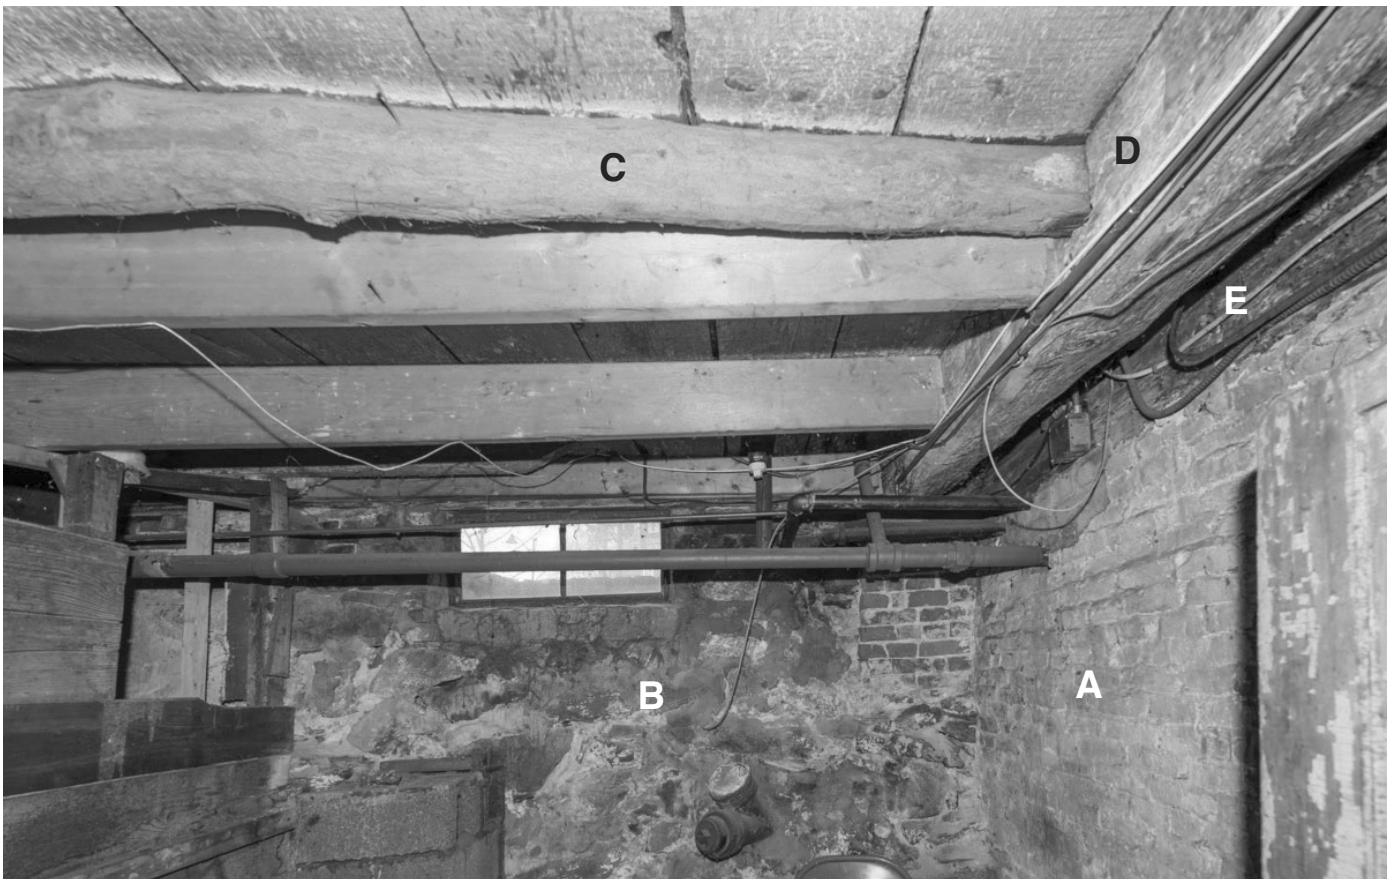
42.1: Room B06 - Looking North. This room is under the east end of the ell. "A" is the west side (i.e., exterior side) of the original west foundation wall of the original house. "B" is the north foundation wall of the ell. "C" is a typical floor joist in the ell, which are mostly half round logs with the bark removed. The joists in the original house are square sawn 3' x 4" or 5" lumber. "D" serves as the east end sill of the ell rather than the original house west sill that is still on top of the brick wall at "E".

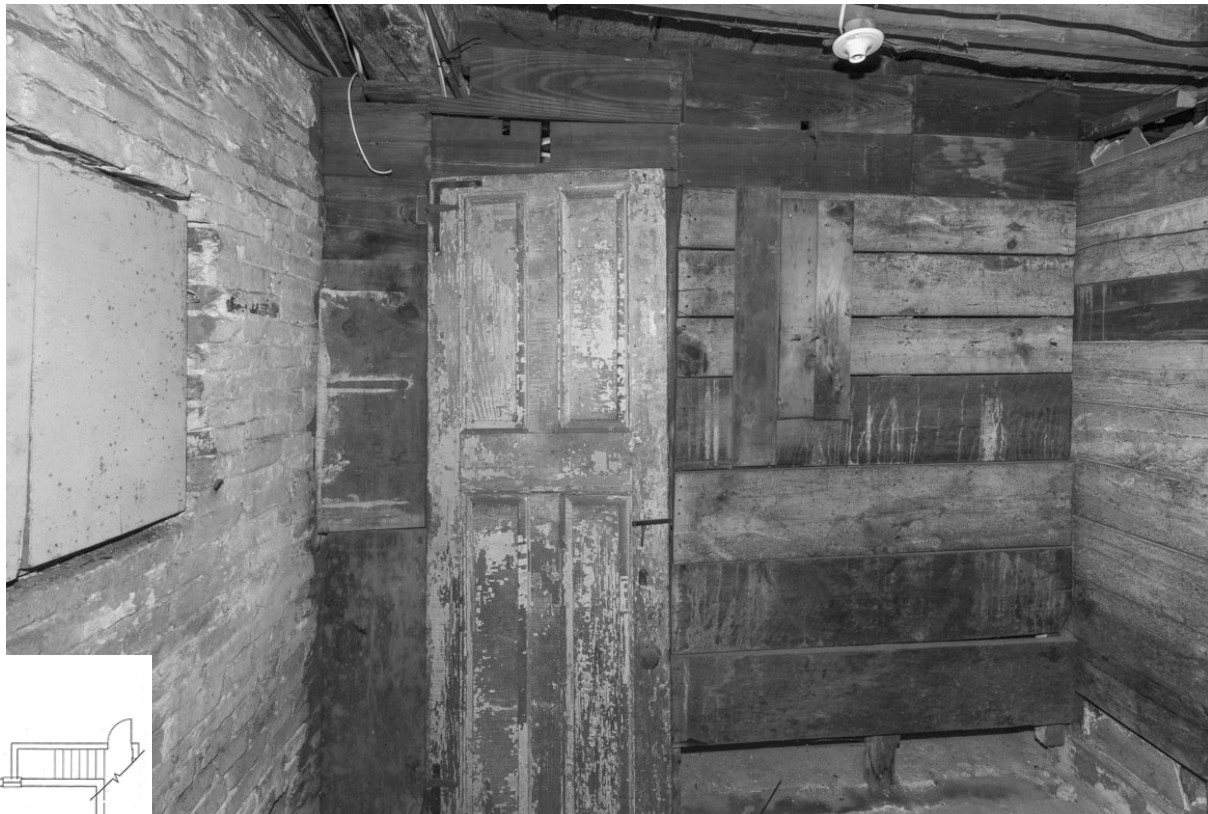
42.2: Room B06 - Looking South (left). This room was constructed in the late 19th century using boards that may have been salvaged. The door is an earlier door that has been reused. Perhaps this room was added as a coal bin.

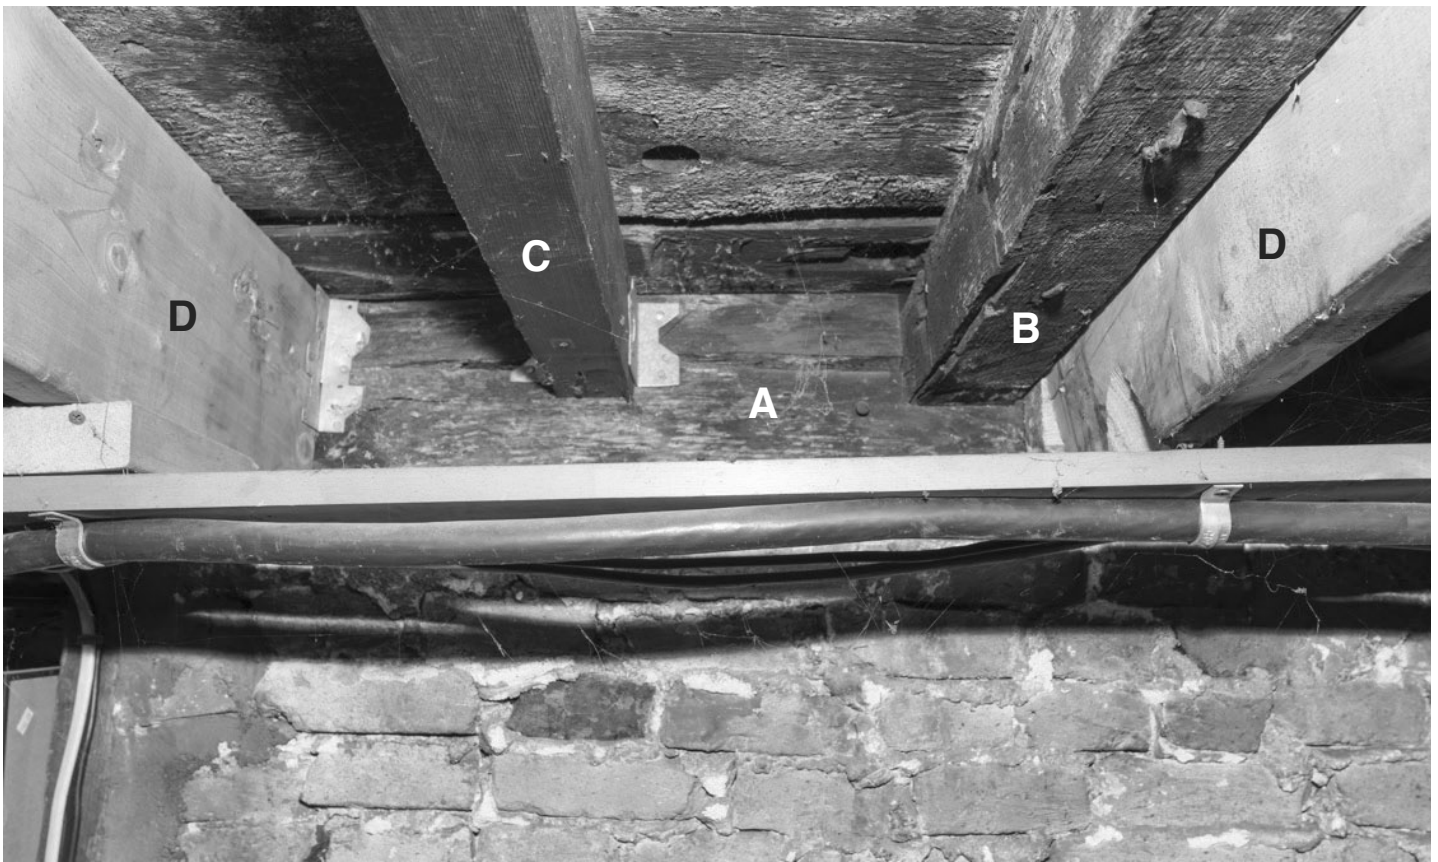
42.3: Room B04 - West Side of Brick Foundation Wall . "A" is the original west sill of the original main house sitting on top of the brick wall that was the original westerly cellar exterior wall prior to the construction of the ell. "B" is an original sawn joist set into an open mortise in the sill. "C" is a ca. 1900 added joist toenailed to the sill with recently added metal hanger. "D" are modern added joists

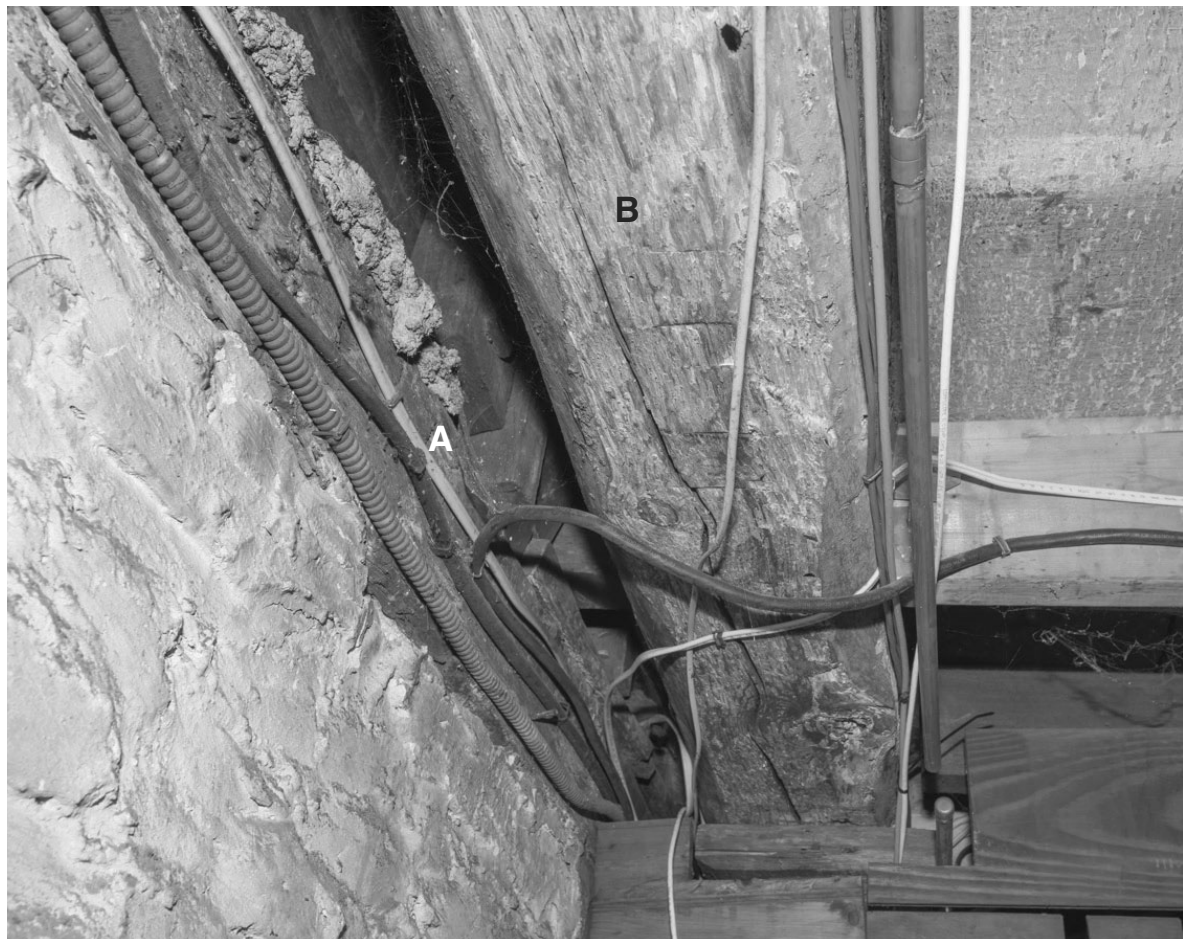
42.4: Room B05 - Ell East Sill (left) . "A" is the original west sill of the original main house sitting on top of the brick wall that was the original westerly cellar exterior wall prior to the construction of the ell. "B" is the easterly ell sill that was installed when the ell was added and that has all the ell floor joists framed into it. Perhaps the builder thought that was easier than cutting new mortises into the existing sill. Both beams span across to the cement block wall at the south side of room B04, although they are now hidden by a modern plaster ceiling.

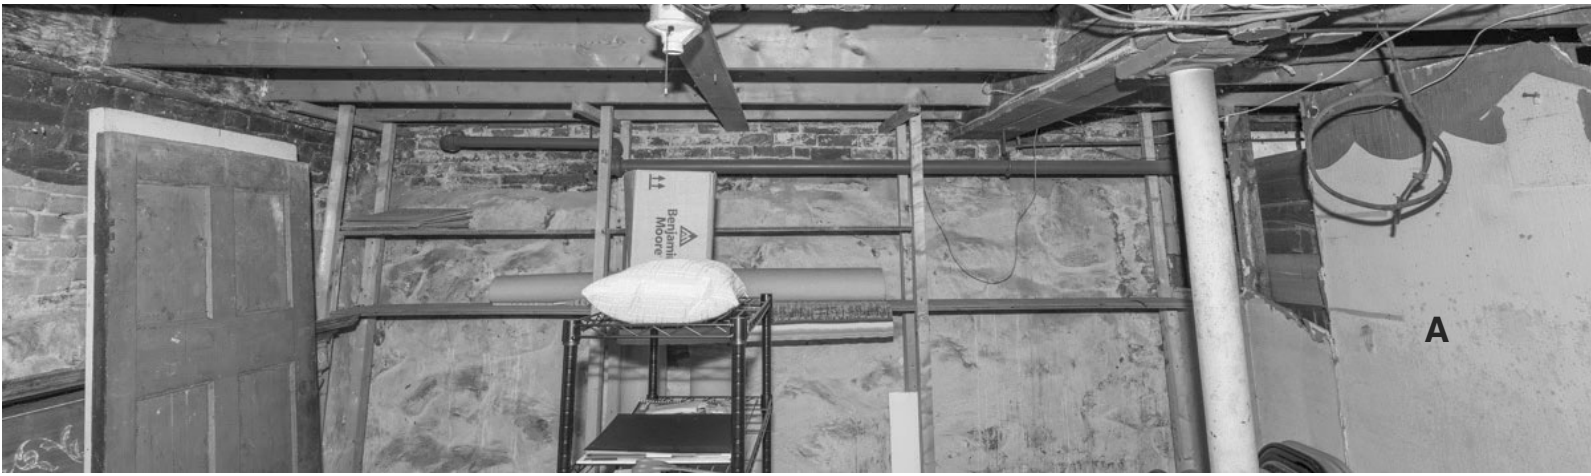
43.5: Room B07 - North Wall. The north foundation wall of the cell is largely stone. "A" marks the modern wallboard that has been placed over the west board wall of room B06.

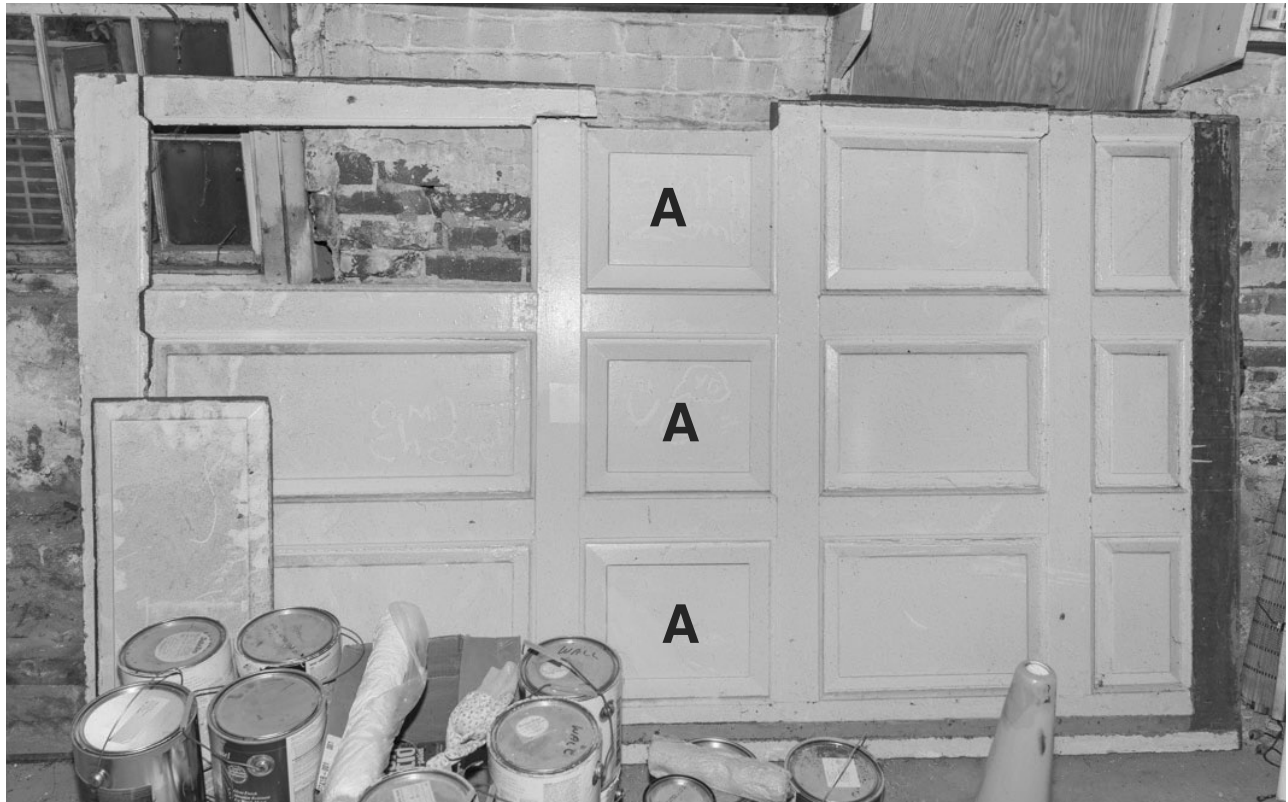
43.6: Room B07 - Paneling Fragment. The HSR speculates that this was originally in passage 100c, but panels marked "A" are modern indicating the paneling has been altered to appearance. Paint analysis might determine if and where it relates to the Wright Tavern.
