ENVIRONMENTAL MONITOR WEEKLY REPORT  
WEEK ENDING **August 11, 2017**

BRUCE FREEMAN RAIL TRAIL  
CONCORD, MA

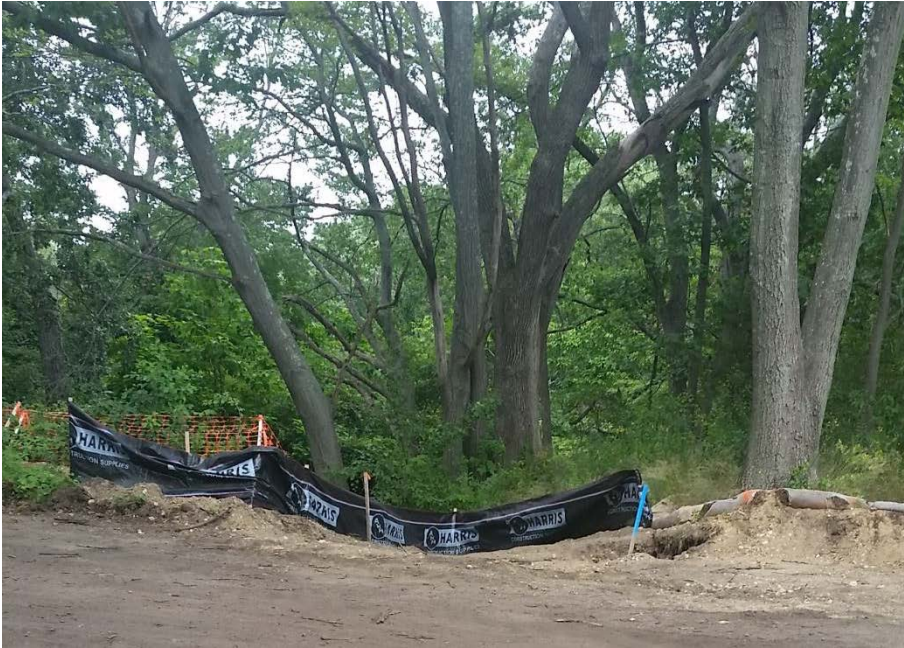
EROSION CONTROL REPLACED WITH SILT FENCE AT PATH

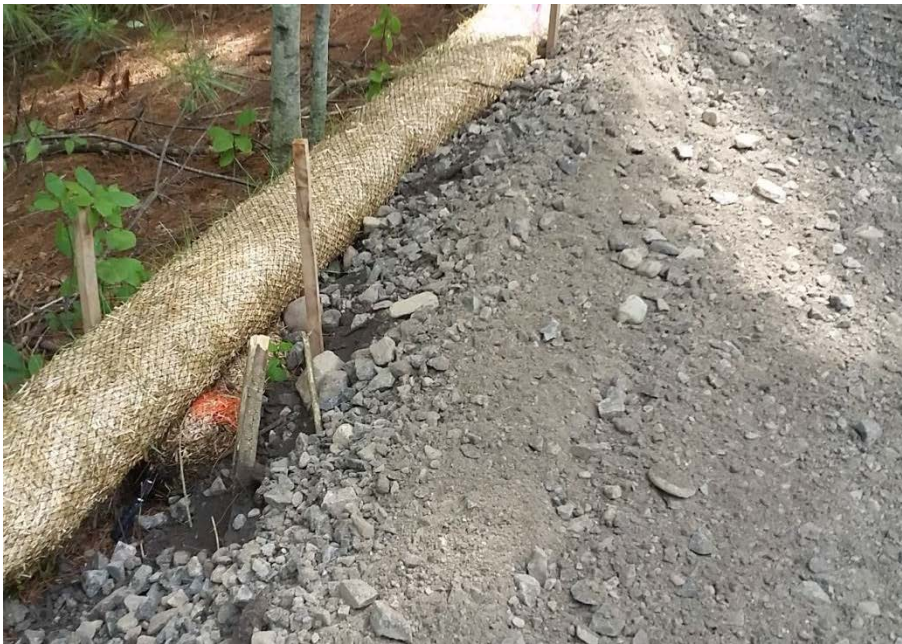
In narrow areas, the subgrade work has resulted in material being placed in contact with the erosion control. In some cases material was placed greater than half the height of the wattles, in other cases the wattles were damaged. As a corrective measure, the contractor had added additional straw wattles in some areas. The contractor was directed to install additional wattles wherever soil has been placed over half of the height of the wattle or to replace wattles where they have been damaged.

REPAIRED E/C AT EDGE OF SUBGRADE. SIMILAR REPAIRS ARE NECESSARY  
ALONG SUBGRADED AREAS.

The contractor is in the process of installing additional straw wattles as needed as a result of the subgrading operation.
