Warner's Pond Water Quality Sampling Locations & Watershed Assessment Results

WARNER'S POND WATERSHED MANAGEMENT PLAN
 Concord, Massachusetts

Watershed Assessment Results

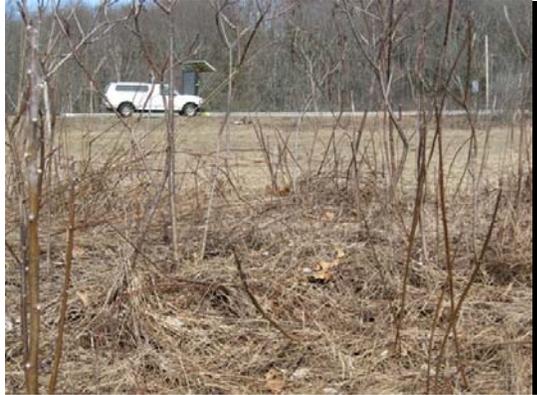
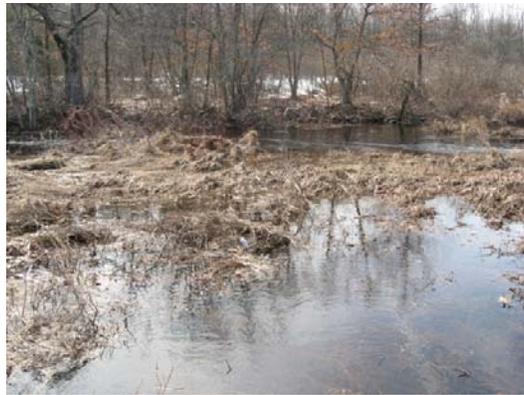
SITE	W-19, Fort Pond Brook (Sampling Station ID = WP-1)
LOCATION	Access off Route 2 East. Pull-off available at railroad track crossing or further down Route 2.
DESCRIPTION	Fort Pond Brook inlet at Route 2. Sample just upstream of confluence with Nashoba Brook. High potential to contribute sediment to Warner's Pond from upstream sources.

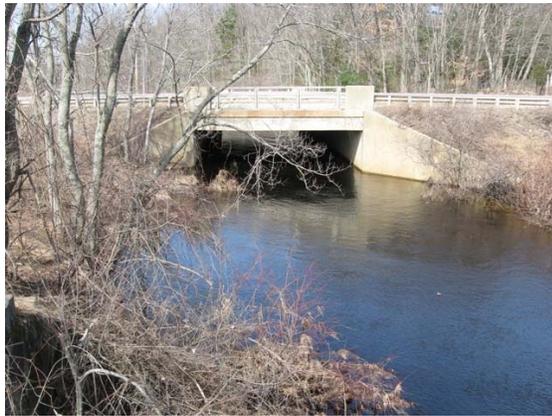
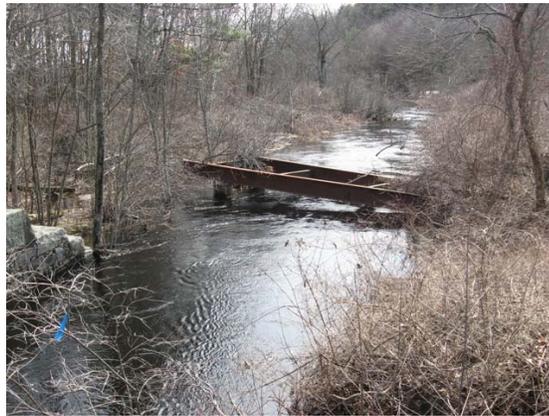
SITE	W-20, Nashoba Brook (Sampling Station ID = WP-2)
LOCATION	Access off Route 2 East. Pull-off available at railroad track crossing or further down Route 2. Same access point as W-19.
DESCRIPTION	Nashoba Brook inlet at Route 2. Sample just below Route 2 bridge crossing and upstream of junction with Fort Pond Brook. High potential to contribute sediment to Warner's Pond from upstream sources.

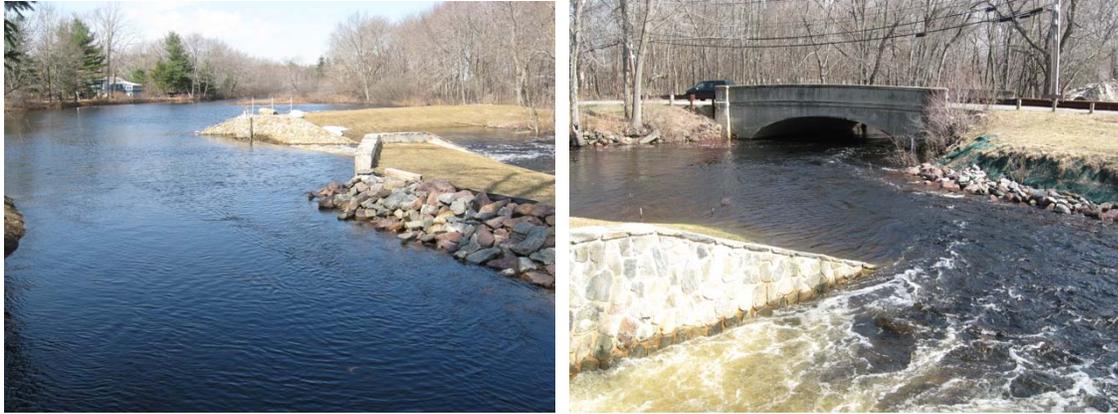
SITE	W-16, Warner's Pond Outlet (Sampling Station ID = WP-3)
LOCATION	Access from Law's Brook Road.
DESCRIPTION	Outlet of Warner's Pond, just upstream of the dam. Access from open grassy area.

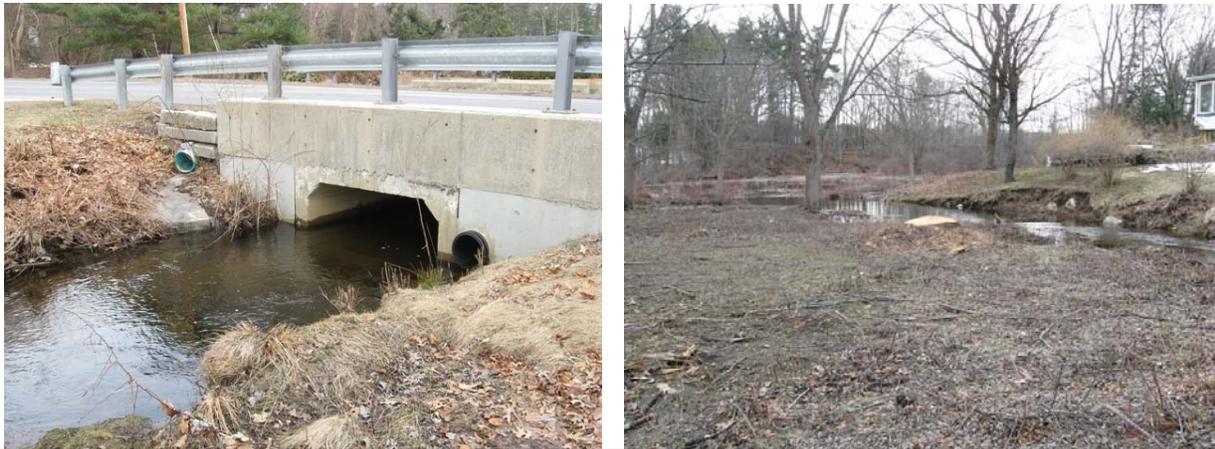
SITE	WP-4A, Coles Brook just upstream of confluence with Fort Pond Brook (Sampling Station ID = WP-4)
LOCATION	Access from Law's Brook Road.
DESCRIPTION	Coles Brook discharges to Fort Pond Brook at corner of Law's Brook Road and School Street. Coles Brook watershed drains portions of Route 2, and very large impervious surface area associated with Adesa Corporation facility at Route 2 and Hosmer Road. Two stormwater outfalls discharge to Coles Brook at this location. Sample downstream of bridge and outfalls. High potential to contribute sediment.

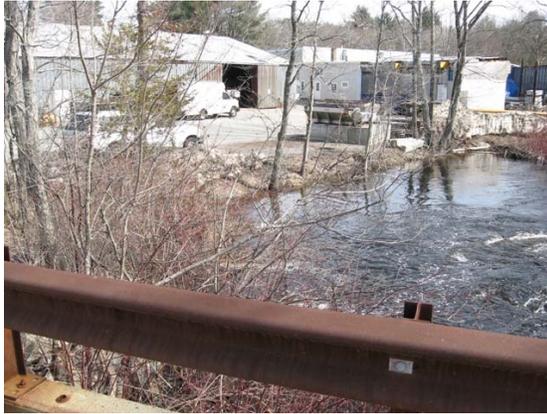
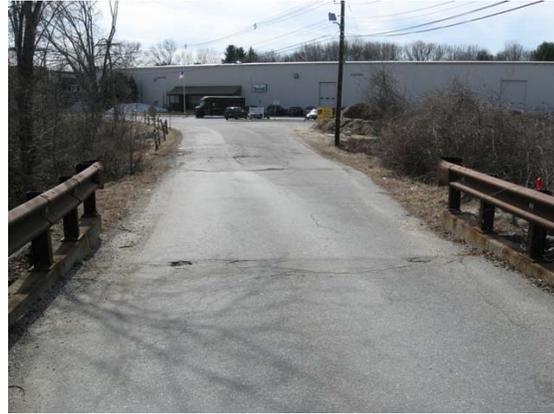
SITE	W-21, Nashoba Brook at unnamed bridge crossing (Sampling Station ID = WP-5)
LOCATION	An unnamed street that leads to Teamworks facility crosses Nashoba Brook at this location. The street is just south of Weatherbee Road.
DESCRIPTION	Highest potential sediment load occurs from this location up to the dam at Concord Road. Numerous businesses on Rt 2A line river bank with little buffer. Landscaping business at this location; other light industrial and commercial businesses upstream.

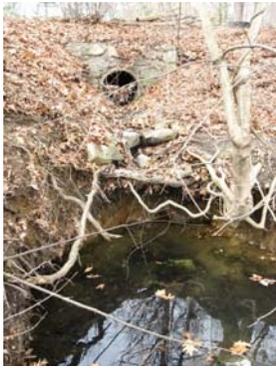
Sample ID	Photo	Description and Notes
W-10

<ul style="list-style-type: none"> • Access from small open space area on east side of Wright Road and walk south • W-10 drains catch basins on Wright Road • Flow during dry weather survey from melting snow • Slightly turbid • Discharges to scrub-shrub wetland
W-11

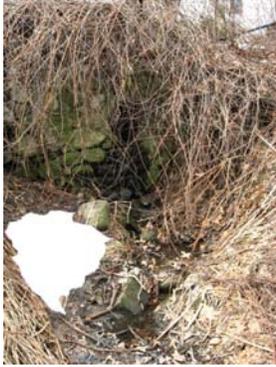
<ul style="list-style-type: none"> • Access from small open space area on east side of Wright Road and walk north • 24" RCP with historic stone headwall • Discharges to scrub-shrub wetland • Low flow from snow melt during dry weather survey
W-12

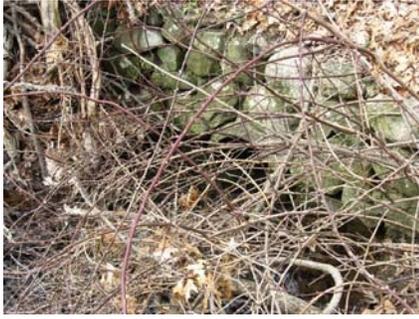
<ul style="list-style-type: none"> • Access from end of Wright Road and follow trail east behind homes • 24" RCP with historic stone headwall • Discharges to scrub-shrub wetland • Slight flow from snow melt during dry weather survey
W-14

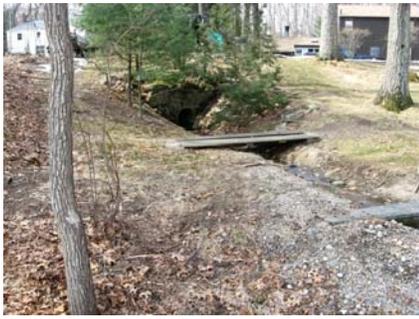
<ul style="list-style-type: none"> • Park at Warner's Woods and access from Law's Brook Road • Follow pond shoreline up through woods • 24" RCP with historic stone headwall • High dry weather flow during survey • No odors or sheens detected to suggest illicit connection; flow likely due to groundwater and snowmelt

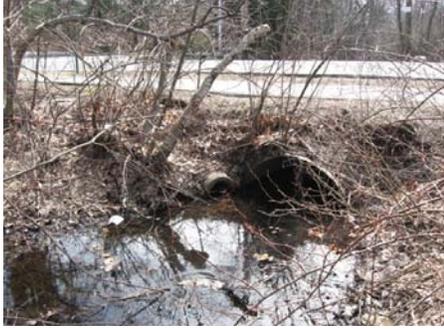
<p>W-15</p>

<ul style="list-style-type: none"> • Access on Law's Brook Road, park at Warner's Woods visitor spot • 2 outfalls – one 12" RCP, one 36" Corrugated Metal pipe • Drains road runoff
<p>W-17</p>

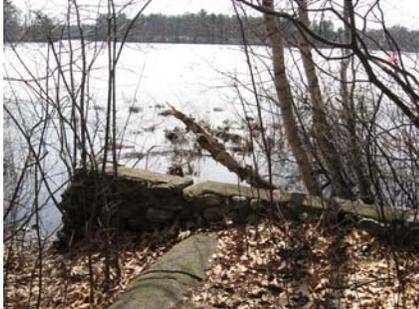
<ul style="list-style-type: none"> • Access from prison parking facility, walk along treeline and follow trail past cemetery through woods to outfall • 36" RCP with low flow during dry weather survey from snowmelt • Slight sheen on water • See AECOM figure of drainage • Drains Rt 2 runoff – discharges directly to pond with no wetland buffer • See GeoSyntec Report for past results • High priority sampling location
<p>W-23</p>

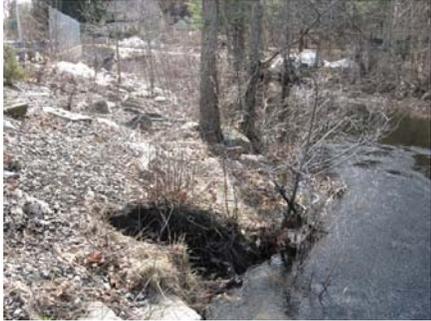
<ul style="list-style-type: none"> • Outfall drains catch basins along Weatherbee Road • Light industry nearby • No flow during dry weather survey but likely runs during wet weather

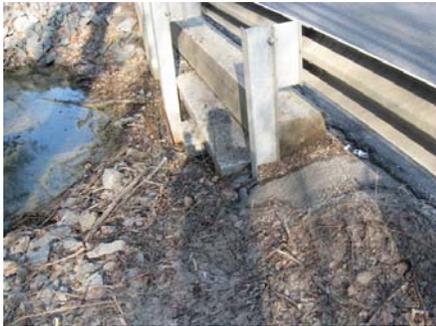
<ul style="list-style-type: none"> • Road cut along Route 111 • Sediment from road discharges to Guggins Brook, a tributary of Fort Pond Brook • Culvert under road is blocked
W-1A

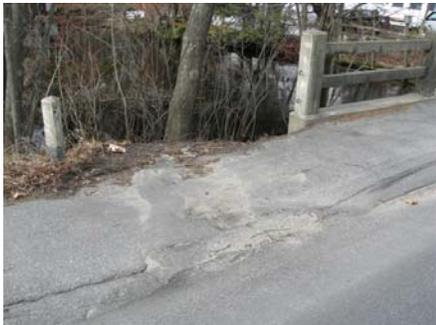
<ul style="list-style-type: none"> • Fort Pond Brook at Central Avenue, West Acton • Road cut with moderate sediment deposition on the roadway
W-3

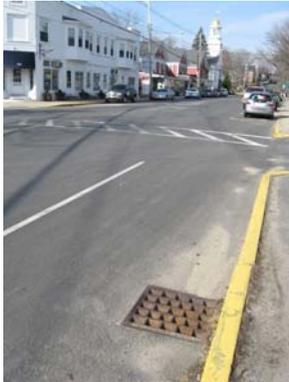
<ul style="list-style-type: none"> • Catch basins along Route 111 in West Acton • Moderate sediment deposition on the roadway • Catch basins likely drain to Fort Pond Brook
W-6

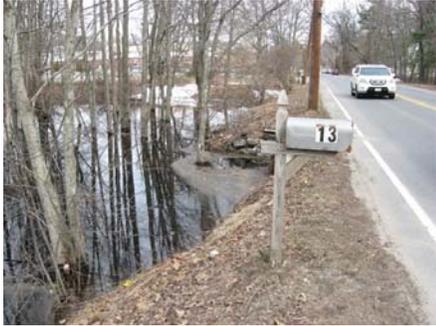
<ul style="list-style-type: none"> • Pratt Brook crossing at Main Street near south Acton • Moderate sediment deposition on the roadway • Large impervious surfaces associated with parking area adjacent to brook and car dealership further north

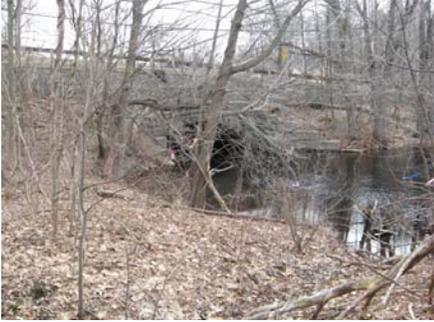
<p>W-7</p>

<ul style="list-style-type: none"> • Fort Pond Brook at Main Street in South Acton • Large parking area at the commuter rail station is located in proximity to the brook, a potential sediment source
<p>W-9</p>

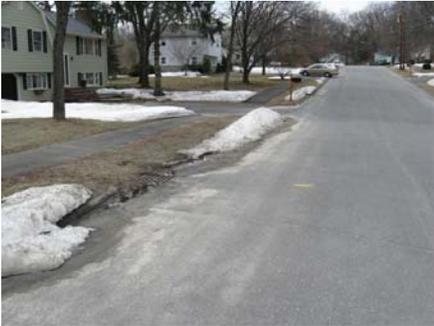
<ul style="list-style-type: none"> • Catch basins along Wright Road discharge sediment load from the street to Warner's Pond via the outfalls on the pond's western shore
<p>W-13</p>

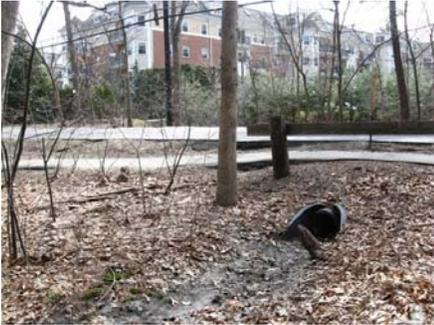
<ul style="list-style-type: none"> • 12" Corrugated Plastic Pipe outfall that drains road runoff from Laws Brook Road • Outfall discharges to forested area and not directly into Warner's Pond; sediment load attenuated by forested buffer • Not recommended for water quality sampling
<p>W-18</p>

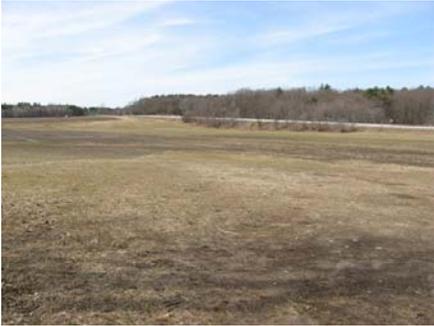
<ul style="list-style-type: none"> • Agricultural fields along Route 2 and School Street • Potential source of nutrient loading to Warner's Pond

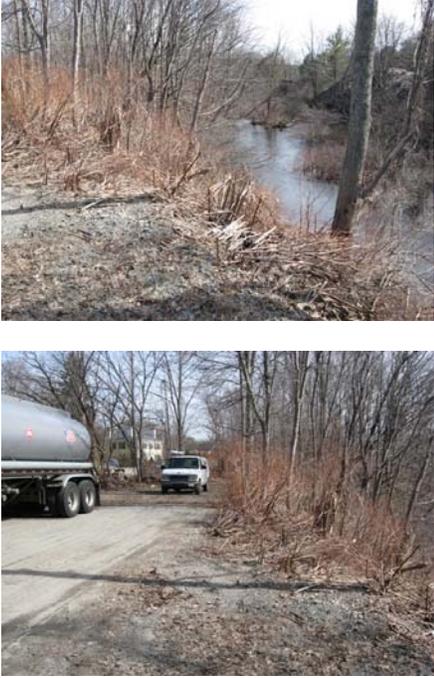
<p>W-22</p>

<ul style="list-style-type: none"> • Eastern bank of Nashoba Brook along Route 2A/Route 119 • This stretch of brook is a sediment-loading hotspot; there are numerous businesses and parking lots along the bank with little forested buffer • Steep eroding banks in this area likely contribute heavy sediment load
<p>W-23</p>

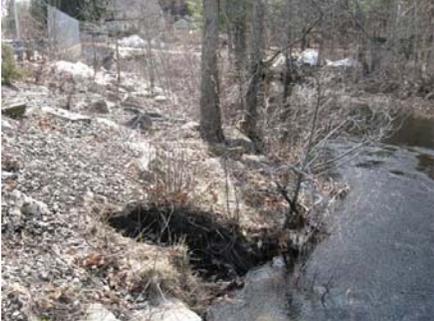
<ul style="list-style-type: none"> • Weatherbee Road Crossing of Nashoba Brook near Route 2A • Numerous business and light industrial areas contribute sediment to the brook along this reach
<p>W-24</p>

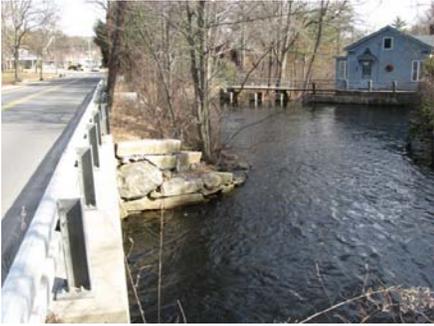
<ul style="list-style-type: none"> • Nashoba Brook at Concord Road with view of dam downstream of Ice House Pond • A proportion of the sediment within the brook likely settles out in front of the dam

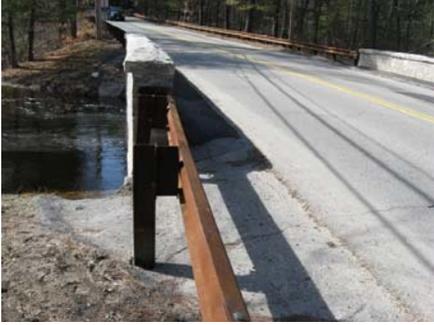
<p>W-25</p>

<ul style="list-style-type: none"> • Nashoba Brook at Brook Street • Road cuts on upstream and downstream side of the brook at this location with moderate sediment load in the roadway • Heavy commercial development to east on Rt 2A/Route 119
<p>W-26</p>

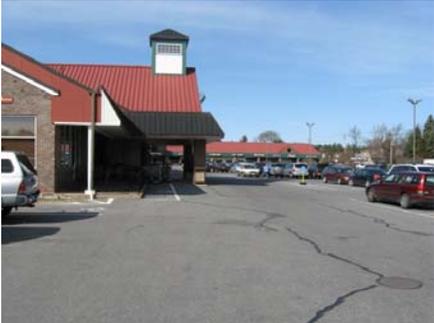
<ul style="list-style-type: none"> • Example of some of the commercial development along Route 2A/Route 119 located to the east of Nashoba Brook • Although this area is a potential source of sediment, much of it is likely attenuated before it reaches the pond given the distance to the pond and presence of dams downstream
<p>W-28</p>

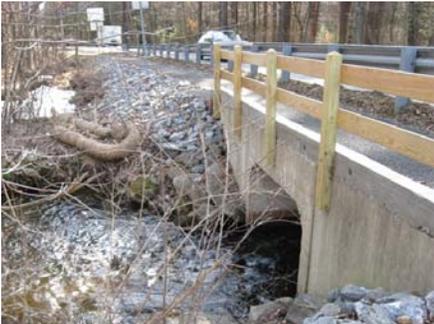
<ul style="list-style-type: none"> • Nagog Brook at Route 27 • Newly installed box culvert • Surrounding area is less developed than southern portion of the watershed • Light sediment deposition on the roadway
<p>W-30</p>

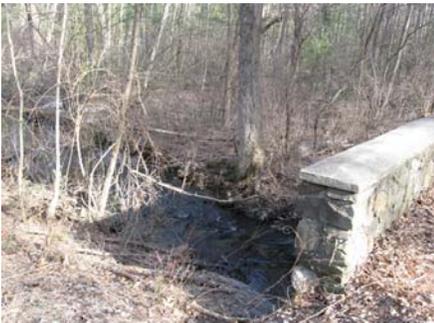
<ul style="list-style-type: none"> • Conant Brook at Nagog Road • Rural area of the watershed • No catch basins on the roadway • Surrounding area has no obvious sources of sediment loading to Warner's Pond

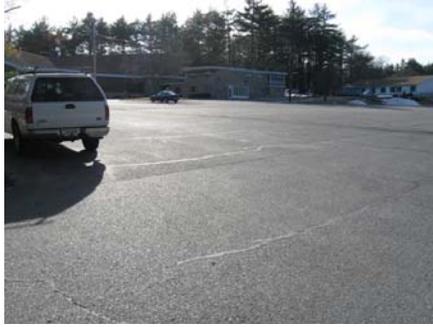
W-32

- Grassy Pond Brook at Arlington Street
- Large church parking area adjacent to the brook is a potential sediment source
