**WILDLIFE
AND
HABITAT ASSESSMENT
WARNER'S POND
CONCORD, MA**

November 4, 1999

RE: Warner's Pond Biological Survey
NEE file 99-1602

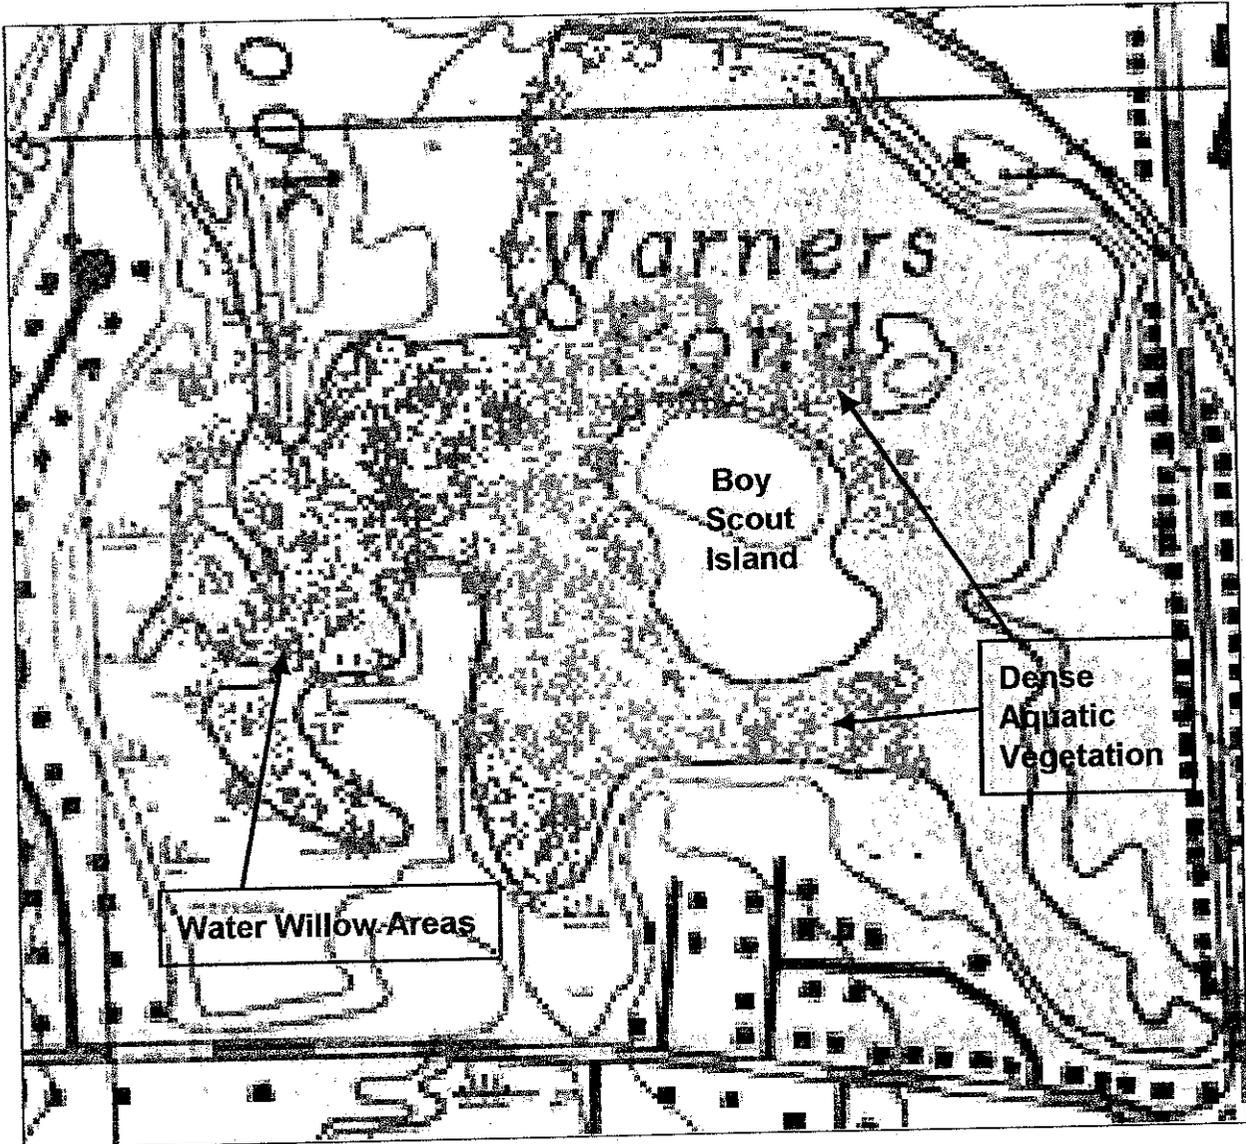
Figure 1. Topographical Map of Warner Pond, Concord, MA, Maynard Quad, 1987

This approximately seventy-seven acre man-made pond can be divided into four habitat types which are shown on the attached site locus map (see Figure 1):

- shallow marsh to the north and west of Boy Scout Island;
- a large water willow, *Decodon verticillatus*, marsh at the inlet;
- open water along the eastern side and in the north; and
- mixed upland forest habitat found on the islands.

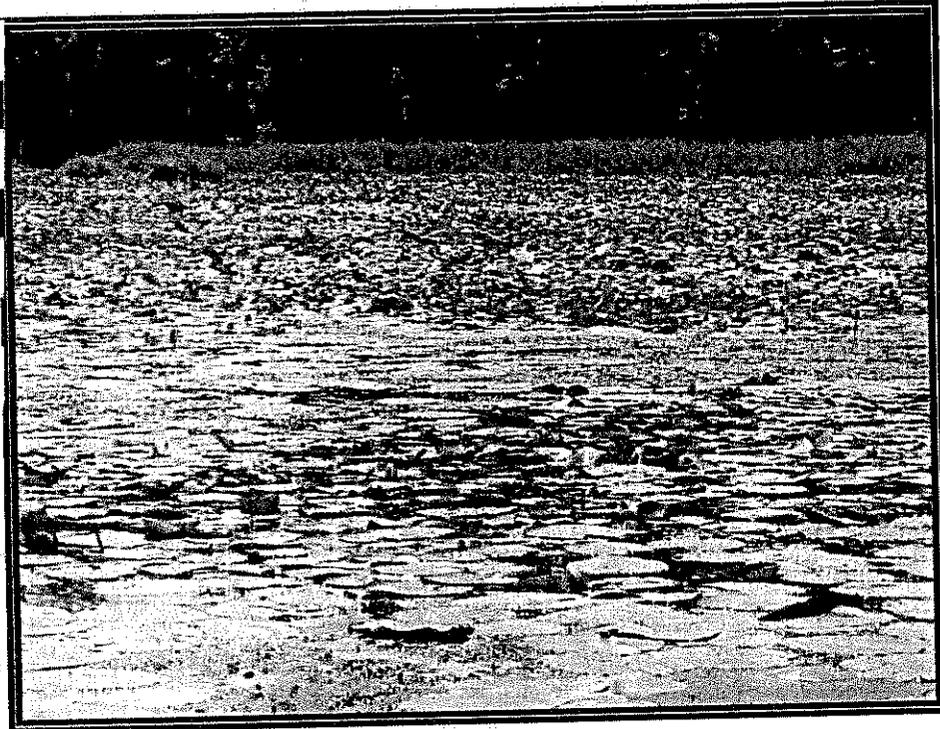
*Typical Northwest Pond Shallow Marsh
Vegetation Cover*

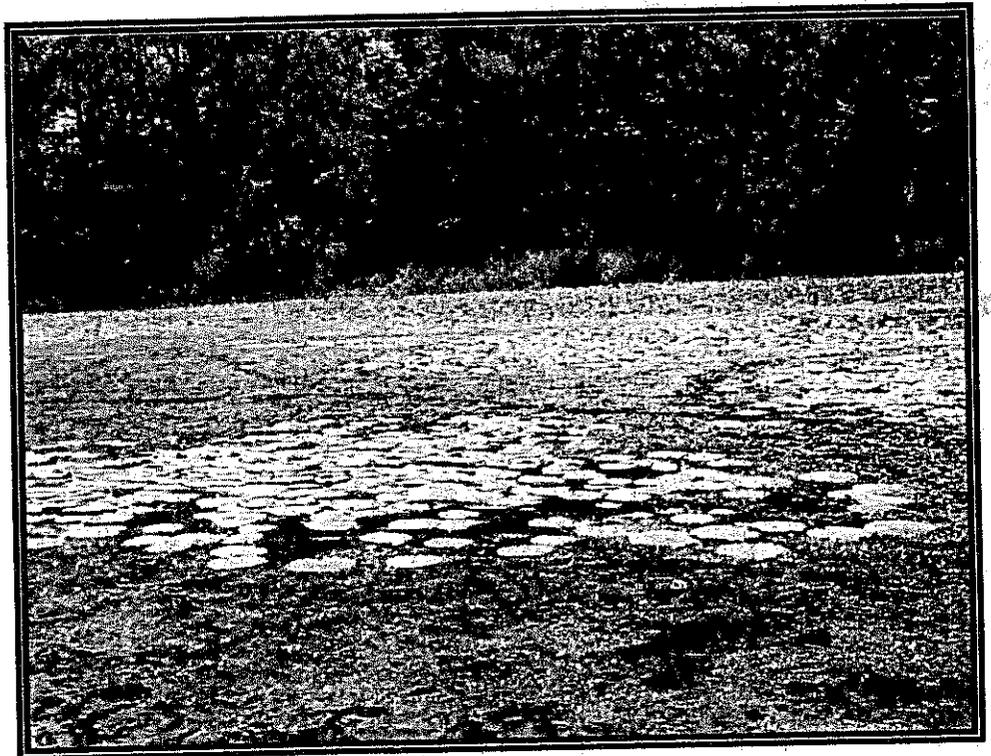
*Visible "trails" within the
floating leaved aquatic
plants are from swimming
Wood ducks*

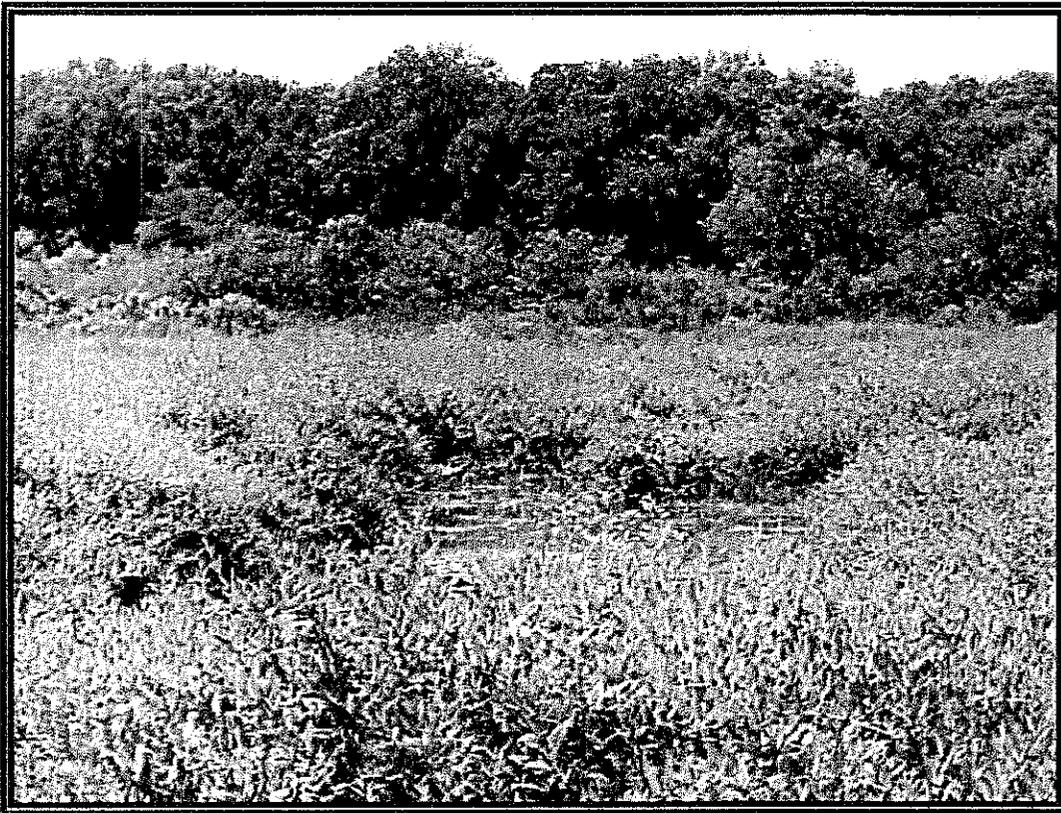
Typical Water Willow community cover at the Nashoba Brook inlet channel into Warner's Pond.

1. Use mechanical (dredging) techniques to recreate a flow through channel between the inlet and outlet of the Pond and to remove sediments deposited in the inlet area and *Decodon* marshes. It is likely that the water levels within the pond will need to be dropped via the outlet structure for this work. Since a man-made dam exists at the outlet, it should be possible to lower the water level within the pond for management and maintenance purposes.

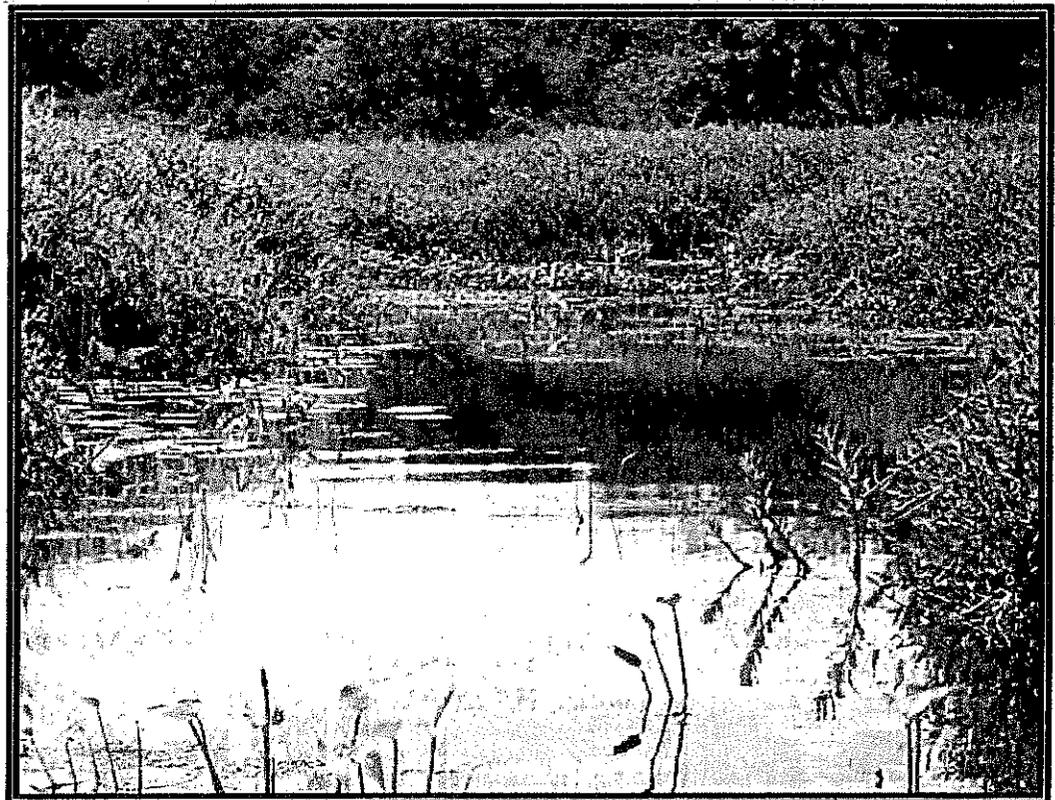
Nashoba Brook Channel into Warner's Pond

3. Consider the draw-down of Warner's Pond to remove invasive aquatic vegetation
4. Create a "sump" at the Nashoba Brook inlet to collect sediment entering the Pond from the upstream watershed by constructing a low berm of rock gabions (or other similar methods). This "sump" should be accessible via the adjacent corn fields, and should be cleaned out on a regular (yearly) basis, thereby preventing sediments from continually filling the Pond. The purpose of this sump, or sediment trap basin, is to provide a means to prevent sediment from upstream sources from

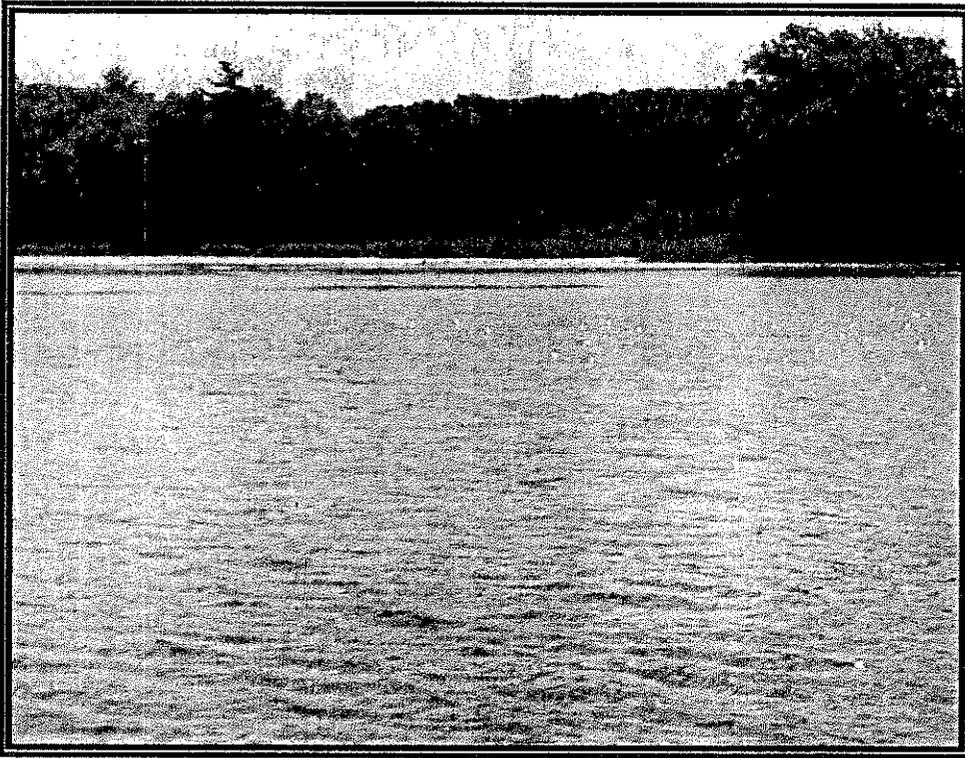
The open water habitat in the northeast section of the Pond contains the deepest water found within of the pond with depths of over 6 feet. Canada Goose, Mallard Duck, Belted Kingfisher, and Double-crested Cormorant all used this area. The deep relatively cool water within this community allow fish to escape the warm shallow low oxygen water of the marsh habitats. This deeper community continues south of the islands to the outlet. The water in the deep area in the

Northeast area of Warner Pond with open water habitat

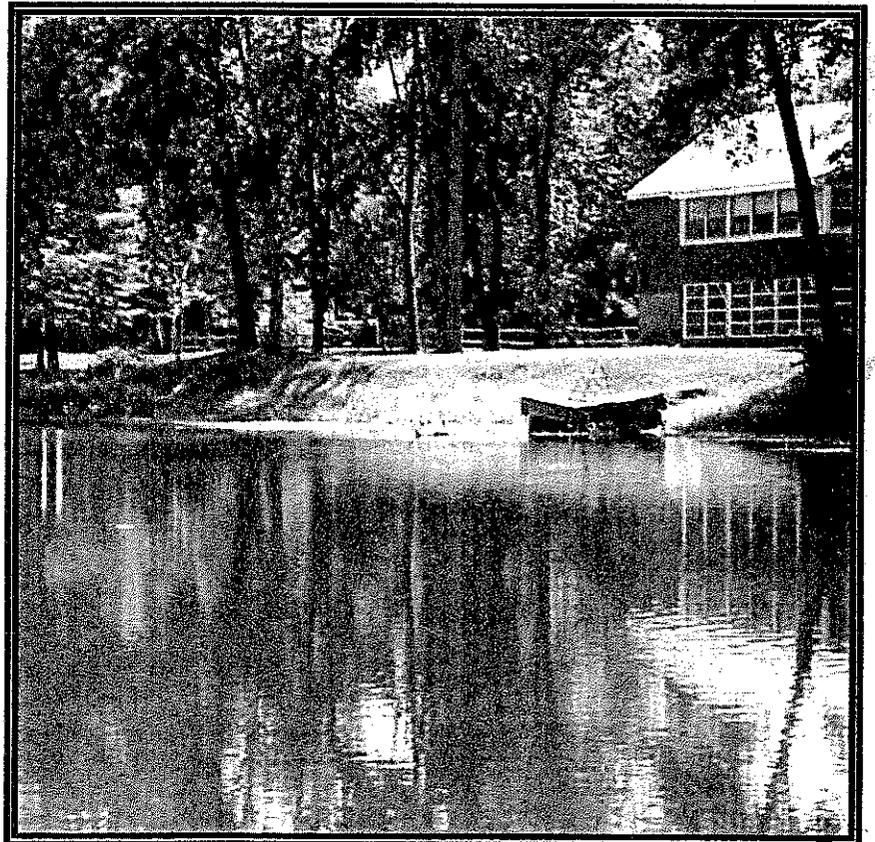
northeast does not appear to be carrying high loads of silt or sediment. In contrast, the water within the outlet channel is carrying an extensive load of silt and is a brown chalky color.

Open Water outlet channel with silty water and typical channel shore line

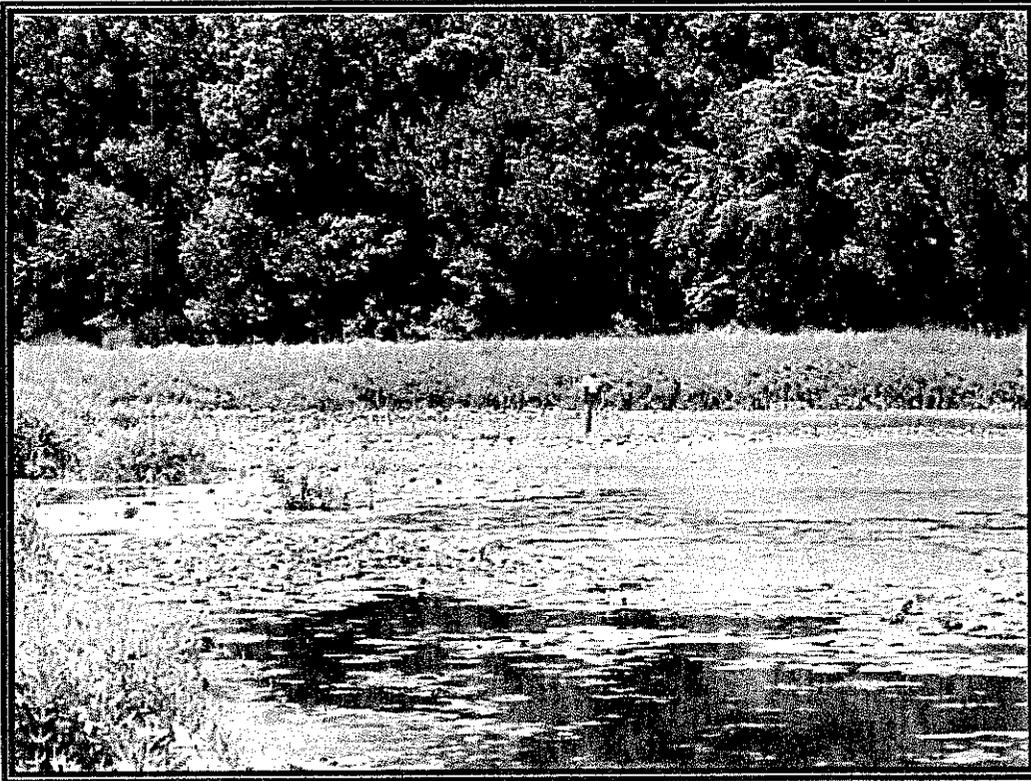
The shorelines throughout the pond are vegetated with Purple Loosestrife, Lythrum salicaria. A large corn field borders Warner's Pond to the northeast. This field is heavily used by the geese from Warner's Pond in both the spring and the fall, when portions of the field are flooded. Note Decodon fringed shoreline, and wood duck box

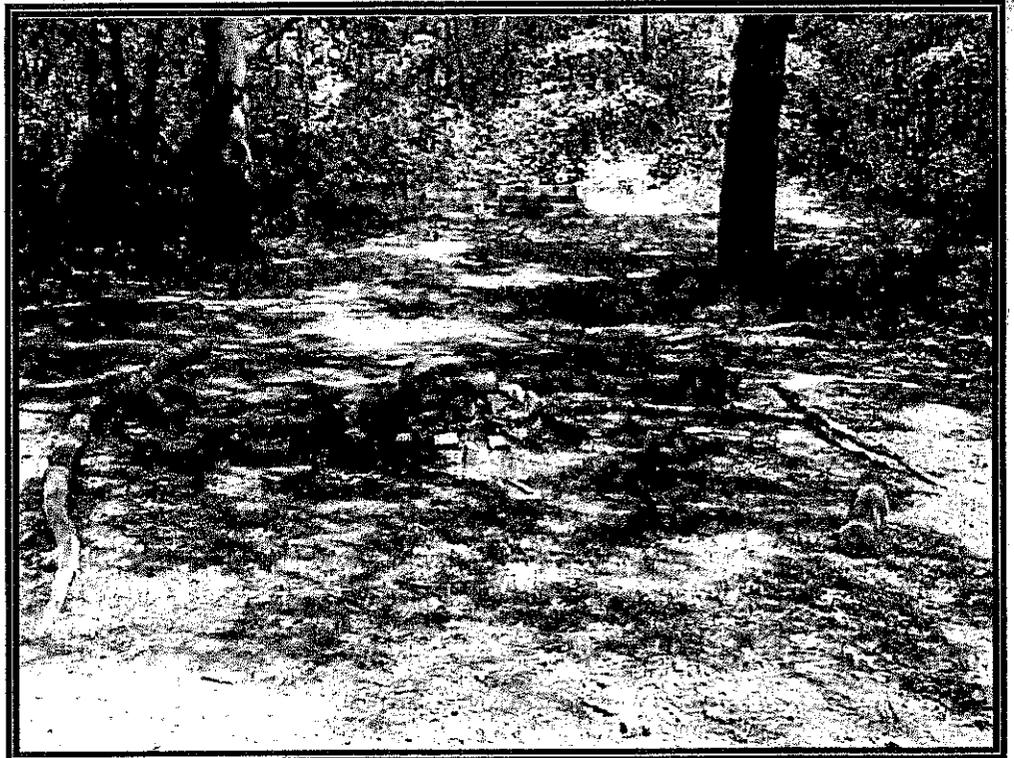
This island also sees some use by people. There are the remains of a house foundation on the largest island, and an existing fire circle (see photograph) indicates that this area continues to be used as an informal campground. Use by people appears to be minimal as there is much dead wood on the island despite the fire circle and a semi-worn trail system. Access to the islands is relatively easy from the conservation landing with a canoe or kayak. Use of a small motor boat is possible, but due to the large quantities of submerged aquatic weeds, not practical.

Fire circle camping area and old foundation on Boy Scout Island.

8. Establish a policy for camping on Boy Scout Island.
9. Consider the creation of a Town camping area on Boy Scout Island. This is a relatively undisturbed wooded island which has the feel of being far from civilization. Only a short canoe paddle away from the landing, it may serve as an interesting overnight area for nature groups, school groups, scouts, etc.
