WARNER'S POND MANAGEMENT PLAN
CONCORD, MASSACHUSETTS

September 1999

Town of Concord
Division of Natural Resources
141 Keyes Road
Concord, MA 01742

Aquatic Control Technology, Inc.
11 John Road
Sutton, MA 01590-2509

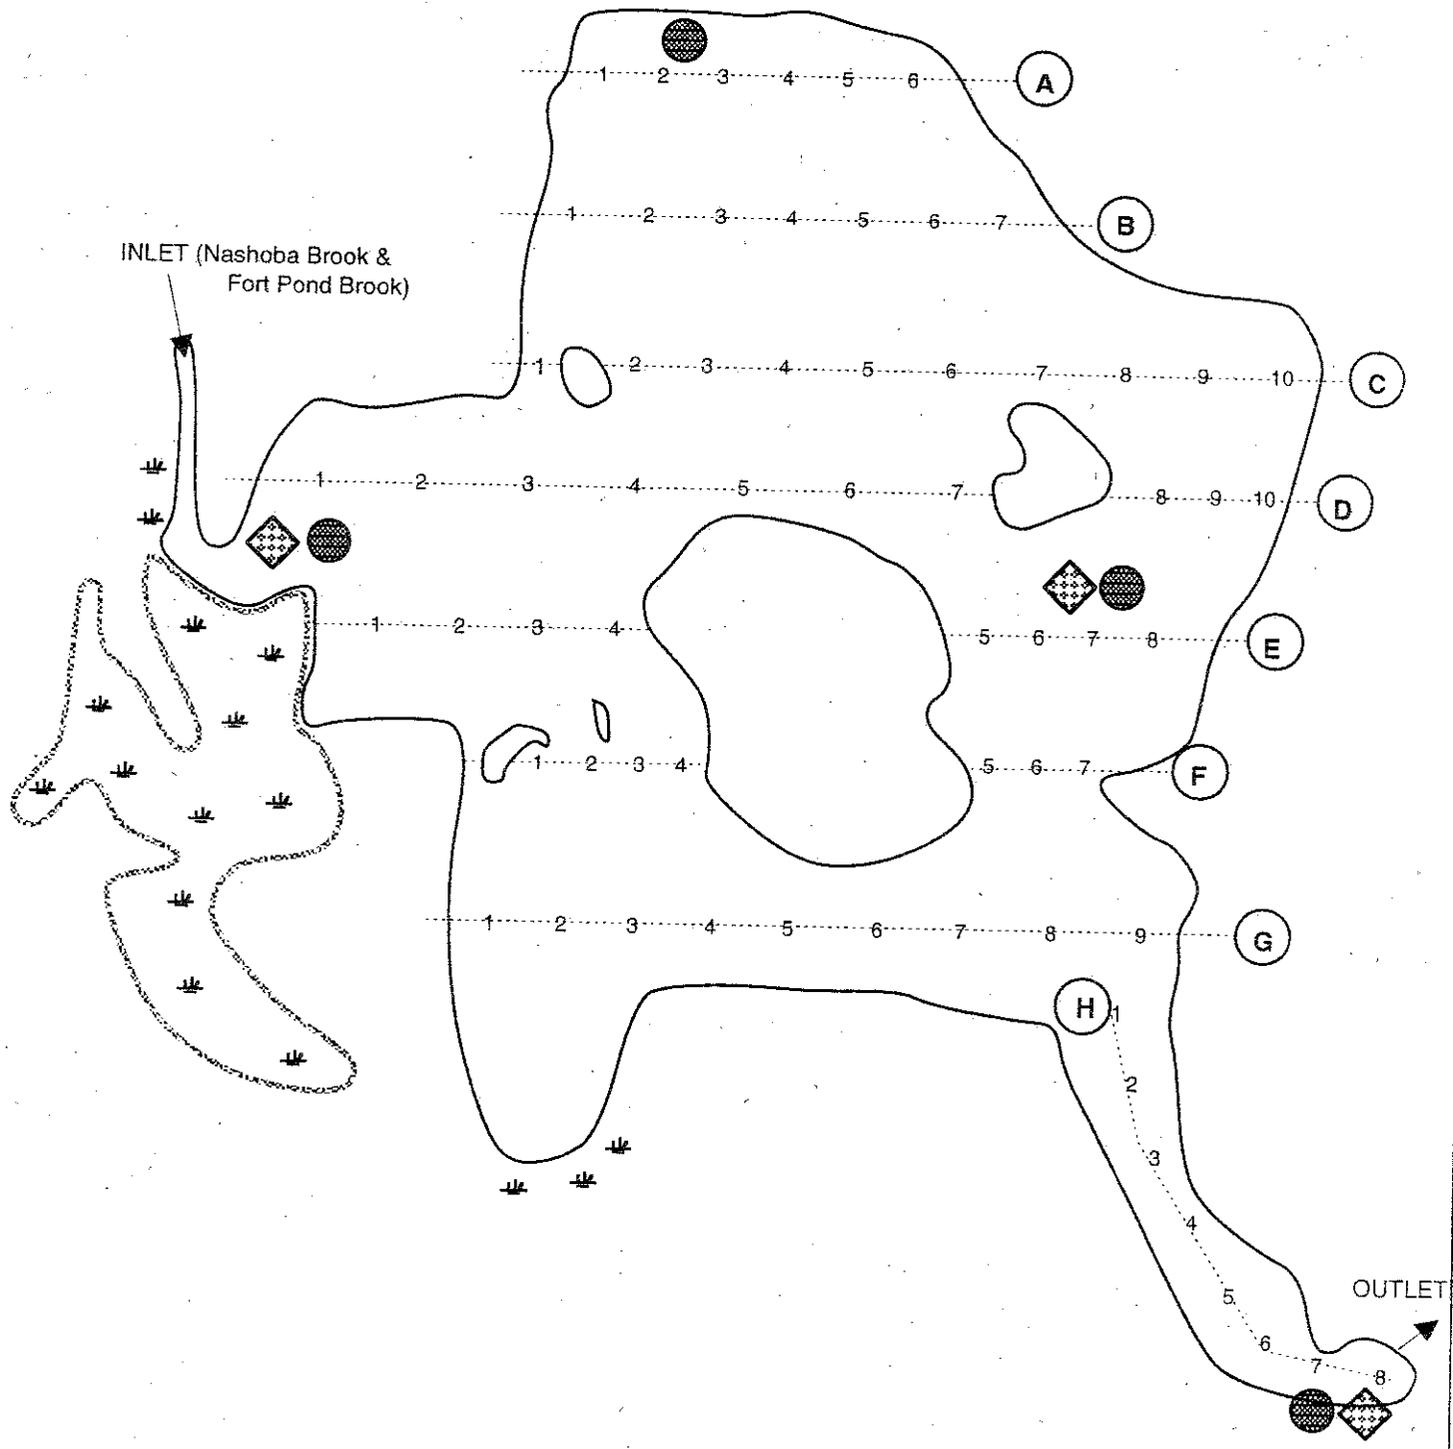
WARNER'S POND
 Concord, MA
Figure 2
 Transect & Data Point
 Location Map
 August 1999

- 1---2---3 (A) Transect and Data Point Locations
- ◆ Water Quality Sampling Locations
- Sediment Core Sample Locations

Pond Area: ≈ 54 acres Scale: 1" = 350'

The following water quality sampling sites were selected within the pond (Figure 2):

nutrient and textural parameters. Sampling locations included the Nashoba Brook inlet, Route 2 overflow, mid-pond and the pond outlet (Figure 2).

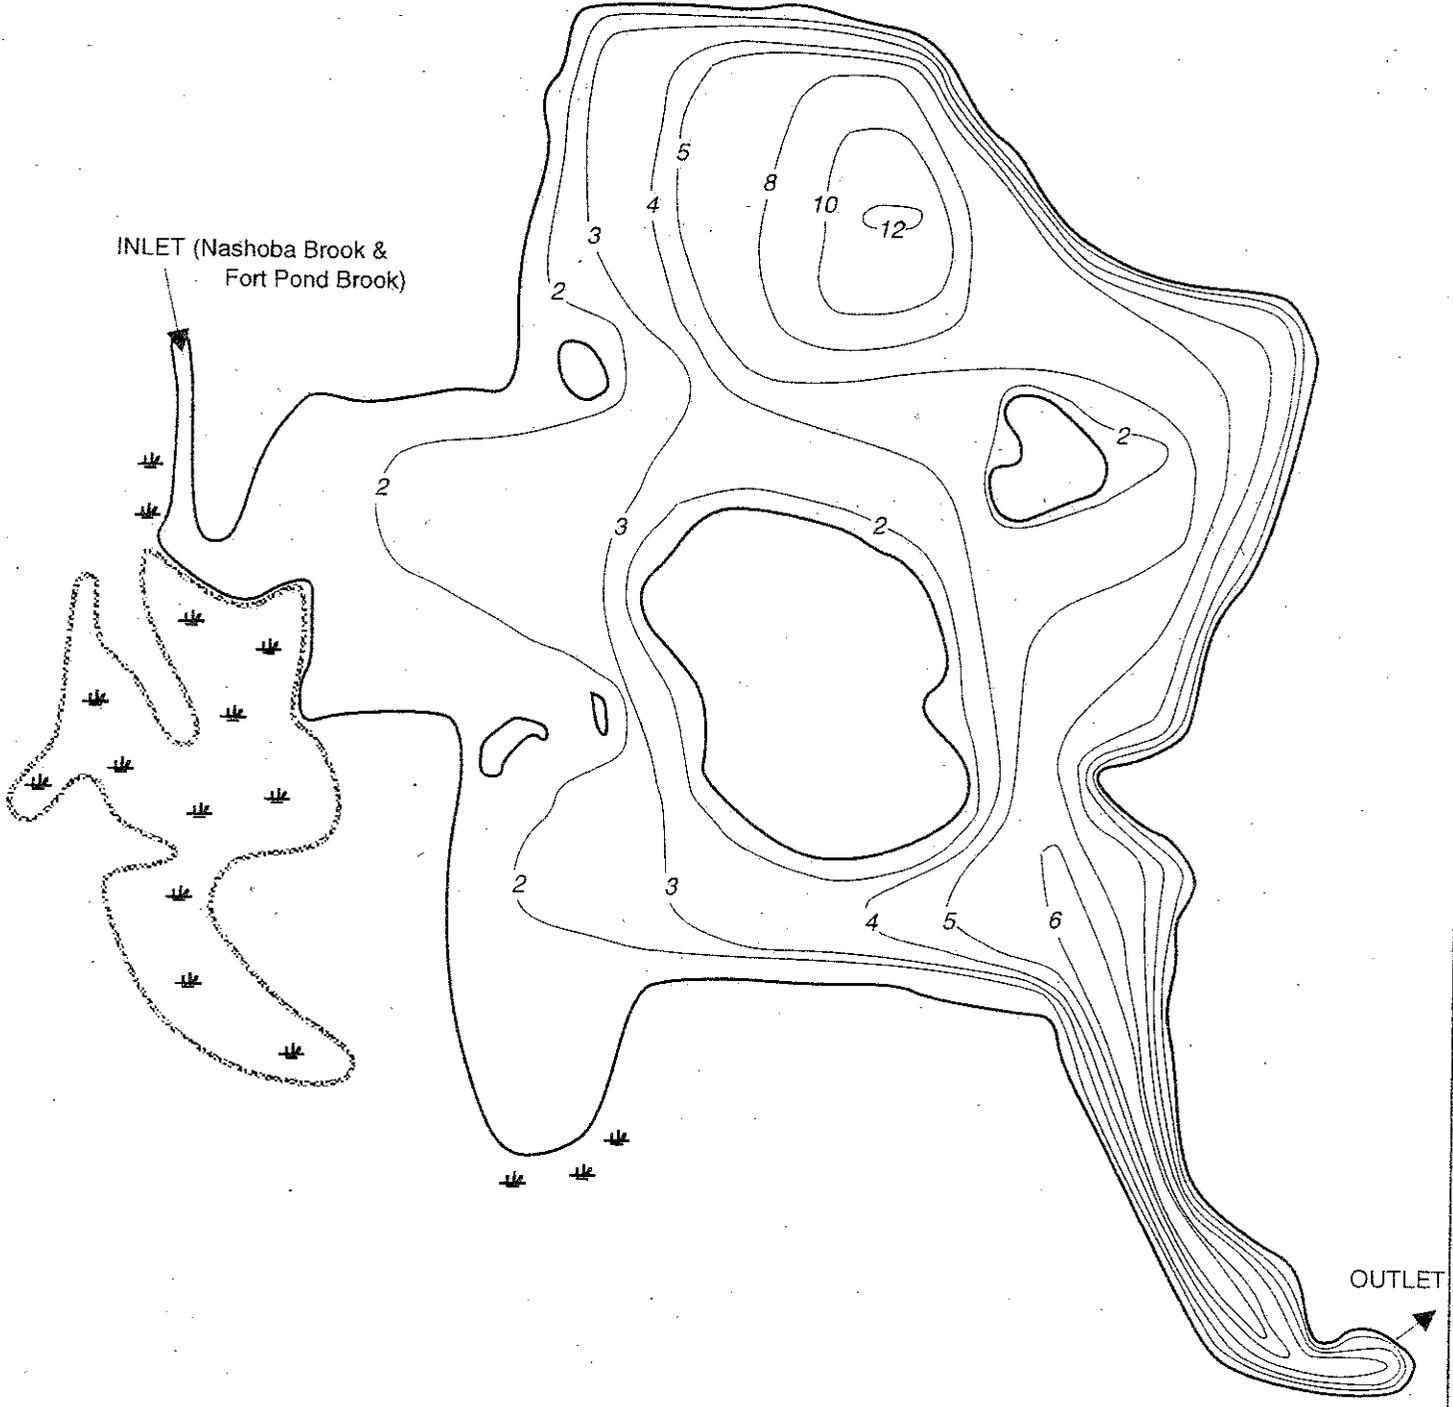
WARNER'S POND
Concord, MA
Figure 3
Bathymetry Map
August 1999

- Depth contour lines are recorded in feet
- The depth contours shown are approximated based on water levels at the top of the stone spillway, or about one foot below the concrete spillway

Pond Area: ~ 54 acres Scale: 1" = 350'

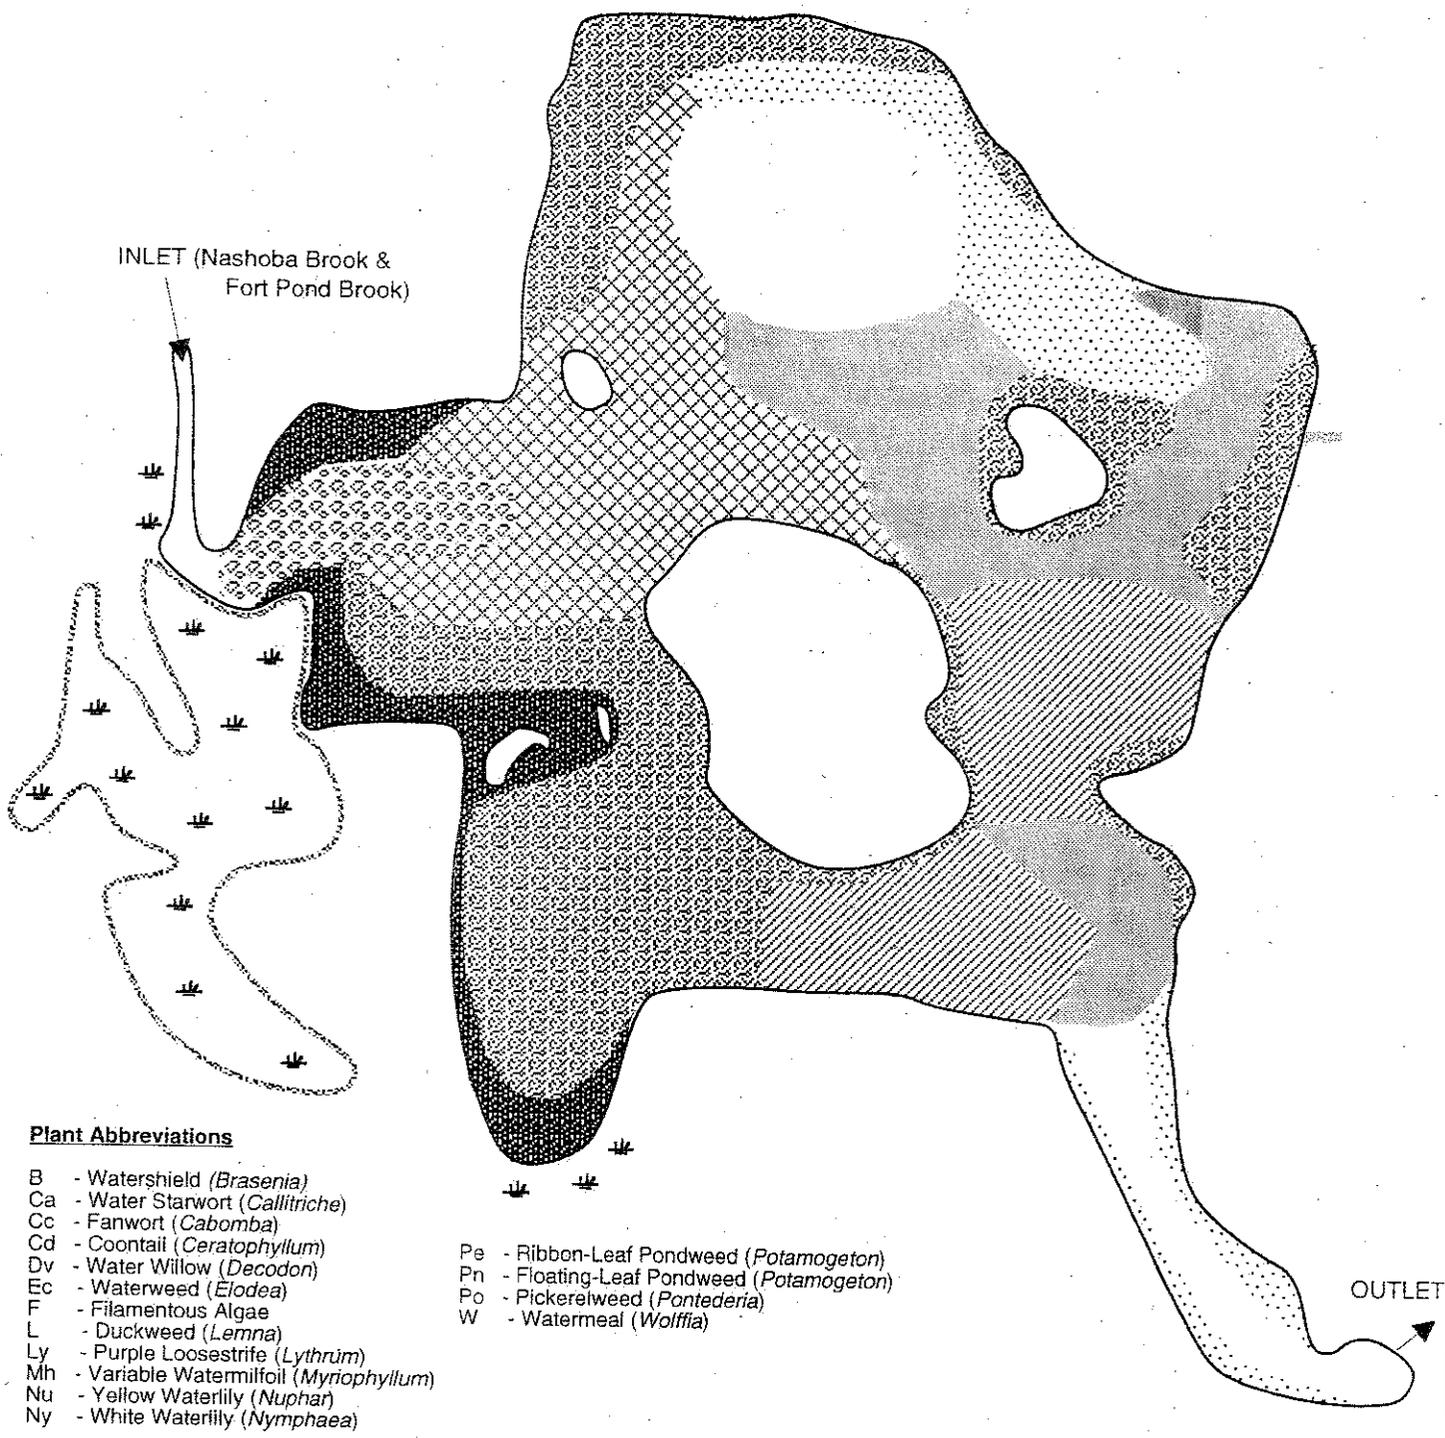
- B - Watershield (*Brasenia*)
- Ca - Water Starwort (*Callitriche*)
- Cc - Fanwort (*Cabomba*)
- Cd - Coontail (*Ceratophyllum*)
- Dv - Water Willow (*Decodon*)
- Ec - Waterweed (*Elodea*)
- F - Filamentous Algae
- L - Duckweed (*Lemna*)
- Ly - Purple Loosestrife (*Lythrum*)
- Mh - Variable Watermilfoil (*Myriophyllum*)
- Nu - Yellow Waterlily (*Nuphar*)
- Ny - White Waterlily (*Nymphaea*)
- Pe - Ribbon-Leaf Pondweed (*Potamogeton*)
- Pn - Floating-Leaf Pondweed (*Potamogeton*)
- Po - Pickerelweed (*Pontederia*)
- W - Watermeal (*Wolffia*)

The most abundant and visible aquatic plant assemblage is the nearly contiguous growth of white and yellow waterlilies. This plant assemblage is found in the southwestern corner of the pond, it also extends around the northern end of the pond and is established in several large patches around the islands and along the shoreline in the eastern half of the pond. Also present in this plant assemblage is a dense understory of submersed plant growth that is dominated by coontail, elodea and pondweed. Duckweed, watermeal and filamentous algae are also floating around the waterlily leaves. There is 100% plant cover in these areas and it is assigned a biomass index of 4, which represents the most abundant plant growth.

The least abundant plant assemblage was limited to the northeastern portion of the pond and along the shorelines of the outlet cove. Coontail, white waterlilies and scattered fanwort growth were found in these areas. Total plant cover was only 25% and the biomass index was 1.

The only sections of the pond that did not support any aquatic plant growth was where water depths exceeded 6 feet at the northern end of the pond and in the center of the outlet cove.

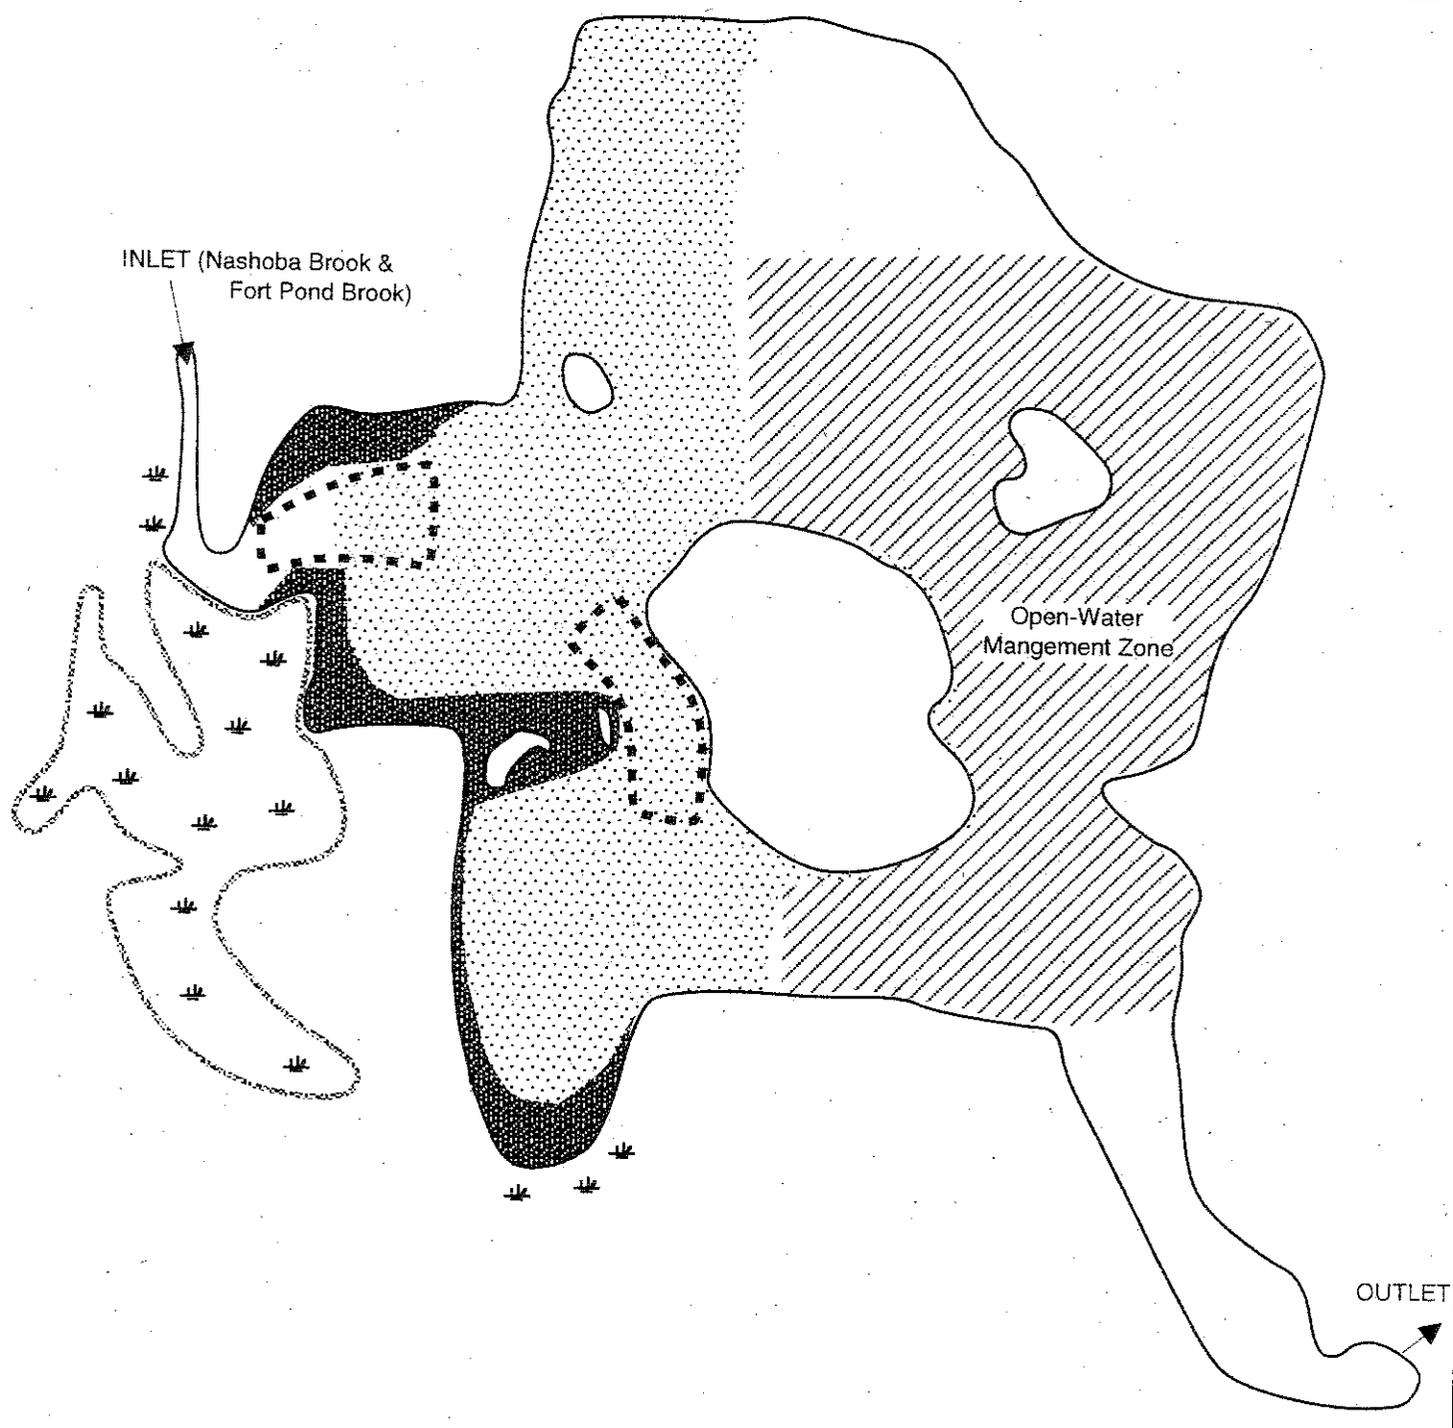
WARNER'S POND
Concord, MA
Figure 7
Proposed
Management Zones
August 1999

- LEGEND**
- Water Willow Marsh - preservation zone
 - Shallow Marsh - preservation zone
 - Open Water - management zone
 - Areas that should be kept free from emergent vegetation - possible future management zone
- Pond Area: ~ 54 acres Scale: 1" = 350'

Increasing open-water habitat – areas that do not have abundant rooted vegetation reaching the surface by mid-summer – will improve access to the pond for recreational activities and restore a diminishing habitat type in the pond. Determining where to focus plant reduction efforts needs to take into account the type of plant cover and the benefits of restoring open-water conditions. Since the most abundant plant coverage occurs where water depths are 3 feet or less, which encompasses practically the entire western half of the pond, this area should be left unmanaged. The western half of the pond provides water willow and shallow marsh habitats that are heavily utilized by wildlife. Plant management efforts in this area would be the least cost-effective and offer the shortest duration of control. Recreational activities in this area would continue to be greatly limited by the 2-3 foot water depths. Leaving this area devoid of vegetation may increase the sediment-water interactions, resulting in further degradation of water quality and possibly lead to increased algal growth. Reducing the plant density to improve open-water habitat should be limited to the eastern half of the pond where water depths range between 4 and 5 feet. The only notable exception would be to prevent contiguous emergent plant cover from becoming established around the inlet or between the western side of Boy Scout Island and the smaller unnamed islands.

The following evaluation of in-pond management strategies focuses on the control of nuisance vegetation to improve open-water conditions in the eastern half of the pond. The applicability of commonly used in-pond management strategies at Warner's Pond is discussed below.
