**CULTURAL, STRUCTURAL &
ENVIRONMENTAL ASSESSMENTS**

THE WHEELER-HARRINGTON PROPERTY
West Concord, MA

February 2015

Prepared for the Town of Concord

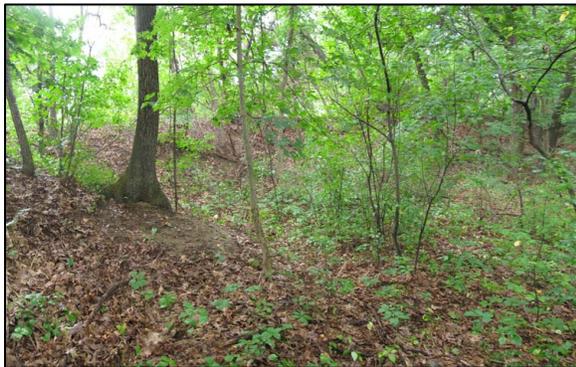
Figure 05: Borrow pit

There is evidence of a town borrow pit and a refuse dump site immediately west of the access path down to the riverfront area (Figures 05 and 06). (Peter Benes interview 2014-09-16). Mr. Benes believes the borrow pit served as a source of gravel for Town road repairs. Cast off appliances, junk and debris remain visible at the dumpsite. See location in Map 02 below.

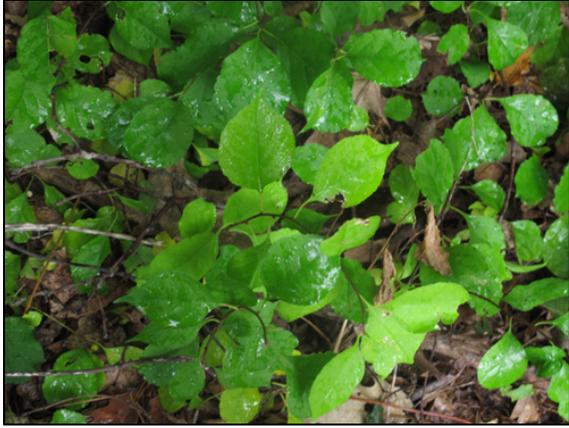
Exotic invasive species of trees, shrubs and vines have infested the upland slope and portions of the meadow landscape of Harrington Park. While not an overwhelming environmental issue at this time, any management scheme should include an invasive species eradication program. Refer to the Environmental Assessment for a listing of the invasive species.

Figure 07: Bittersweet Vine

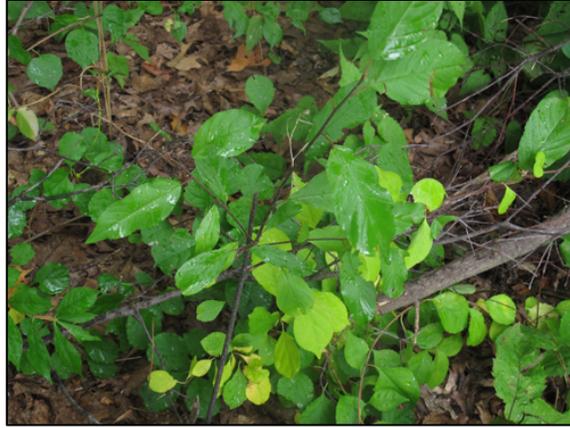
Figure 08: Buckthorn

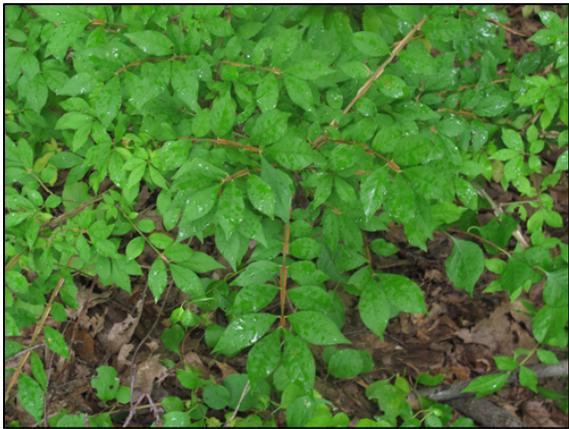
Figure 09: Burning Bush

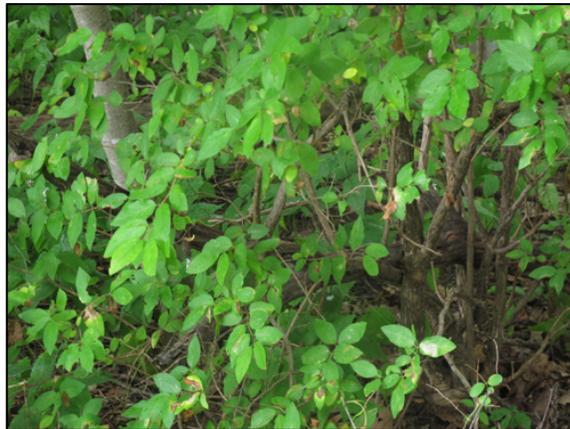
Figure 10: Honeysuckle

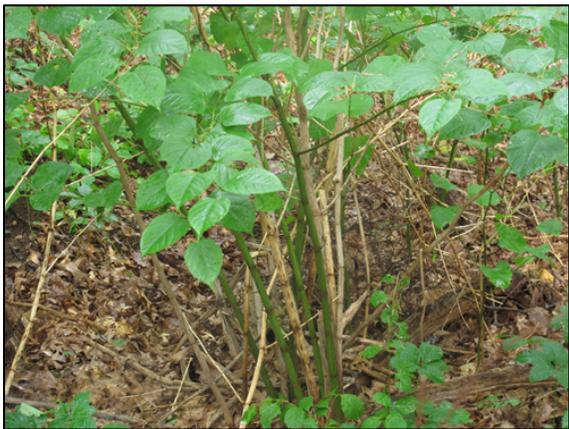
Figure 11: Japanese Knotweed

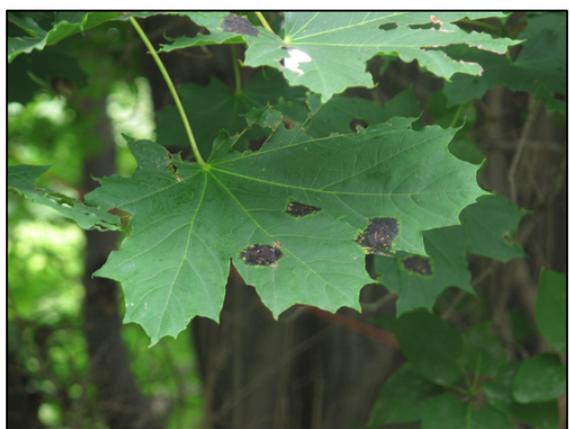
Figure 12: Norway Maple

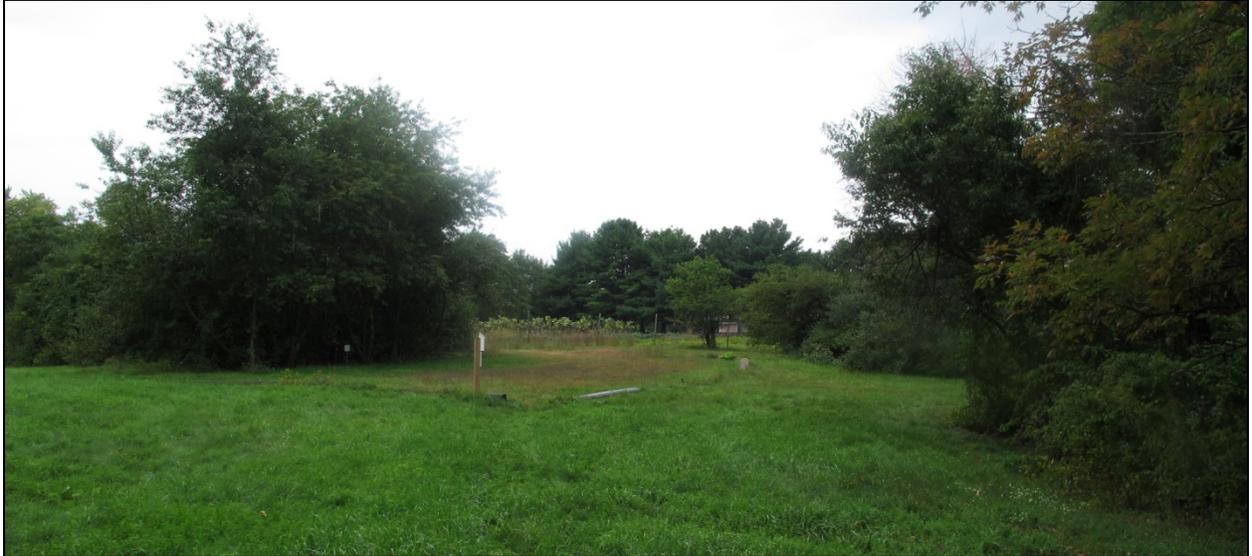
An obscure driveway connects Harrington Avenue to a parking lot towards the rear of the parcel (Figure 13). Concern has been expressed that the Harrington Park parking lot cannot be seen from Harrington Avenue and is utilized for illicit activities beyond amorous teenagers and occasional beer drinking. Obscuring the parking area is a copse of trees overgrown with volunteer trees, shrubs and weeds. (Figures 14 and 15)

Figure 14: Looking west from the Wheeler-Harrington House to the parking lot at Harrington Park. Copse of trees on south side of parking lot obscures views of parking lot from Harrington Avenue.

As noted previously, the view of the parking lot from Harrington Avenue is obscured by the copse of trees on the south side of the parking lot. This will continue to be a policing issue best resolved by clearing out all of the vegetation except the two mature trees in the stand. (Figure 15). But just as important, this copse of trees makes the park look smaller than it actually is. By removing this vegetation, the depth of the view into the Park from Harrington Avenue will be increased.

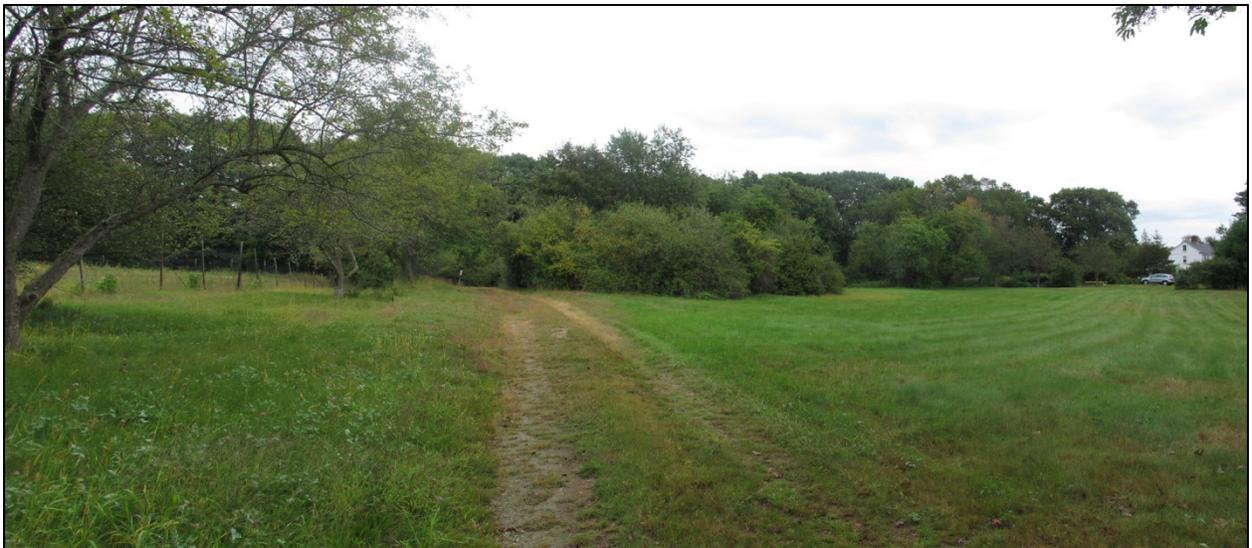
Figure 15: Looking north from Harrington Avenue; Harrington Park driveway. Copse of trees obscures views of parking lot from Harrington Avenue.

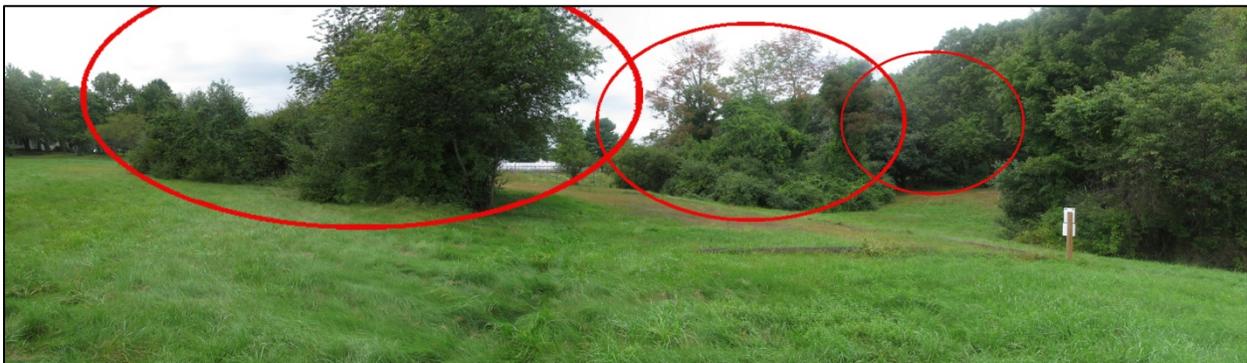
In addition to removing the undergrowth of the copse of trees at the parking lot, there are two additional groves of trees that should be cleaned up and unwanted volunteer and invasive species removed. In Figure 17 the middle group of trees are White Ash, a species of trees that turns a copper bronze color early in the fall. Once this tree species was prolific. It is now in serious decline. Any opportunity to showcase this species should be taken.

Figure 17: Clearing out the understory of groves of trees at the northwest corner of the site.

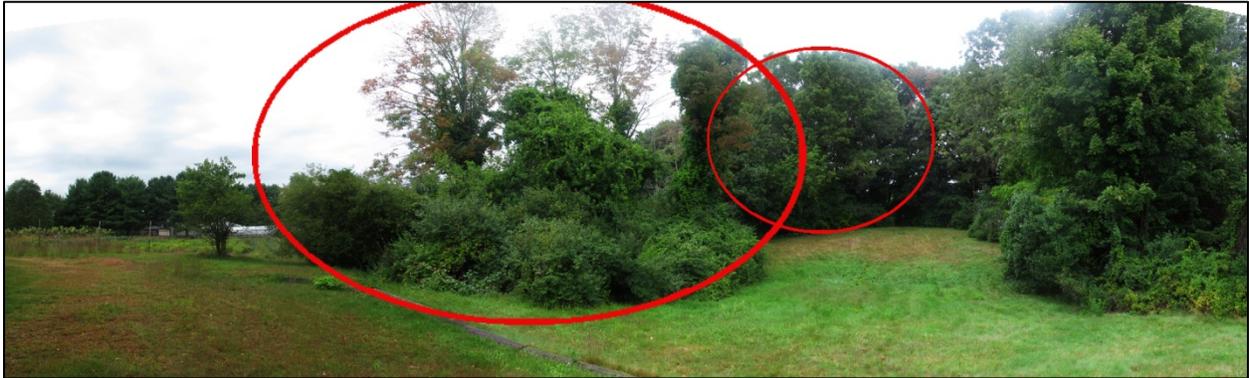
The trees to the far right of Figure 17 and closer still in Figure 18 are predominantly Red Oaks. These are also being taken over by invasive species and would benefit greatly by having the understory completely removed.

Figure 18: Showcasing the White Ash left and Red Oaks right by clearing out invasive species

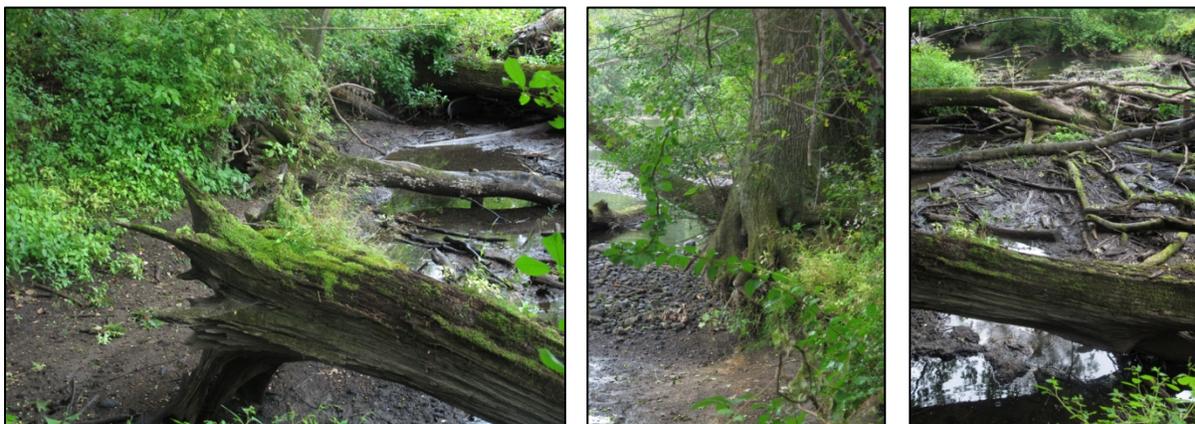
The riverfront area of Harrington Park had been used as a canoe launch in past years. Use of the Assabet River for canoeing and kayaking has fallen off over the past several decades as river current has undercut the riverbank and trees have fallen into the river channel (Figures 28, 29, 30). Should the Town consider establishing a canoe launch along this reach of the Assabet River, a careful review of regulations at Federal, State and Local levels will be required. At this point along the south bank of the Assabet, the deeply cut banks and debris in the River may make this section of the River hazardous for canoe and kayak use.

Figure 28, 29 & 30: fallen trees and undercut bank on the Assabet River

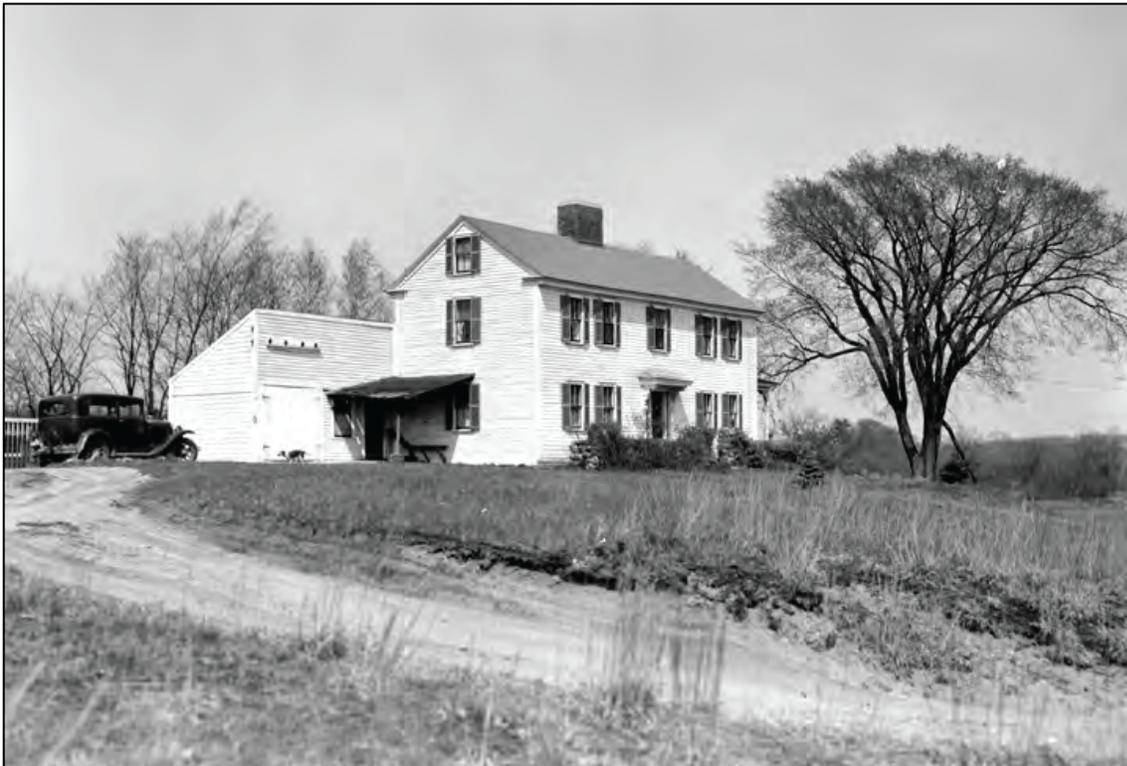
Figure 43: Harrington House, 1937; photograph by George Shepard, from the Ruth Wheeler House File. Courtesy of William, Munroe Special Collections, Concord Free Public Library.

These two spruce were planted in the mid-1930s, as indicated in the historic photograph, Figure 43. In light of their age and proximity to the House, these two trees should be considered hazards. The potential for wind throw and damage to the wood frame structure of the Wheeler-Harrington House is significant.

- b. South Façade and Landscape:
 - i. Remove and discard the two large Colorado blue spruce immediately. These are hazard trees and pose a serious danger to the House. Consider replacing these trees with either Princeton Elms or Valley Forge Elms, both American elm varieties that have shown strong disease resistance and echo the large elm seed in the Gleason photograph (Figure 43).

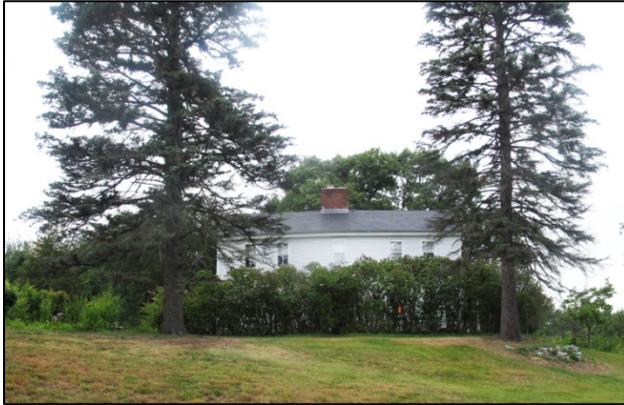
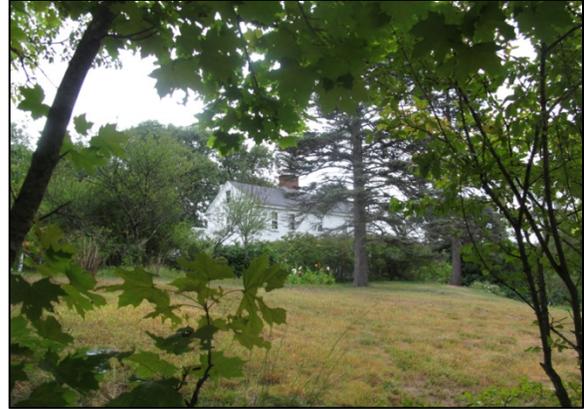
Figures 44 and 45: Obscured South Façade of the Wheeler-Harrington House.

The stone border is a late 20th century replacement for the stone wall shown in historic photographs of the house from 1916 and 1937 (See Figures 44 and 48). The lilac hedge is not historic.

- ii. Remove and discard the lilac hedge and Vinca minor groundcover.
 - iii. Remove the stone filled wood troughs that collect roof runoff. Replace with a flush French drain system, an excavated, stone lined and covered drainage trench with perforated pipe that connects to drywells set back from the south façade of the

- building. Coordinate with Historic Structures Assessment for connection of the downspout from the entry hood over the front door.
- iv. Remove the rounded stone border and replace with a dry laid, free standing field stone wall, similar to the stone wall shown in the 1916 and 1937 photographs (Figures 43 and 48). The foundation for the dry laid stone wall should be a deep and broad bed of 3/4-inch crushed stone (ASTM C33 No. 57 stone), which can serve the dual purpose of foundation and drywell from roof runoff collected by the French drain and for the isolated low point serving the west façade.

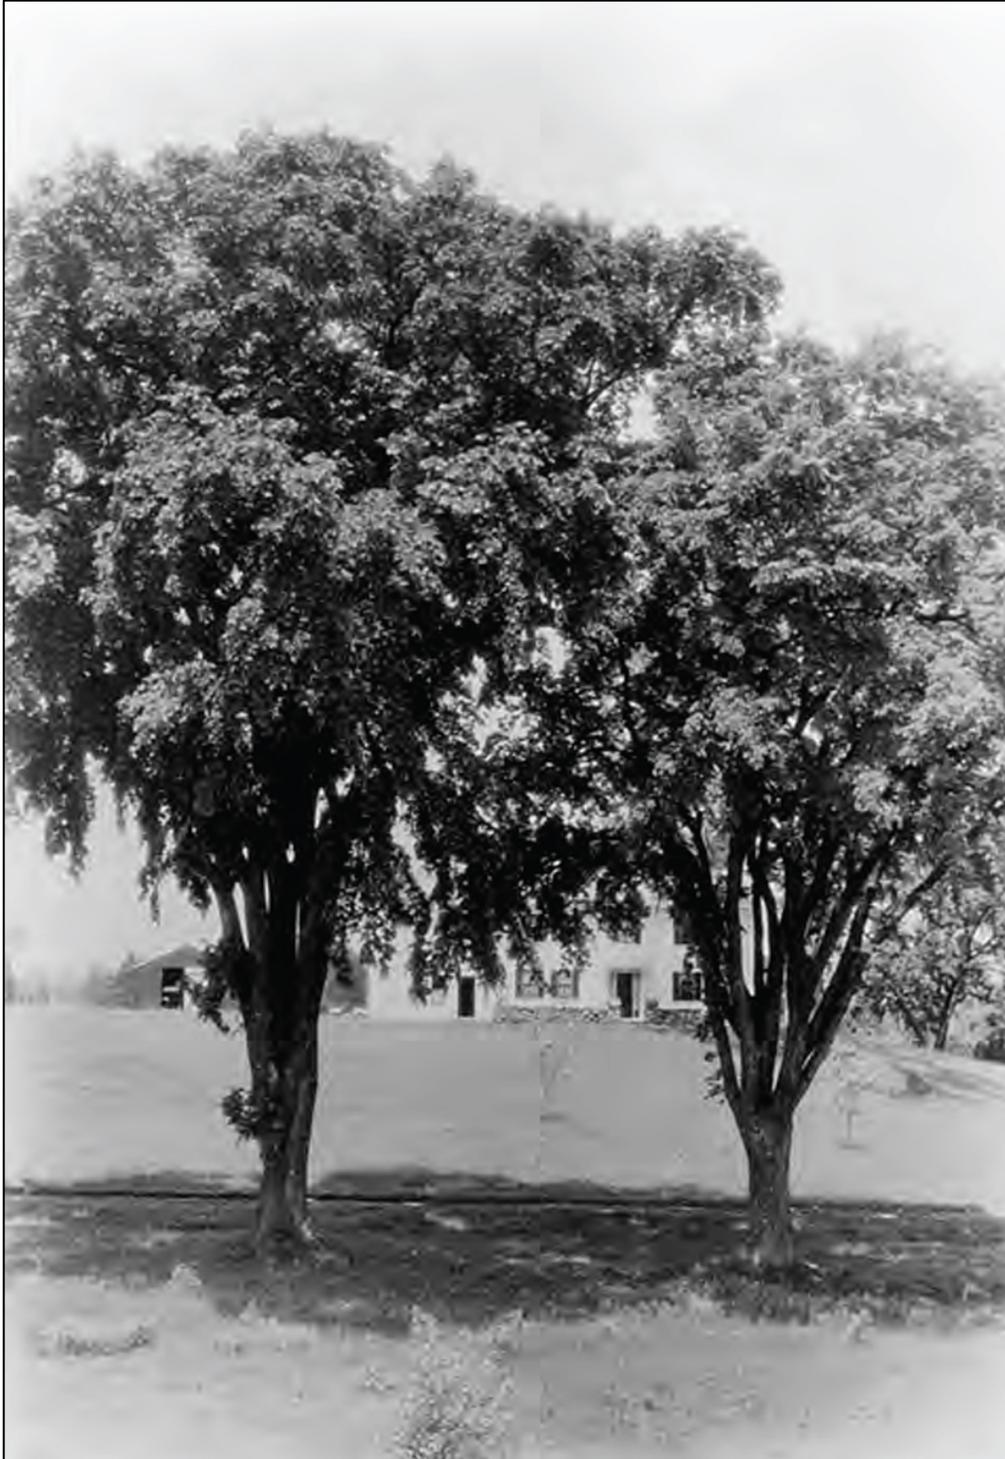
Figure 48, a 1916 photograph of the House and south hillside shows what appears to be an unpaved dirt track at the bottom of the slope.

Figure 48: Historic Harrington Avenue; Elms at Harrington's, Concord; 1916 photograph by Herbert Wendell Gleason, from the Robbins-Mills Collection of Gleason Negatives. Courtesy William Munroe Special Collections, Concord Free Public Library.

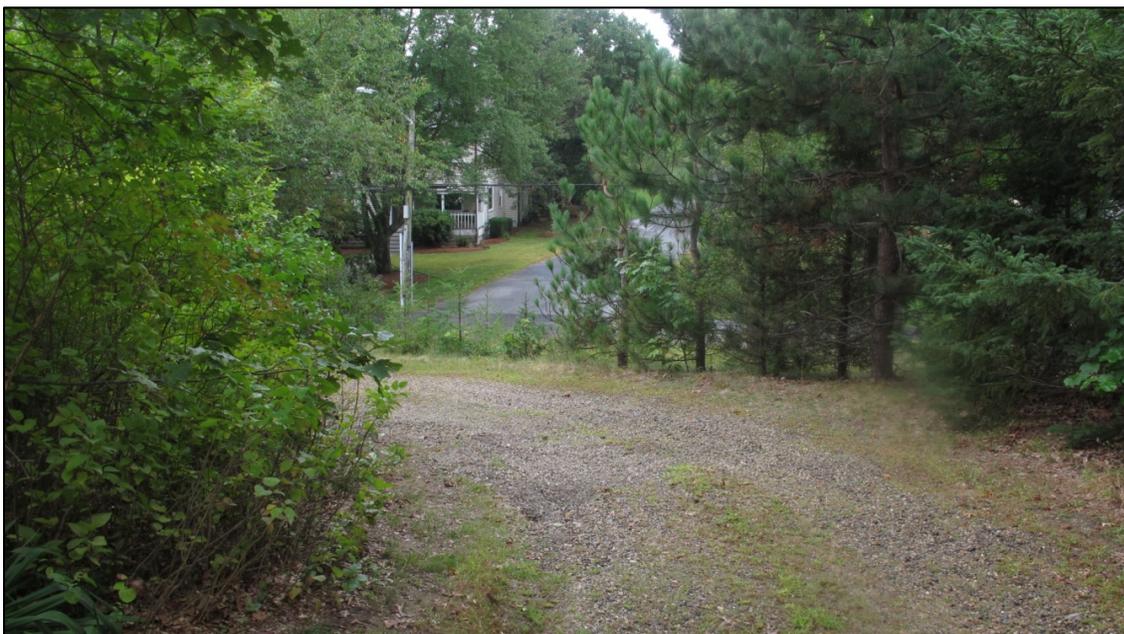
Figure 51: Driveway with evergreen windbreak on right

As the driveway turns uphill an evergreen hedgerow has been planted to the west and serves as a windbreak (Figures 50 and 51). Peter and Jane Benes have been attempting to manage snowfall on the drive for over 20 years and have found the location of the evergreen windbreak to be an effective management tool against snow fall drifting over the driveway. Nonetheless, Peter Benes has a tractor-mounted snow blower to clear snow from the driveway.

As significant as the driveway is as a feature of the cultural landscape, it is subject to annual erosion. During rain events, stormwater flows down the driveway from the parking area at top as well as from the hillside below the House. Saturated soil conditions and vehicle use cause erosion and displacement of the stone surfacing. Many years ago Peter Benes dug up the driveway surface and set large stones into place to serve as a hardened foundation against continued deep cut erosion. But each spring, Peter Benes repairs the surficial erosion that has occurred over the preceding winter. Management of stormwater on the driveway should be considered.

- c. Secure the services of a design consultant to evaluate stormwater runoff from the parking area and develop recommendations to intercept stormwater from the parking area before it can run down the driveway where it will cause erosion of the driveway surfaces. Include protecting the historic qualities of the driveway landform, materials and layout as an essential aspect of the design contract.

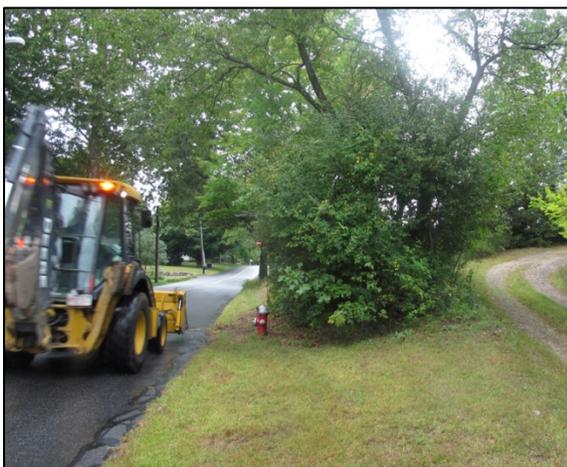
The streetscape westward from the residential drive is obscured by the volunteer shrub species that grow around the black cherry (Figure 56). Beyond the residential driveway and the evergreen windbreak the streetscape opens up. A series of street trees line Harrington Avenue up to the driveway entrance to Harrington Park (Figure 27).

Figure 56: Obscured sight lines west of driveway

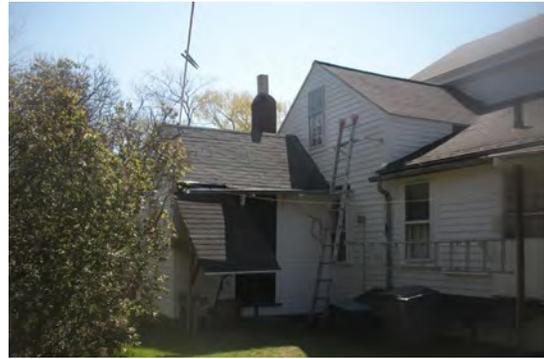
Gables at north end of west elevation.

- Priority 2: The roof to wall intersection of the old bathroom gable and the old kitchen exterior wall is buttered with roofing cement. No flashing is visible at this vulnerable location and the interior shows past evidence of leaking along this joint. Remove the cement and sealant, inspect sheathing and siding for sound material, and replace anything soft or deteriorated. Install proper stepped flashing.

- Priority 2: Clapboards appear deteriorated at the roof-to-wall intersection of the old kitchen gable and the main block of the house. Clapboards are unevenly trimmed. Clapboards should be carefully removed, new step flashing with an 8-inch return up the wall installed, and the clapboards reinstalled with the edges closest to the roof neatly cut to give 1-1/2 inches of clear space between the clapboard edge and the roofing material. Any raw wood should be primed and painted.

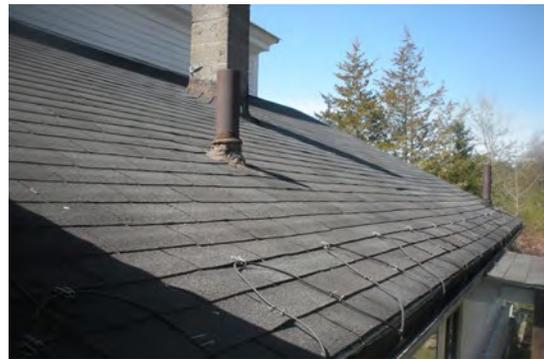
Heat trace cable along kitchen wing shed roof.

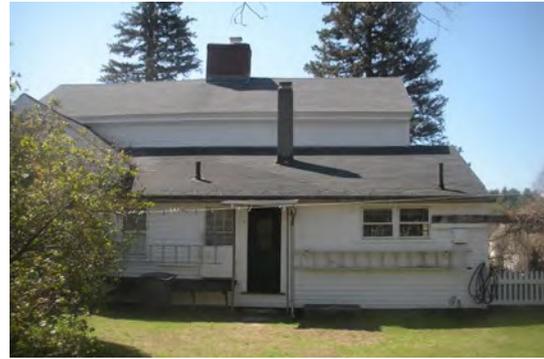
Asphalt shingles at the main house gable (above) have more years of service than those on the kitchen shed roof.

- Priority 3: The three-tab asphalt shingles on the kitchen shed roof and the old bathroom gable will require replacement sooner than the other roof shingles. When they are replaced, consider wood shingles as a more historically appropriate material and install ice and water membrane along the eave, ridge and rake lines.

- Priority 4: The three-tab asphalt shingles on the main gable, east porch and door awnings appear to have many more years of use. When they are replaced, consider wood shingles as a more historically appropriate material and install ice and water membrane along the eave, ridge and rake lines.

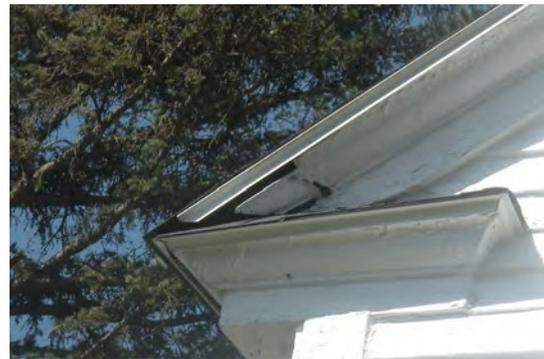
Asphalt-shingled eave return at main gable.

- Priority 4: The eave returns at the main gable are clad in asphalt shingles. The shingles appear to be in good condition. Adjacent rake molding and eave returns have mitered joints vulnerable to water; consider replacing the asphalt shingle with copper flashing for longer life and improved protection of the adjacent wood joinery. Although listed as Priority 4, this work might be done at the same time as the front entry hood since the proper skilled craftsmen will be on site.

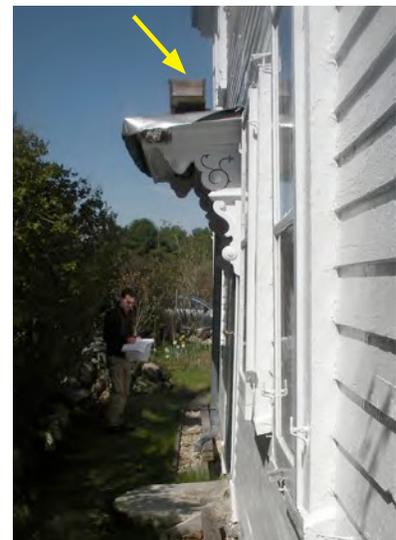
Sheet metal flashing and water catching trough (arrow) at main entry door hood.

- Priority 1: Remove the layered sheet metal flashing and water catching trough. Remove roofing material and repair roof sheathing. Install new flat seam copper over felt and high temperature underlayment. Design with a shallow gutter and outlet to divert roof run-off to downspout.

- Priority 1: Remove trough from front door hood, incorporate gutter into entry hood re-roofing project, and install downspout on west side.
- Priority 2: The fascia board behind the wood gutter at the kitchen is looking warn. Remove the wooden gutter, replace the fascia (primed and painted front and back). Replace the wood gutter.

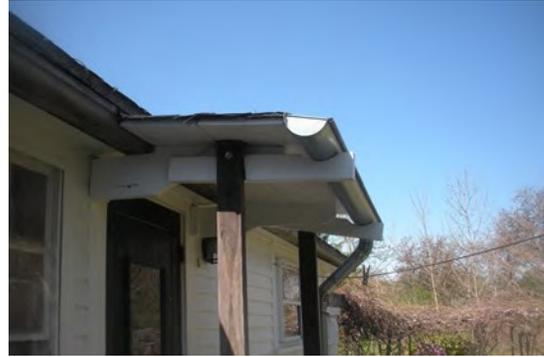
The exterior kitchen door, the mudroom exterior door and the exterior door to the old bathroom door have low slope awning roofs with asphalt shingles. These do not appear to be historic but the convenience of their design seems clear.

Awning roof over the exterior kitchen door.

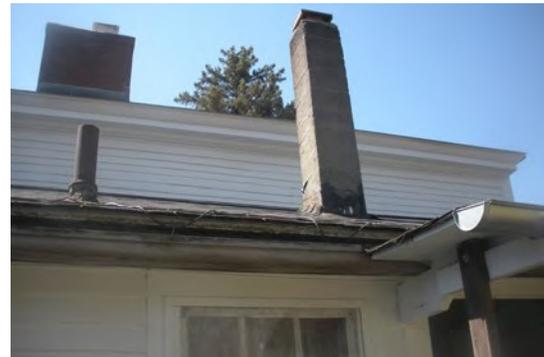
The main gable chimney at top left, cast iron vent stack at lower left, and concrete block chimney at right.

- Priority 2: The rear brick chimney mortar joints and cement cap wash are failing. The joints should be repointed with a moderately soft mortar and the wash at the top replaced with a durable mortar-cement wash.
- Priority 2: Flashing at the concrete block chimney and the rear brick chimney is liberally covered with roofing cement. The cement may have been a suitable stop gap but it conceals potential leak sources. The cement should be removed and the base flashing and counter flashing at the two chimneys replaced.
- Priority 3: It appears the concrete block chimney is capped and not used for venting. Consider removing the stack down to the basement. This will free up some space in the mudroom and eliminate a source of historic leaks.

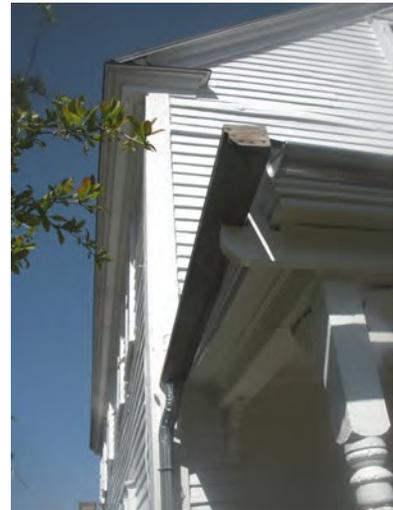
Wood and metal gutters meet at the porch roof on the east elevation.

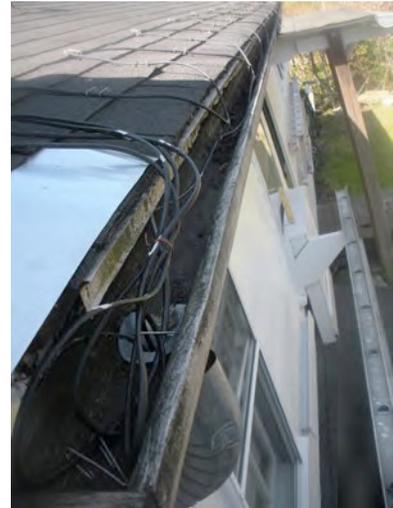
Wood gutter along kitchen wing.

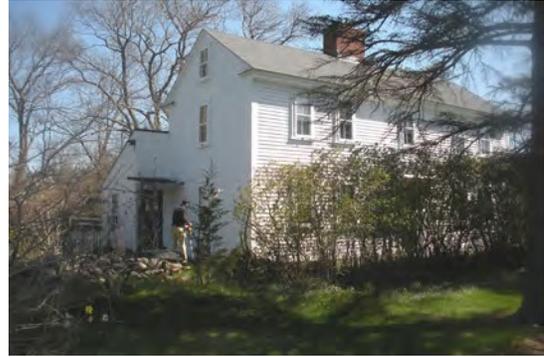
There is deep paint build-up on the clapboards, wood trim at the cornice, corner boards and door and window surrounds on the façade. There is considerably less paint build-up at the kitchen. From the first floor window sills down to the foundation the siding and trim is replacement and has fewer layers of paint.

The windows are well maintained and glazed. The woodwork appears to be in good condition although paint layers may conceal some deterioration.

South elevation (facade) with projecting face wall of kitchen wing at left.

- Priority 1: Remove the acrylic sheets at the front door side lites. Paint and reglaze side lites. Make new wood frames for protective glazing and install frames with clips for easy removal.
- Priority 2: The mortar wash around the basement window to the right of the main entry is cracked and failing. Chip out existing mortar and place new wash and repoint around opening.

- Priority 3: The façade will require repainting in five to seven years. Samples should be taken of paint layers to establish a paint history for dating purposes. Consideration of complete paint removal should be given in this or the next round of painting. This will allow exposure of wood to determine conditions and reveal detail that is obscured by the thick paint accumulation.
- Restoration Recommendation: Wood shutter reinstallation. (Not a requirement for preservation.) If elected, this work would achieve a 19th century appearance which is in keeping with the windows and ornament at the porch and the door hood.

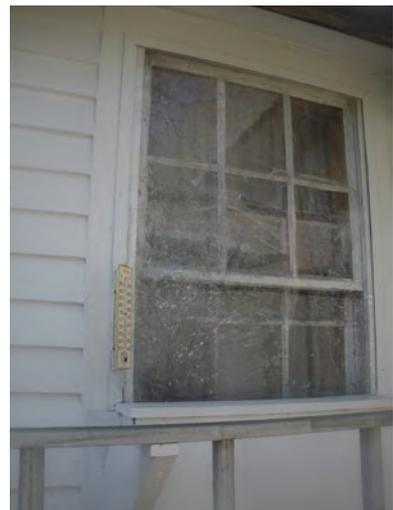
Trapped dryer lint at mudroom window.

The windows are wood. Those in the kitchen wing are modern single pane divided lites. The other windows are single pane, 2-over-2 wood windows. The windows are in good condition. The window at the mudroom is filled with dryer lint between the fixed clear acrylic panel and the sash due to a wood panel infill at the lower sash opening containing the dryer vent. All windows have aluminum storm windows.

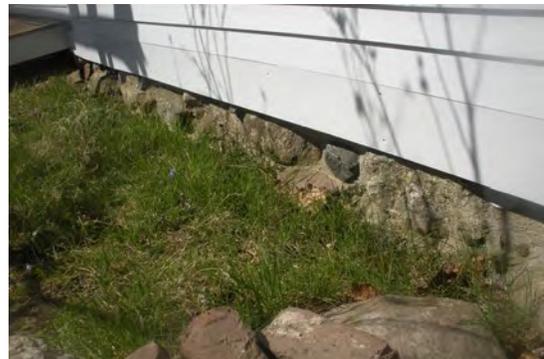
Rubble foundation at northeast kitchen addition.

- Priority 2: The ground at the interior corner between the old sink room and the northeast kitchen addition gable takes on a lot of water. Discuss drainage options with the landscape architect and a civil engineer.
- Priority 2: Repoint the rubble foundations at the old sink room and the northeast kitchen addition.
- Priority 3: The elevation will require repainting in five to seven years. Samples should be taken of paint layers to establish a paint history for dating purposes. Consideration of complete paint removal should be given in this or the next round of painting. This will allow exposure of wood to determine conditions and reveal detail that is obscured by the thick paint accumulation.

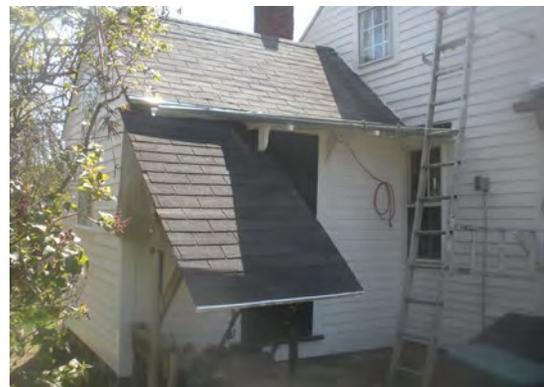
The west elevation of the sink room ell at the northeast corner of the house has a rubble foundation. The door into the old sink room is protected by a wood storm door.

West elevation of sink room ell.

- Priority 1: Complete repairs to siding, woodwork and windowsill at west wall of kitchen wing.
- Priority 2: Repoint the rubble foundations at the gable end of the main block, adjust local grade to create a swale four feet out from the foundation, and adjust the stoop into the kitchen accordingly.
- Priority 2: Repoint the rubble foundations at the sink room ell.
- Priority 3: The elevation at the main block and kitchen wing will require repainting in five to seven years. Samples should be taken of paint layers to establish a paint history for dating purposes. Consideration of complete paint removal should be given in this or the next round of painting. This will allow exposure of wood to determine conditions and reveal detail that is obscured by the thick paint accumulation.

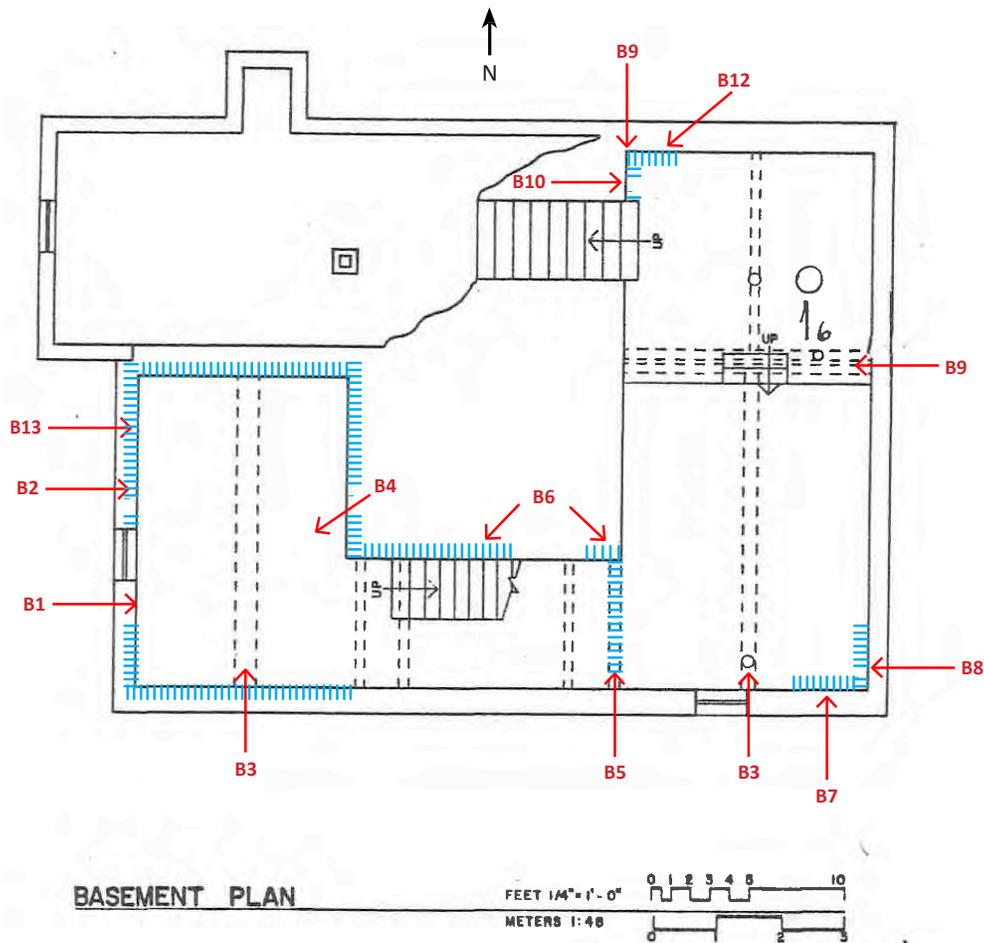
Red locations refer to recommendations in the accompanying text and the structural conditions report.

- B1: Monitor the bulge in the west stone foundation and repair/rebuild if it gets larger.
- B2: Cut and point open and cracked mortar joints on stone walls and chimney base.

- B3: Treat exposed beams in the east and west basement bays and affected joists for beetle damage. Use borate treatment and reinforce members structurally if needed.

- B4: Replace rotted joist OR borate treat/sister the joist between west bay central beam and chimney.
- B5: Treat beetle and rot damage along south wall at the east and west central beams and east chimney girt. Repair crushed beam with Dutchmen and review the bearing load atop the post. Analyze chimney beam and assist with intermediate post if needed. Borate treat all wood.

- B6: Cut and point cracked mortar joints at the foundation wall of the chimney along the stairs. Monitor for new cracks; if movement continues, reconstruct, bolster or repair masonry.

- B9: Analyze rot damaged sill beam and sister dividing main house from addition at northeast corner. Reinforce/repair if needed.
- B10: Cut and cracked mortar joints in stone masonry at west wall in northeast addition. Monitor for re-cracking.

- B12: Repair the damaged sill at the north wall with Dutchmen. Borate treat and monitor for future deterioration.

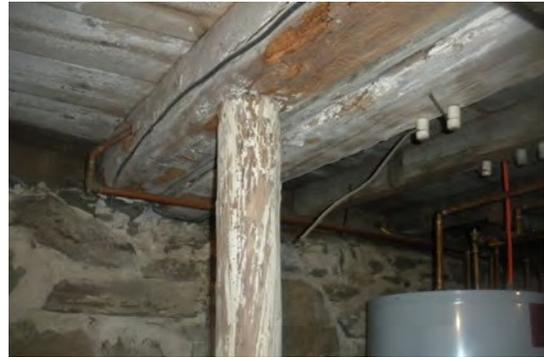
Post and beam in basement.

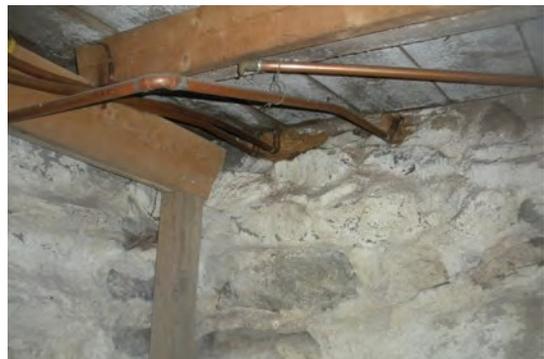
Whitewashed rubble stone foundation.

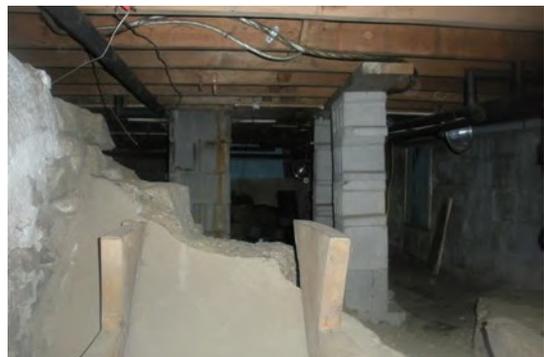
Crawl space under 1960s kitchen.

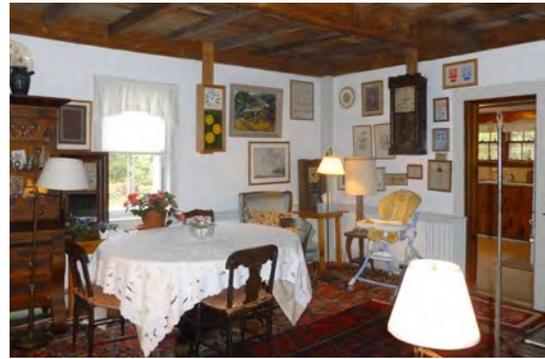
Plaster walls and exposed framing at ceiling in parlor.

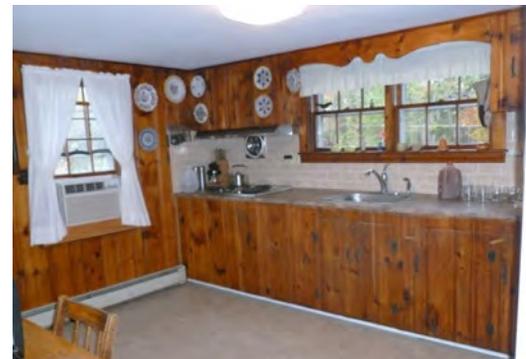
Wood paneling in shed-roofed kitchen wing.

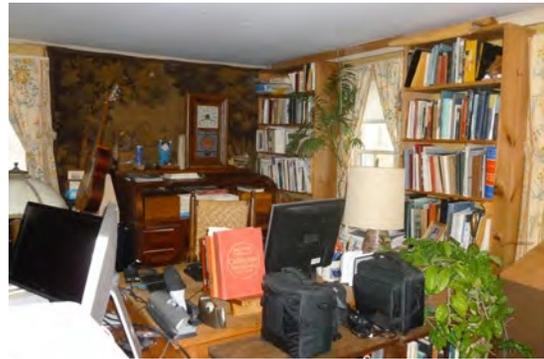
Note faint ceiling marks in the east chamber denoting old partitions.

- Priority 2: Repaint ceiling of west chamber. Confirm prior layers on ceiling are not calcimine.
- Priority 2: Patch cracked plaster on north wall of east chamber.

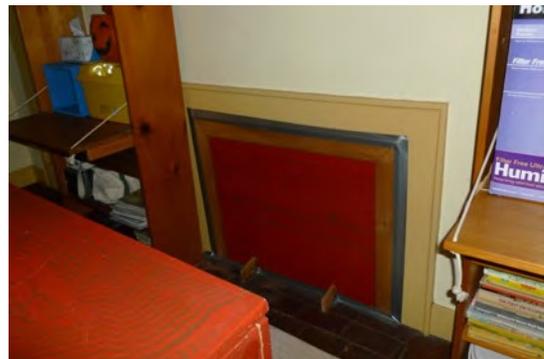
Closed fireplace in west chamber.

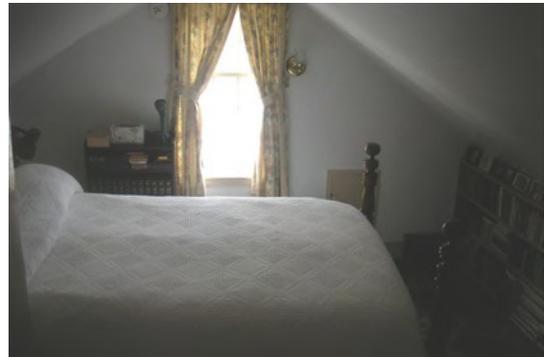
Northeast chamber is several inches lower than adjacent rooms.

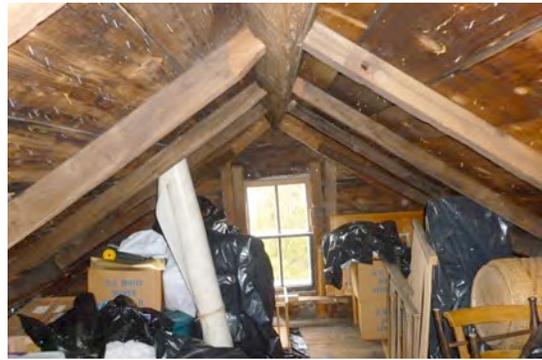
Attic framing.

- R2: Cut and point cracks in brick masonry and bulged area of exposed brick chimney on its south face.
- R3: There is evidence of water infiltration (cracked, spalled and crumbling bricks) on all sides of the chimney. Review/repair flashing as needed, replace worst of spalled bricks, and reset any cracked and loose masonry.
- R4: There is a hole into the flue on the north face of the chimney. Fill in the opening in the brick masonry.
- R5: Borate treat and sister or replace the damaged header at the north side of the chimney.
- R8: Cut and point eroded mortar joints at chimney at northeast kitchen addition. Check flashing to make sure that damage is limited to above the roof.

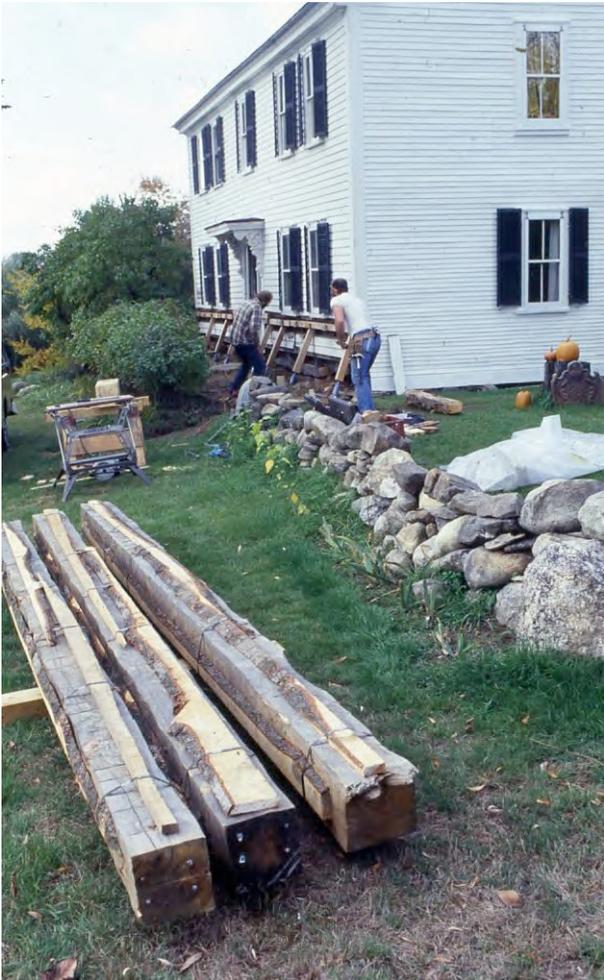
Front sill replacement.

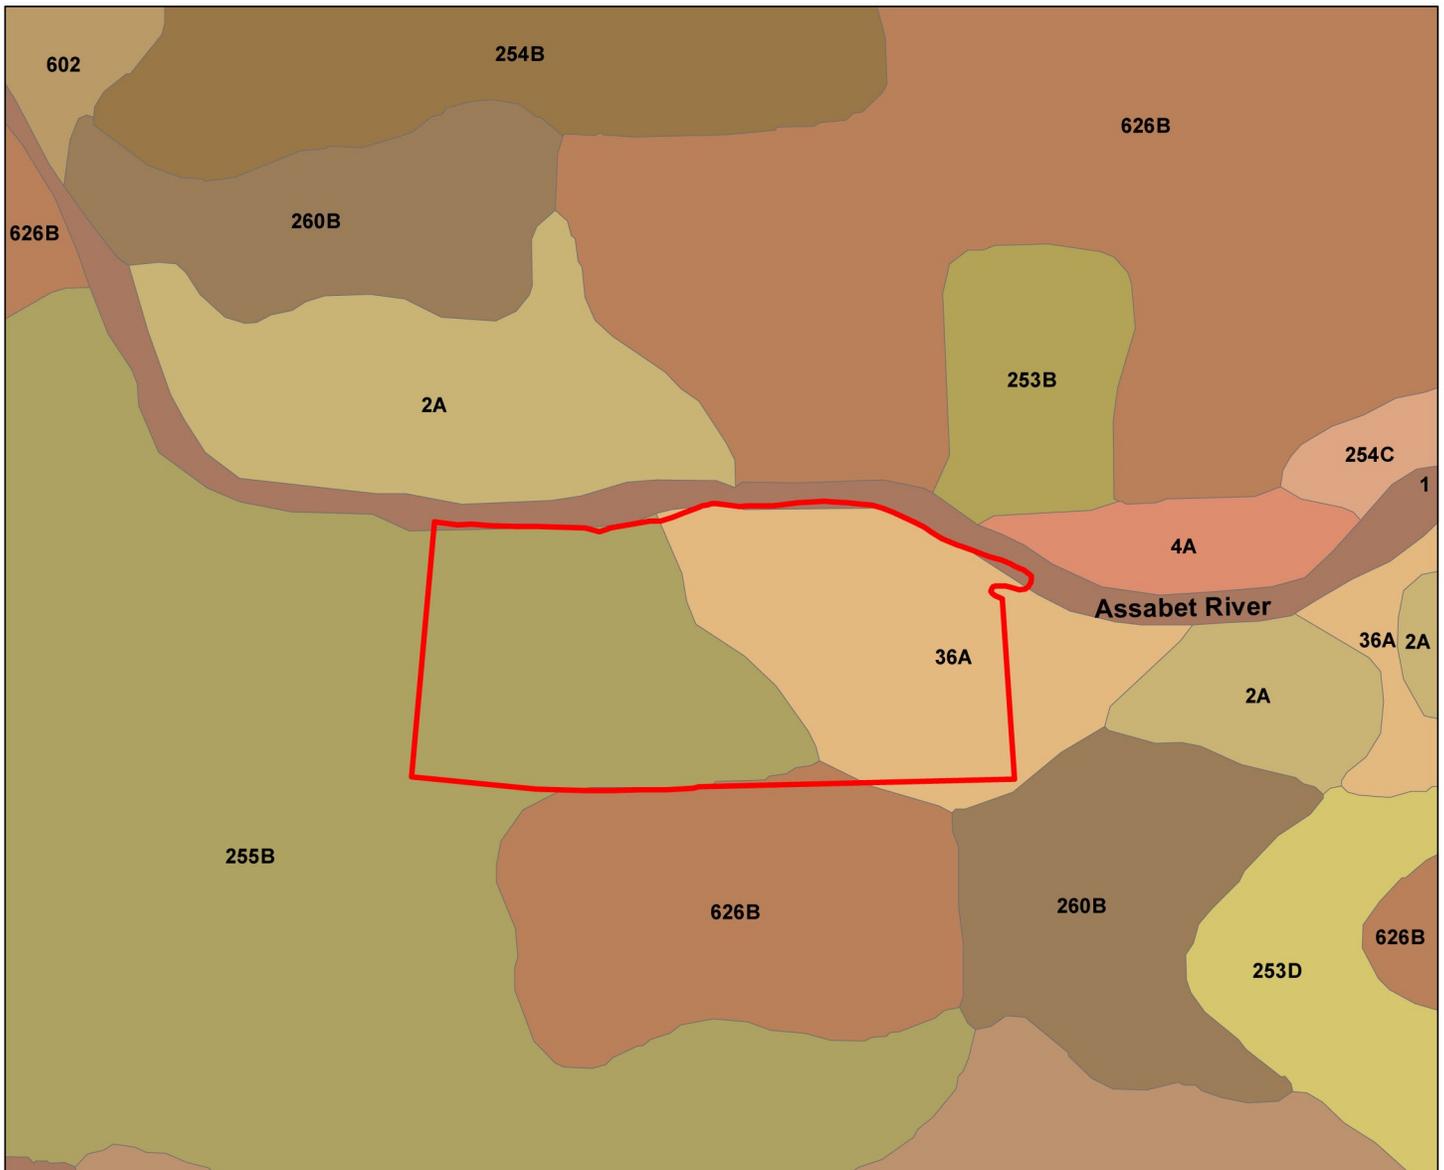
FIGURE 7 DATE: 9/15/2014

As previously discussed, a wetland/upland mosaic is located throughout the low elevation area on the Site, which is hydrologically connected to the Assabet River. According to MassGIS, the wetlands consist of deciduous wooded swamp and shrub swamp (see Figure 7 in Attachment A); however, marsh areas were also observed during the site visit. Per the Cowardin classification system, these wetlands are palustrine forested (PFO), palustrine scrub-shrub (PSS), and palustrine emergent (PEM) wetlands (Cowardin et al., 1979). Wetlands depicted on

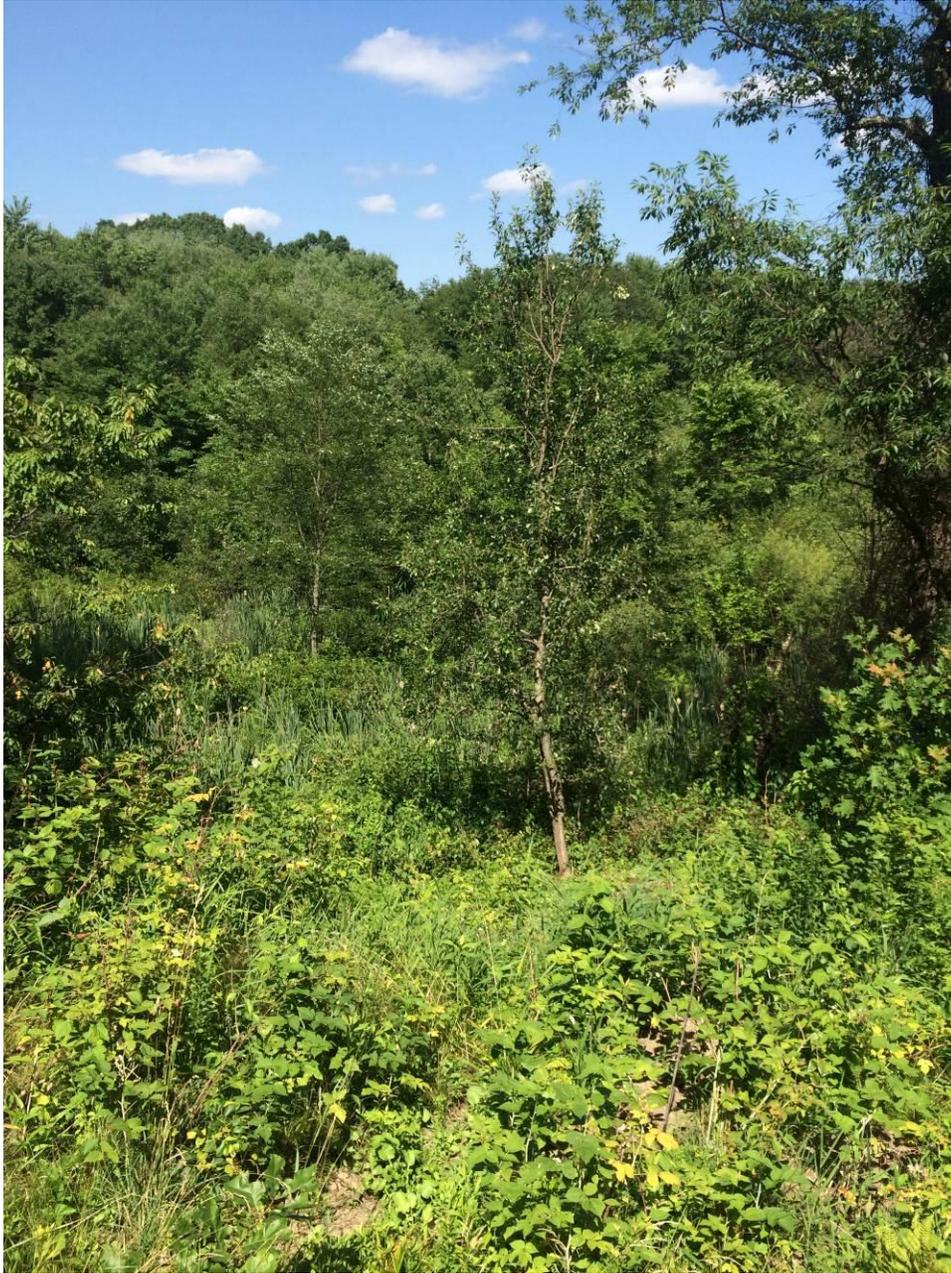
Photo 1: View facing northeast from the southeast corner of the Wheeler-Harrington House, looking downslope toward palustrine emergent (PEM), palustrine scrub-shrub (PSS), and palustrine forested (PFO) wetlands that occupy a majority of the lower area on the Site.
