**CULTURAL, STRUCTURAL &
ENVIRONMENTAL ASSESSMENTS**

THE WHEELER-HARRINGTON PROPERTY
West Concord, MA

February 2015

Prepared for the Town of Concord

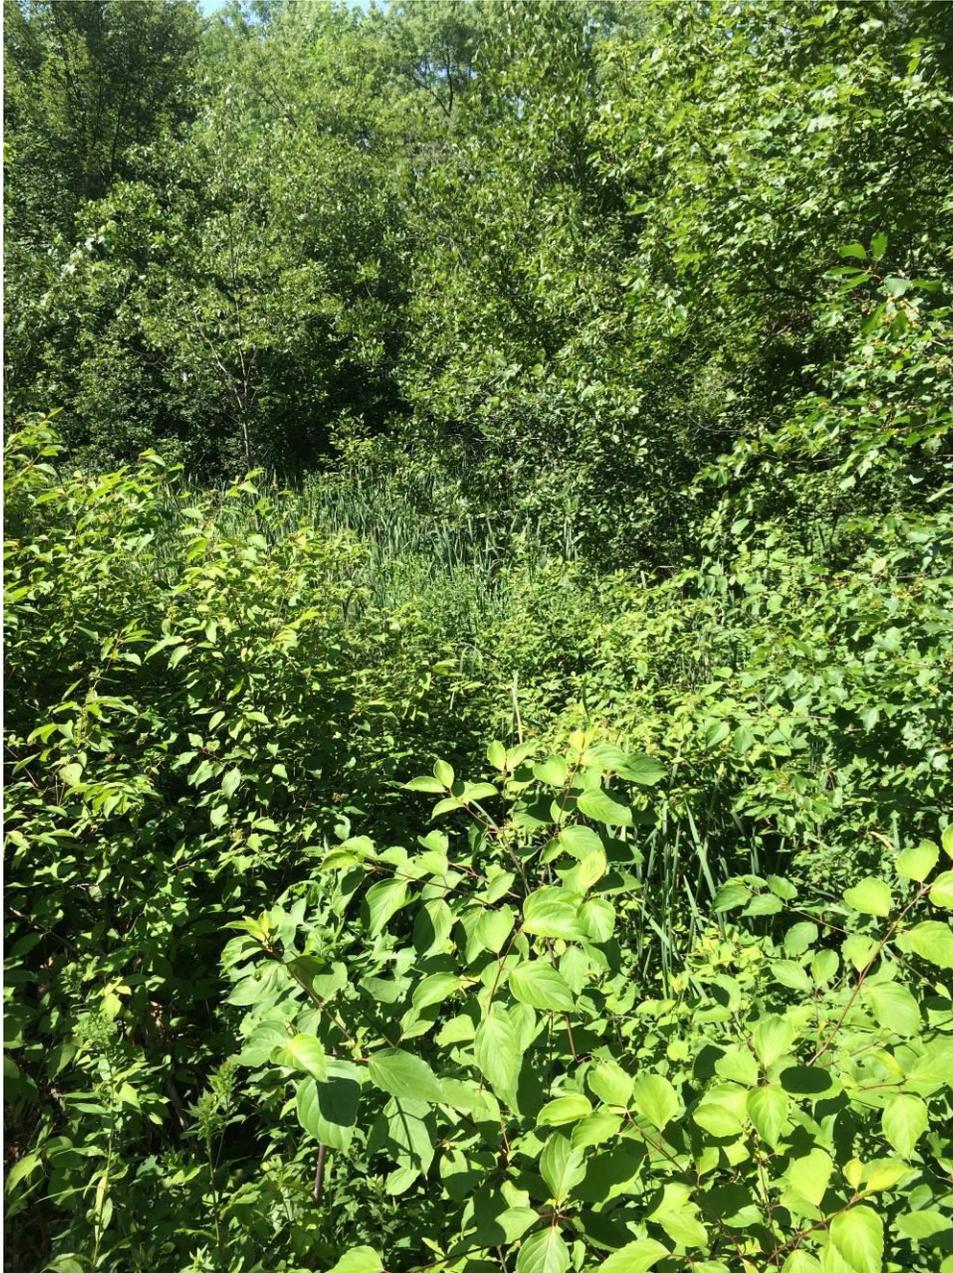
Photo 2: View facing northwest from Harrington Avenue at the southeast corner of the Site showing densely vegetated PEM and PFO wetlands.

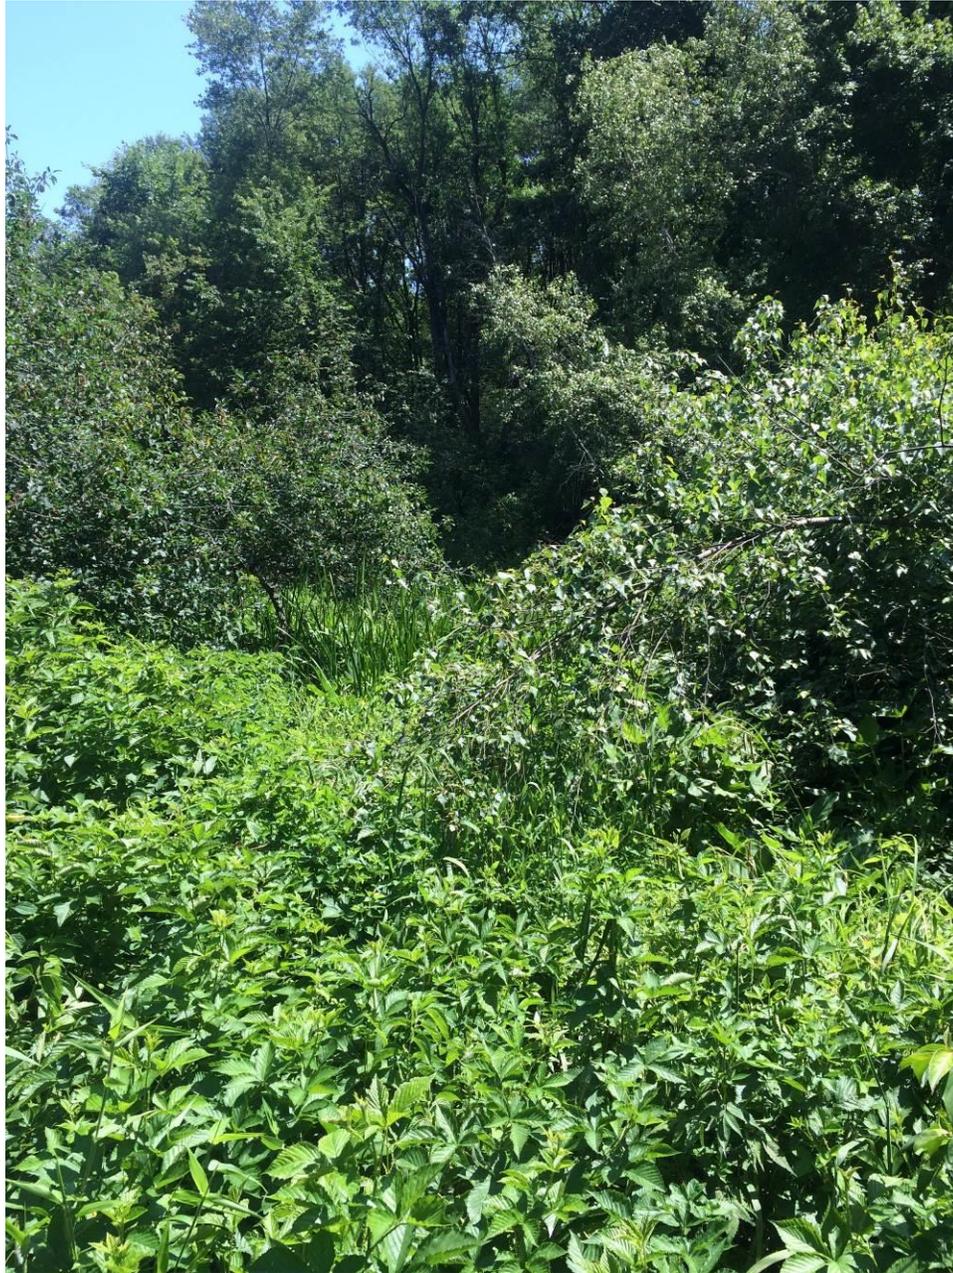
Photo 3: View facing southeast at the northeast corner of the Site showing densely vegetated interspersed PEM, PSS, and PFO wetlands.

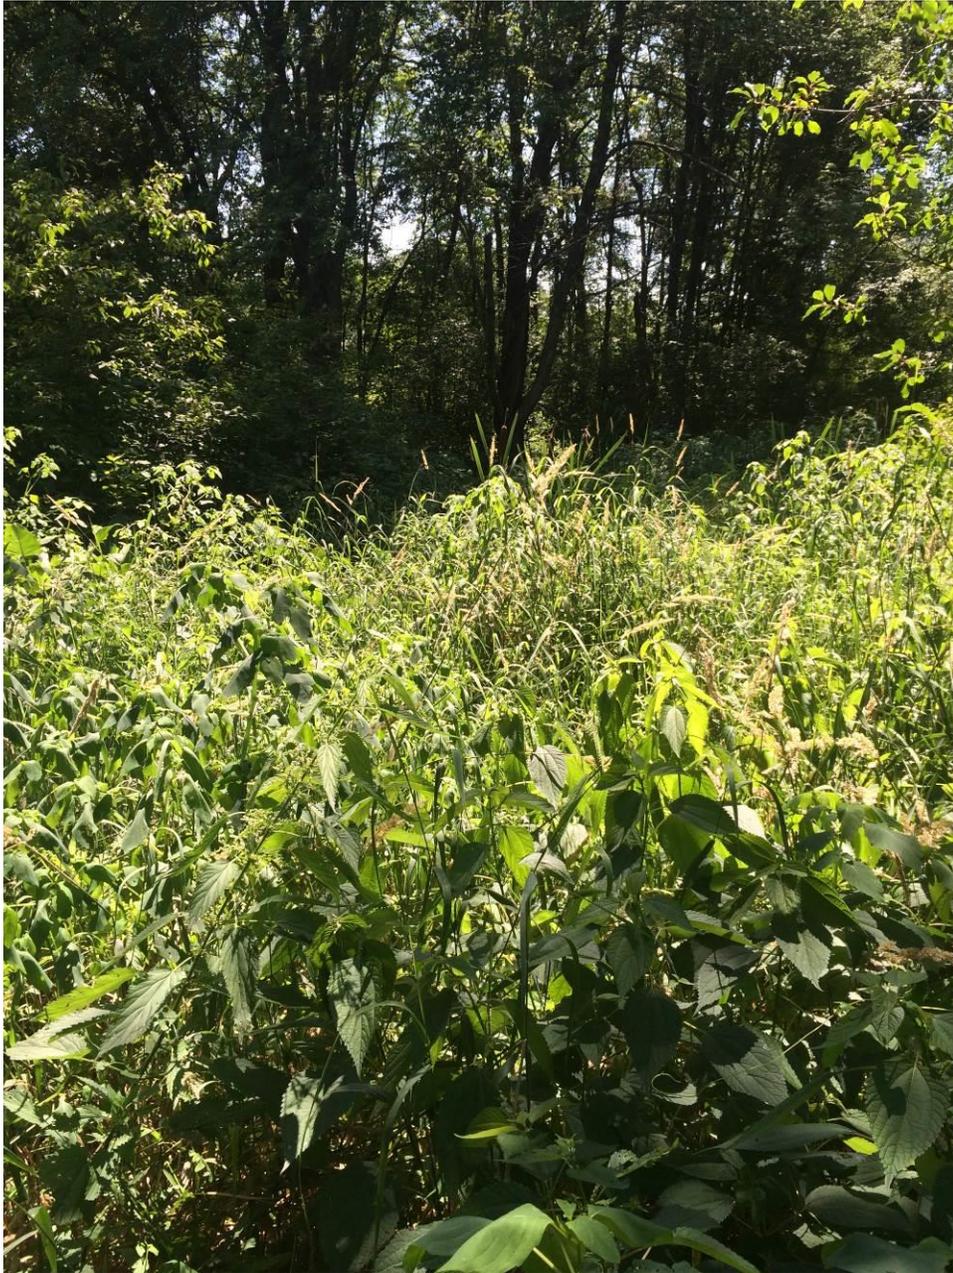
Photo 4: View facing south showing PEM wetlands from near the same location as Photo 3.

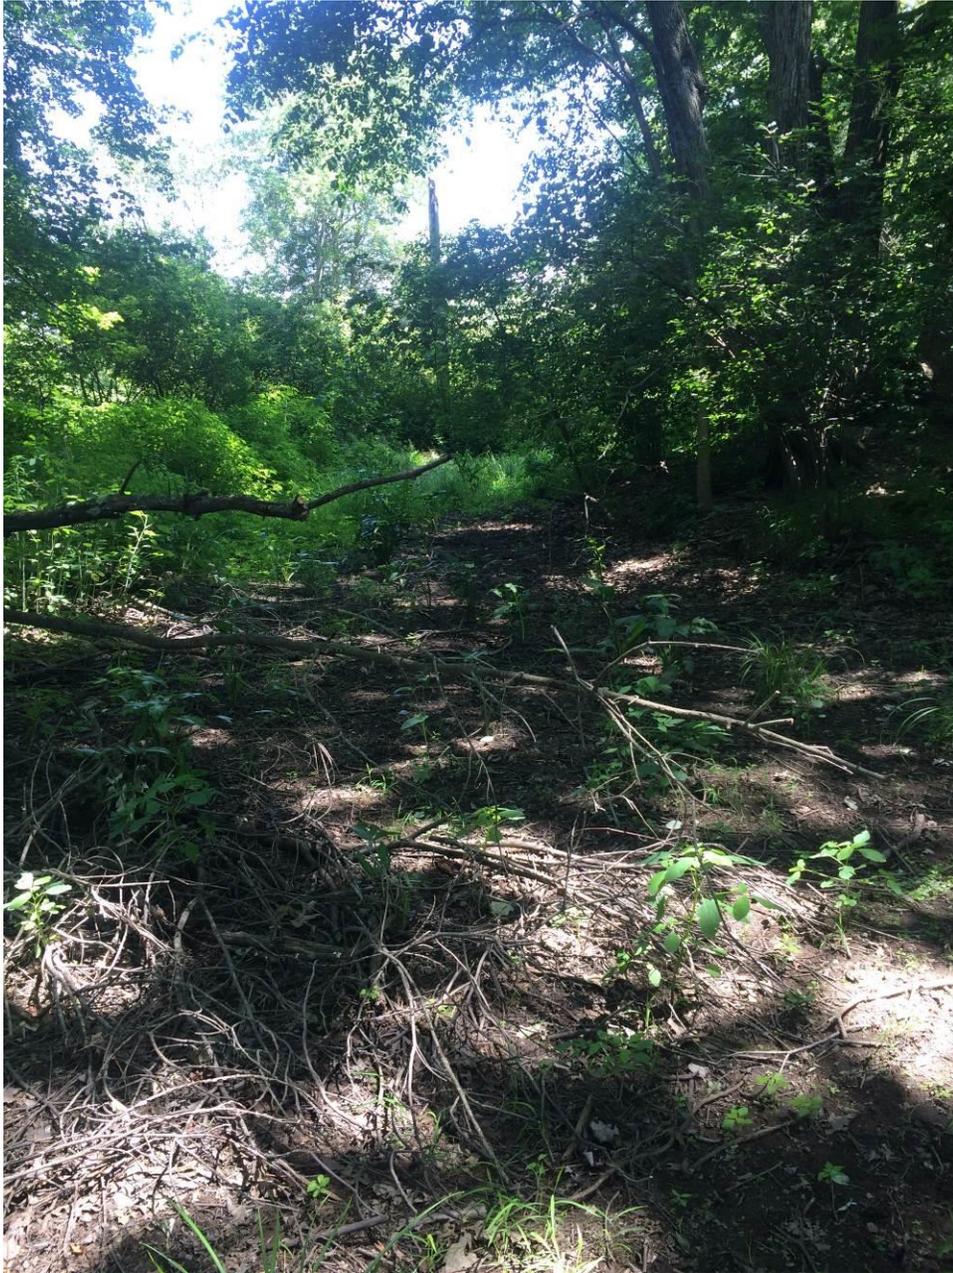
Photo 5: View facing east in the north-central portion of the Site, showing a representative PFO wetland.

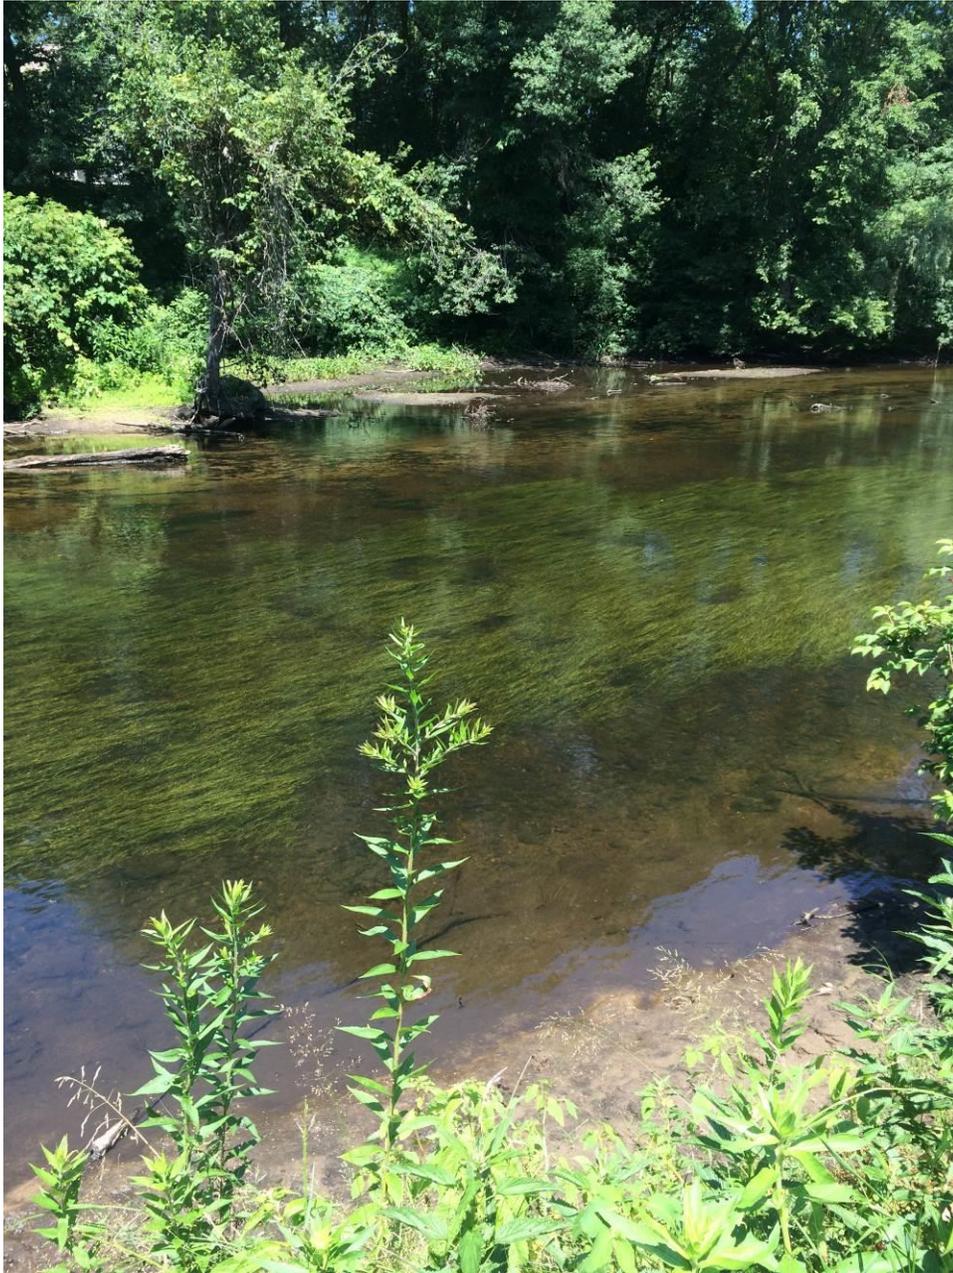
Photo 6: View facing northeast of the Assabet River from the north-central Site boundary.

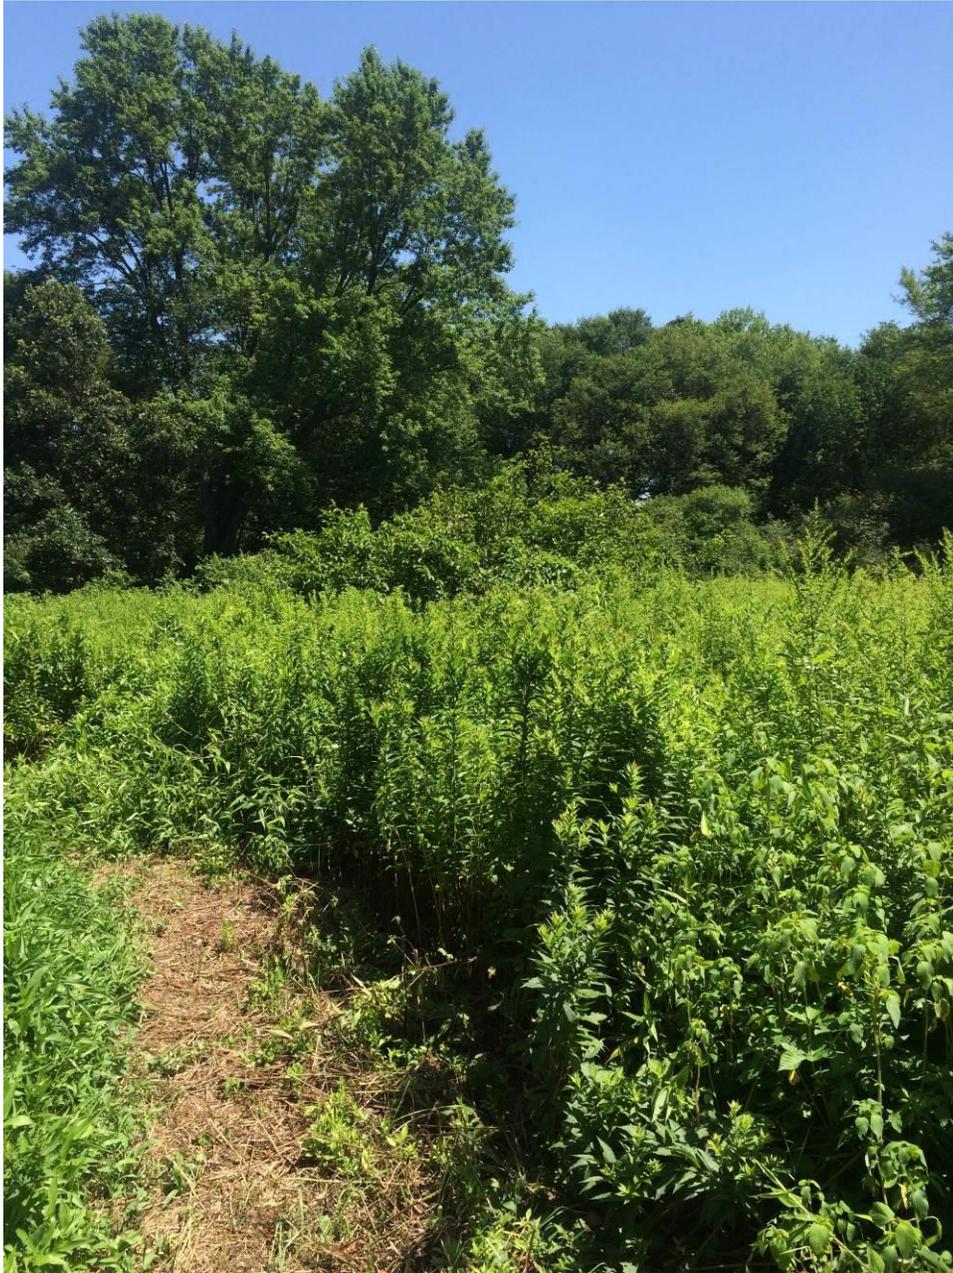
Photo 7: View facing east of a representative herbaceous upland area in the north-central portion of the Site, dominated primarily by goldenrod (*Solidago* sp.).

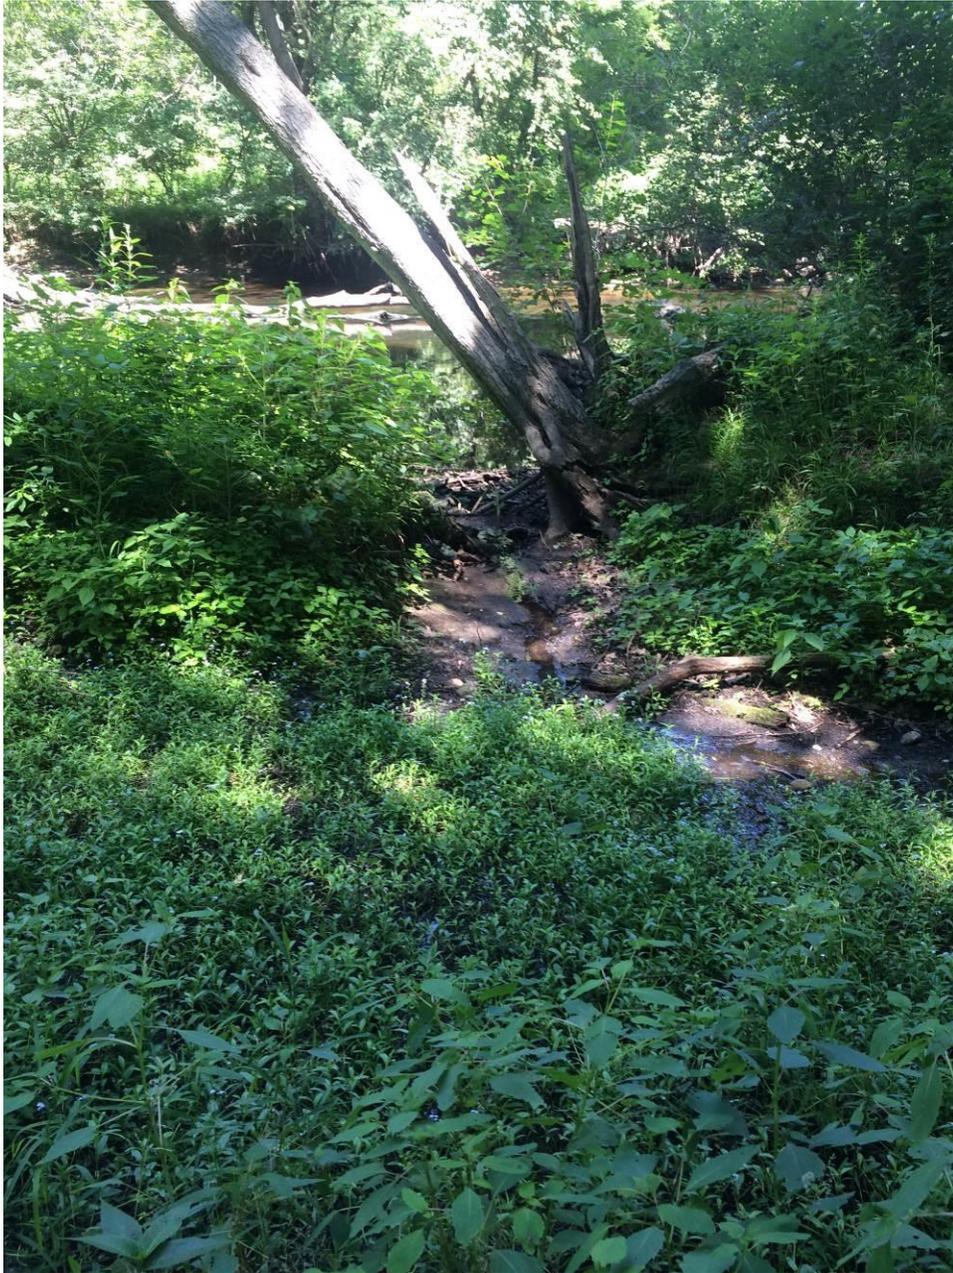
Photo 8: View facing north on the northwest Site boundary of a PEM and PFO wetland between the base of the slope associated with the upper area and the Assabet River.

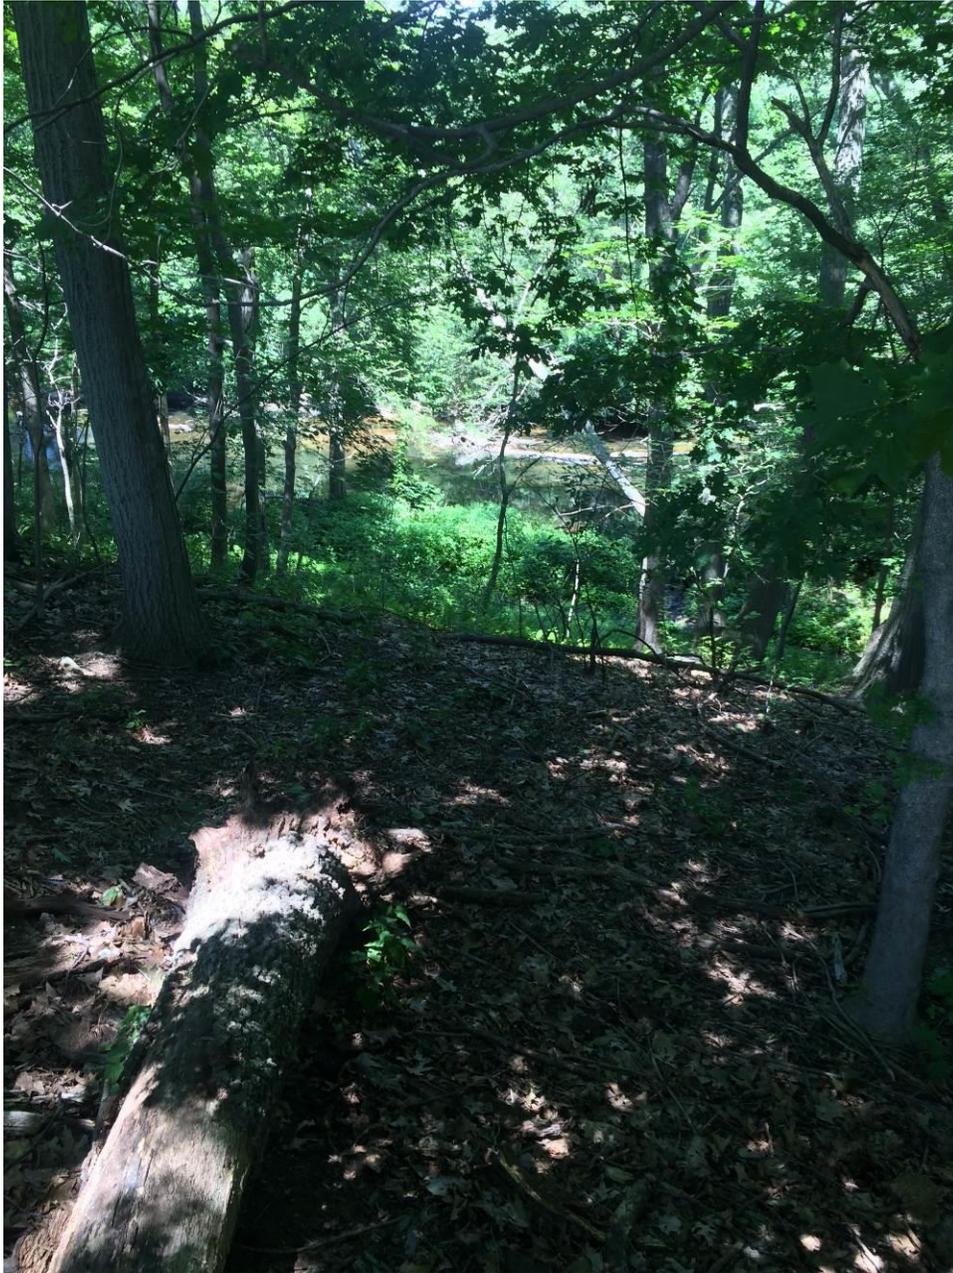
Photo 9: View facing north looking downslope toward the location of Photo 8. The Assabet River is visible in the background.

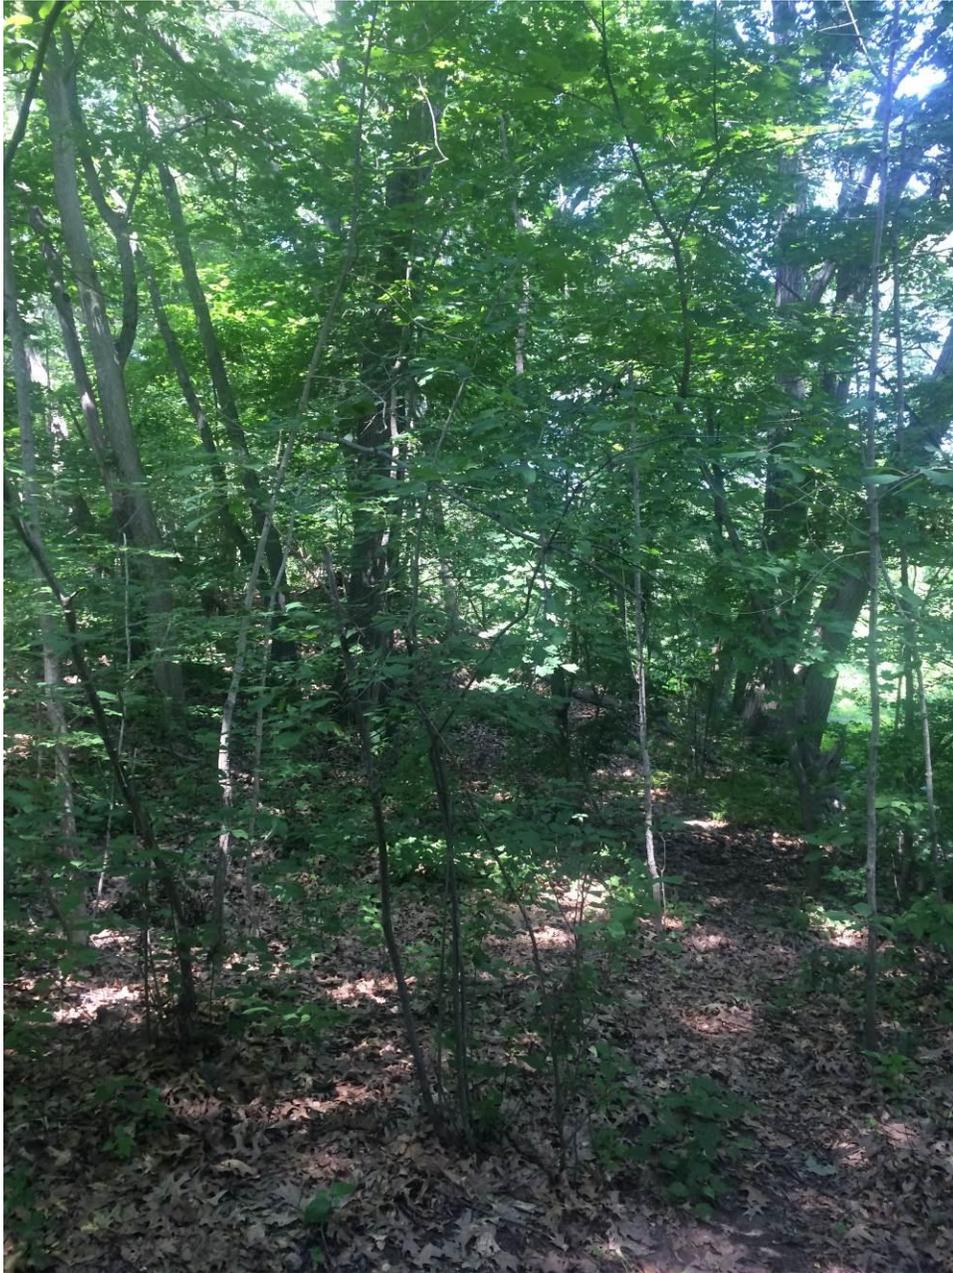
Photo 10: View facing northwest of the forested slope on the central portion of the Site.

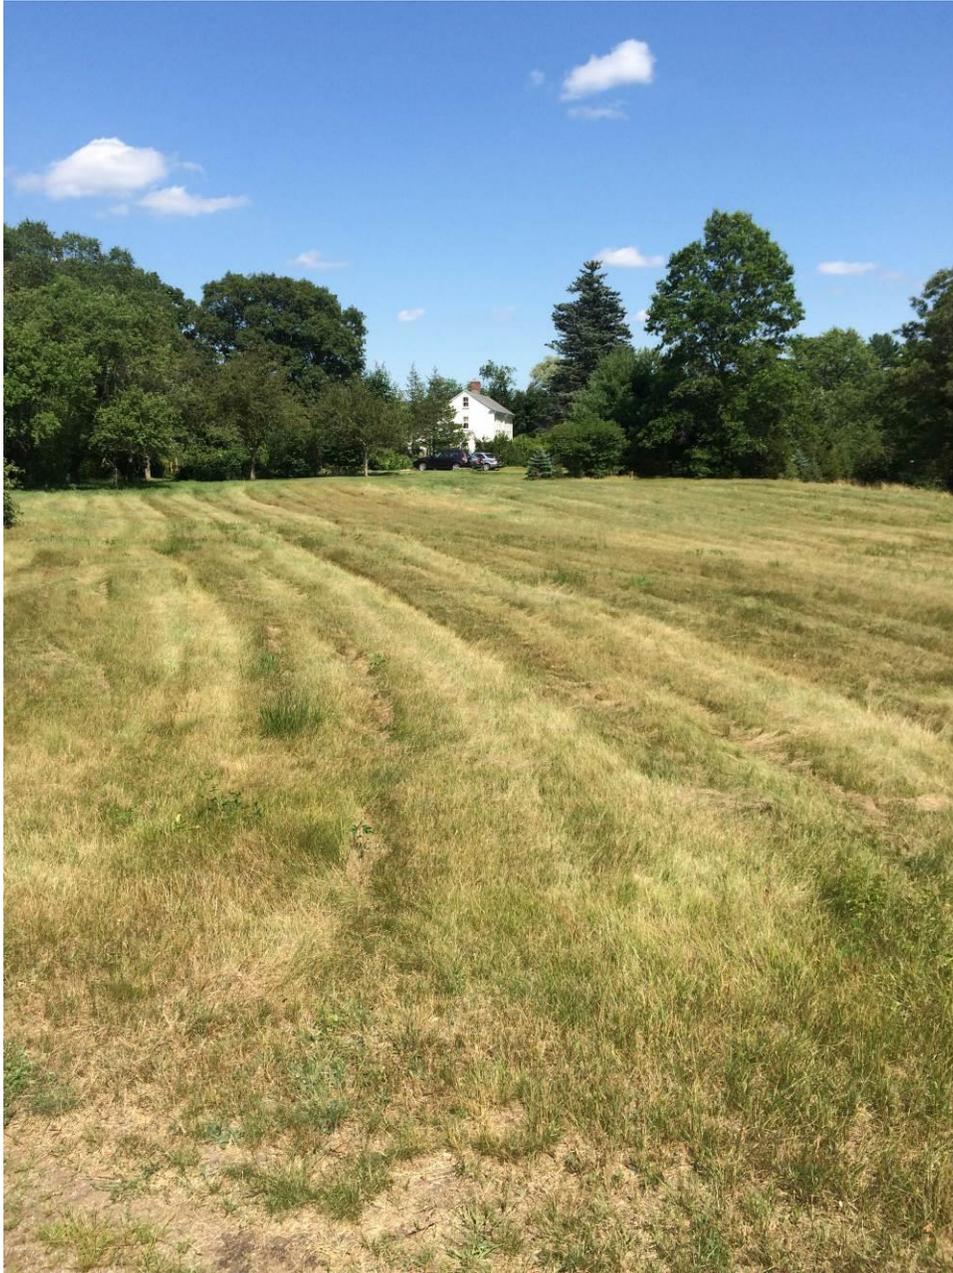
Photo 11: View facing east of the mowed and maintained area associated with Harrington Park on the southwest portion of the Site. The Wheeler-Harrington House is visible in the background.
