# Article 27

**387 SUBURBY ROAD**  
**CONCORD, MA**

DANTE F. MONTUORI, P.E.

Re: Property 387 Sudbury Rd., Concord, MA

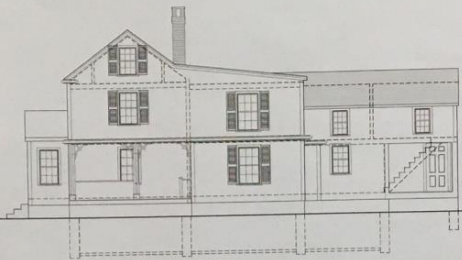
**RIGHT SIDE ELEVATION**  
 SCALE: 1/4" = 1'-0"  
 DATE: 08/13/2013  
 DRAWN BY: J. W. [unreadable]  
 CHECKED BY: J. W. [unreadable]

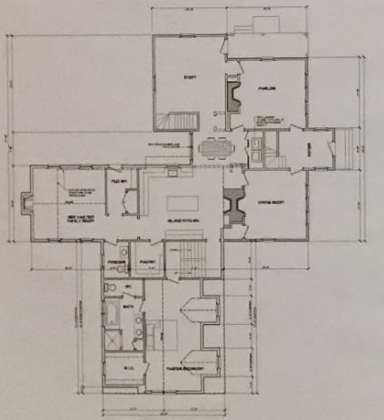
**FIRST FLOOR PLAN**  
 SCALE: 1/8" = 1'-0"  
 DATE: 08/13/2013  
 DRAWN BY: J. W. [unreadable]  
 CHECKED BY: J. W. [unreadable]

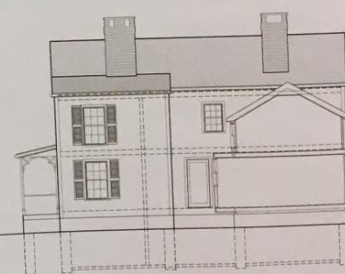
**MAIN ELEVATION**  
 SCALE: 1/4" = 1'-0"  
 DATE: 08/13/2013  
 DRAWN BY: J. W. [unreadable]  
 CHECKED BY: J. W. [unreadable]
