Sleepy Hollow Cemetery

Record Date June 2020
Cemetery Location Sleepy Hollow, Concord, MA

HISTORIC GRAVESTONE SERVICES *Conservation Form* TLC* 2020

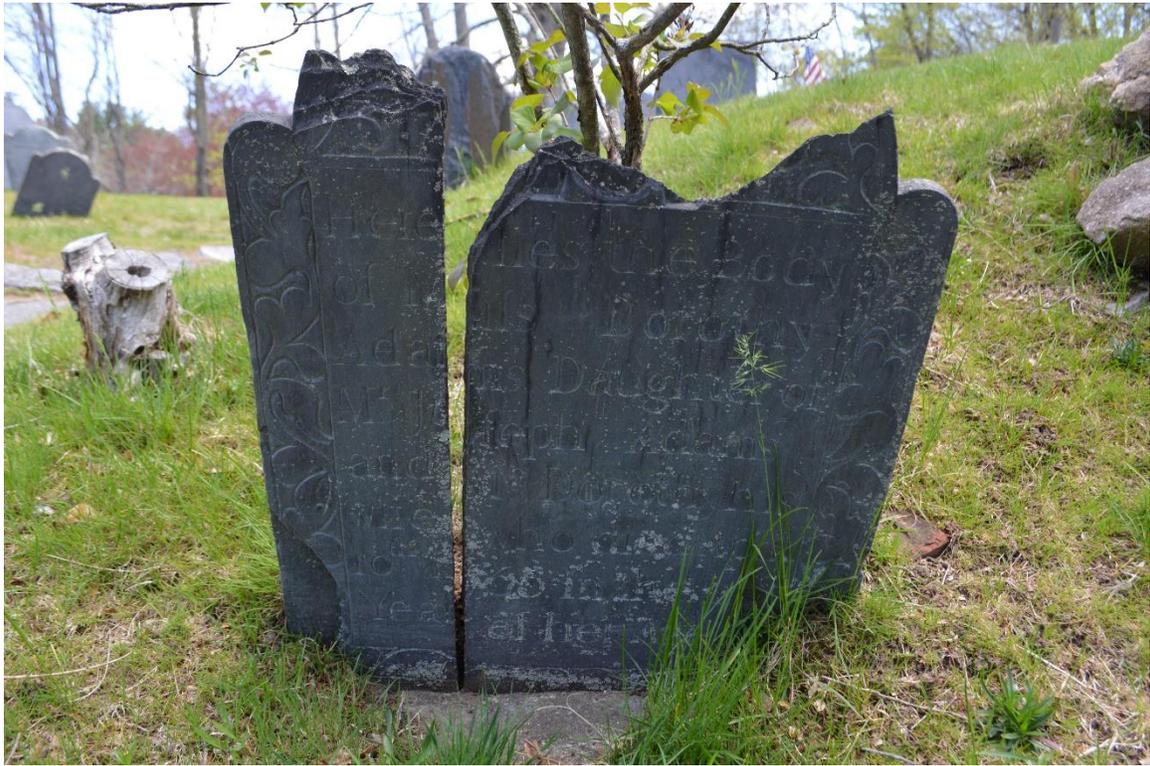
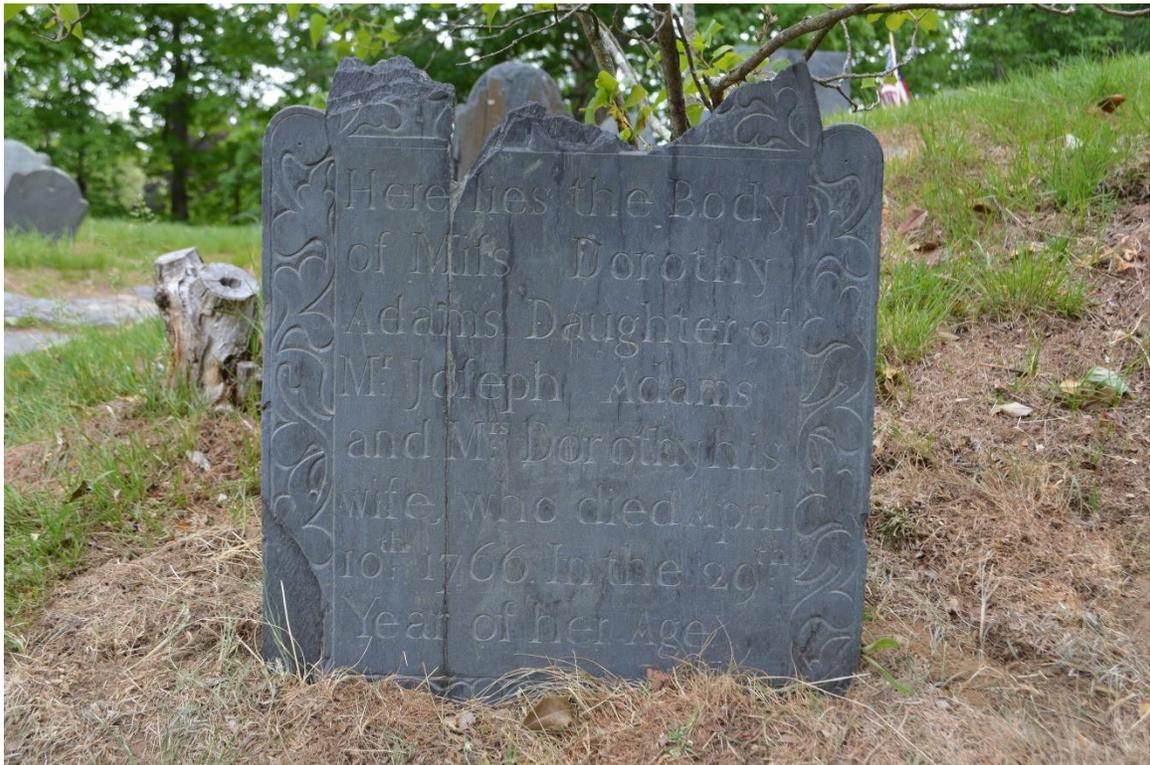
Name Adams, Dorothy
Date of Death April 10, 1766

Material Slate
Marker Type tablet
Carving Condition 80% - 100% readable

Stone Condition Ambient dirt & biological growth
Broken, 2 fragments, epoxy residue from previous repair,
concrete around base

Treatment Clean & treat with D2 for biological growths
Remove concrete and epoxy residue
Create new below grade base
Reset stone into base with lime mortar
Reattach fragments with Jahn M160

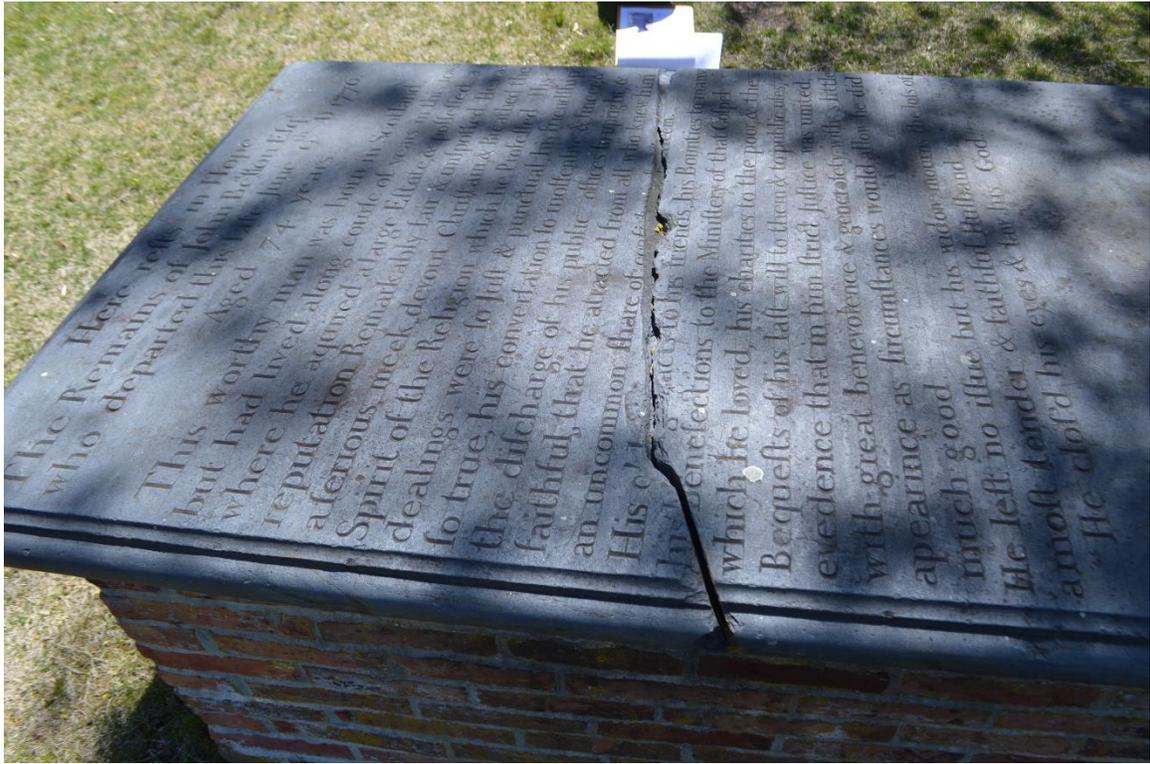
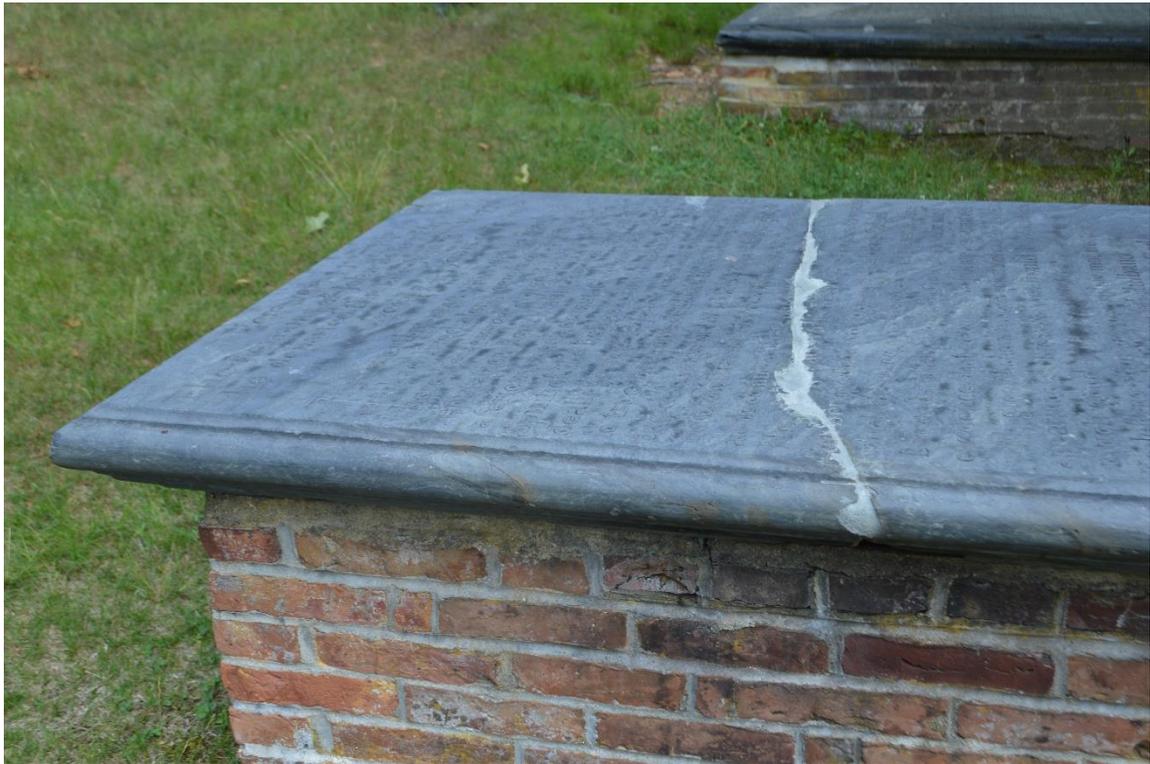
Name Beatton, John
Date of Death June 9, 1776

Material Slate
Marker Type brick box tomb with ledger
Carving Condition 80% - 100% readable

Stone Condition Ambient dirt & biological growth
Ledger stone broken, 2 fragments

Treatment Clean & treat with D2 for biological growths
Reset stone together
Reattach fragment with Jahn M160

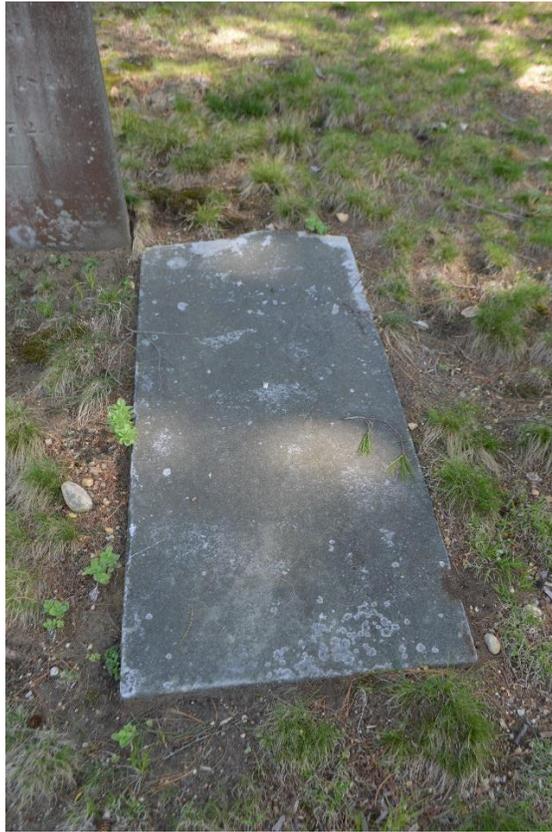
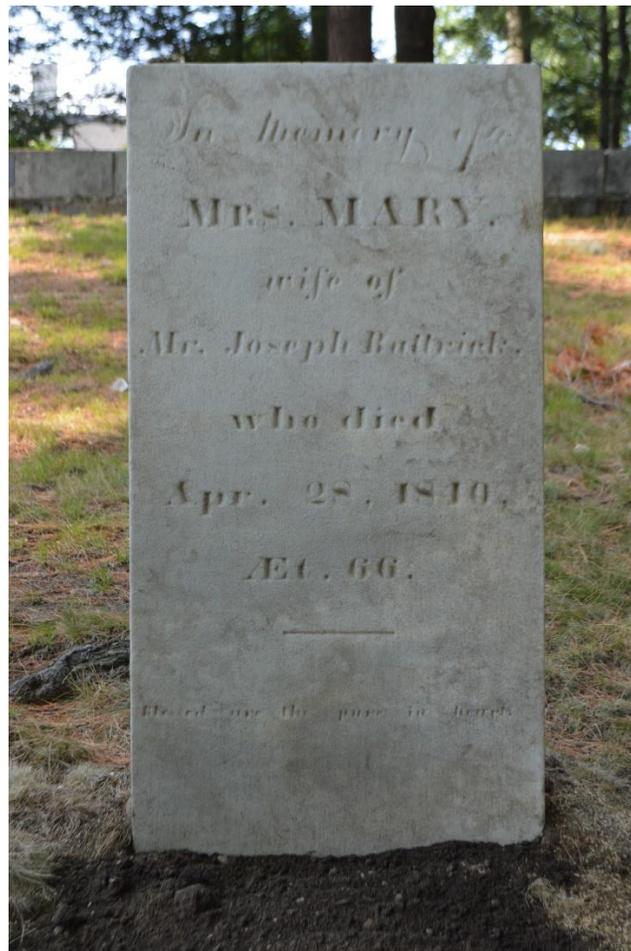
Material Marble
Marker Type tablet
Carving Condition 80% - 100% readable

Stone Condition Ambient dirt & biological growth
Broken, 2 fragments, fallen

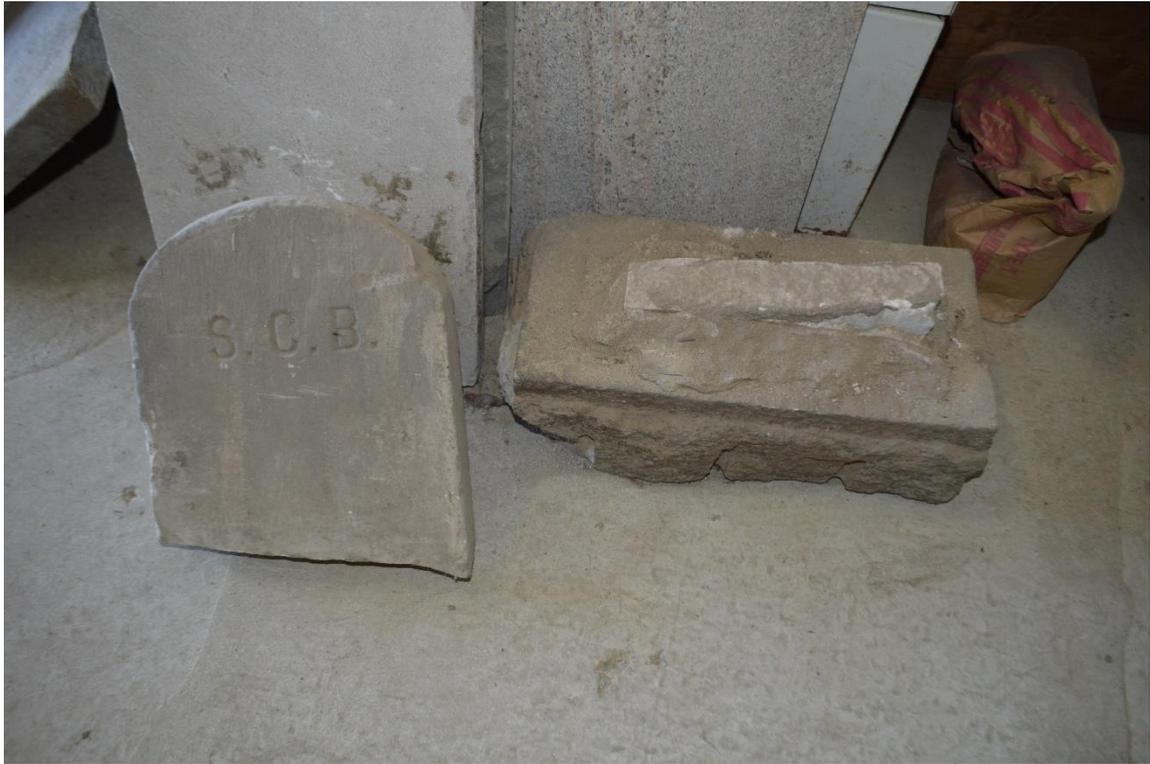
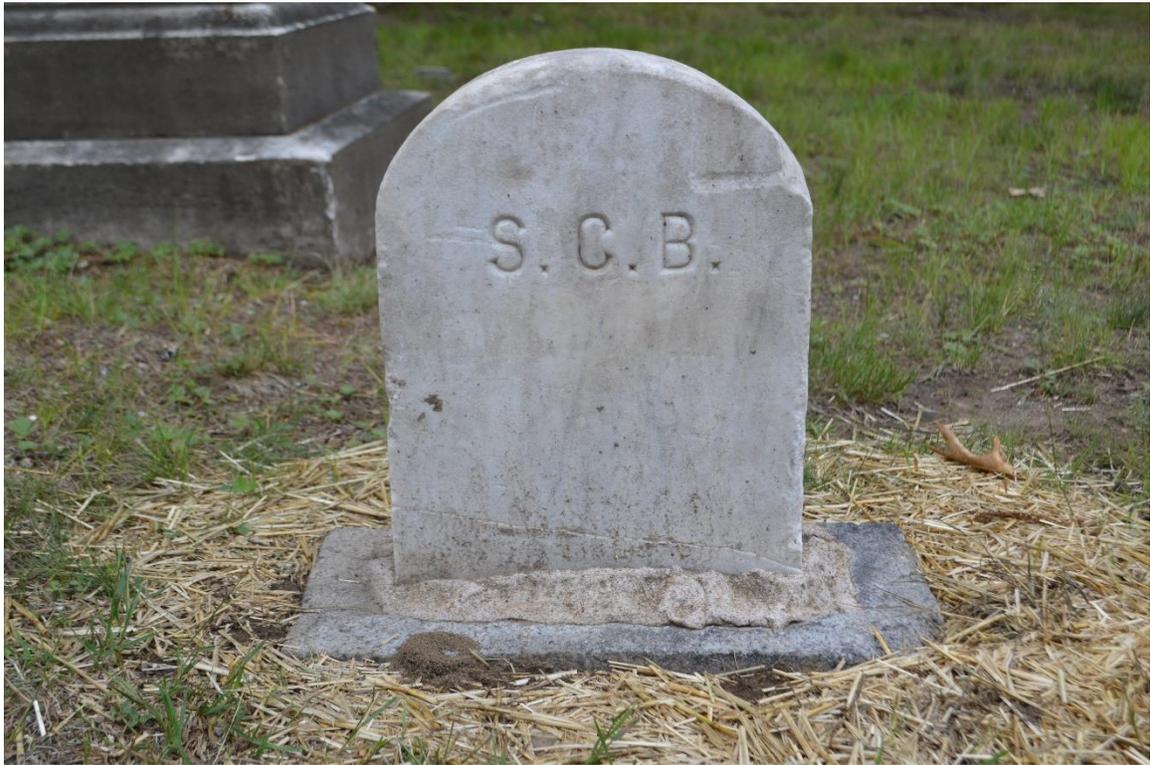
Material Marble
Marker Type marker with base
Carving Condition 80% - 100% readable

Stone Condition Ambient dirt & biological growth
Broken, 2 fragments

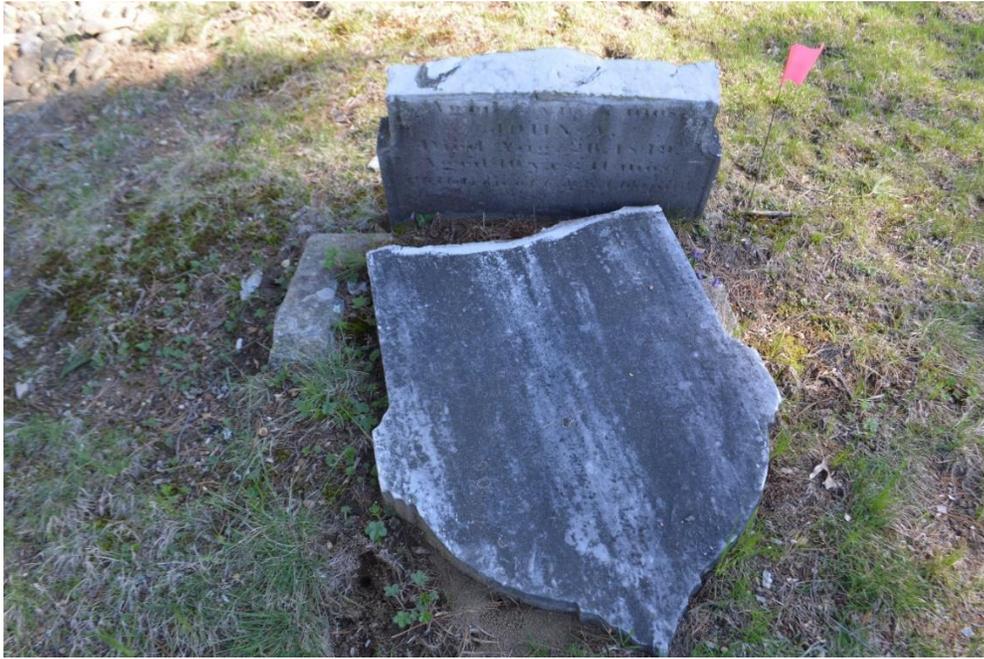
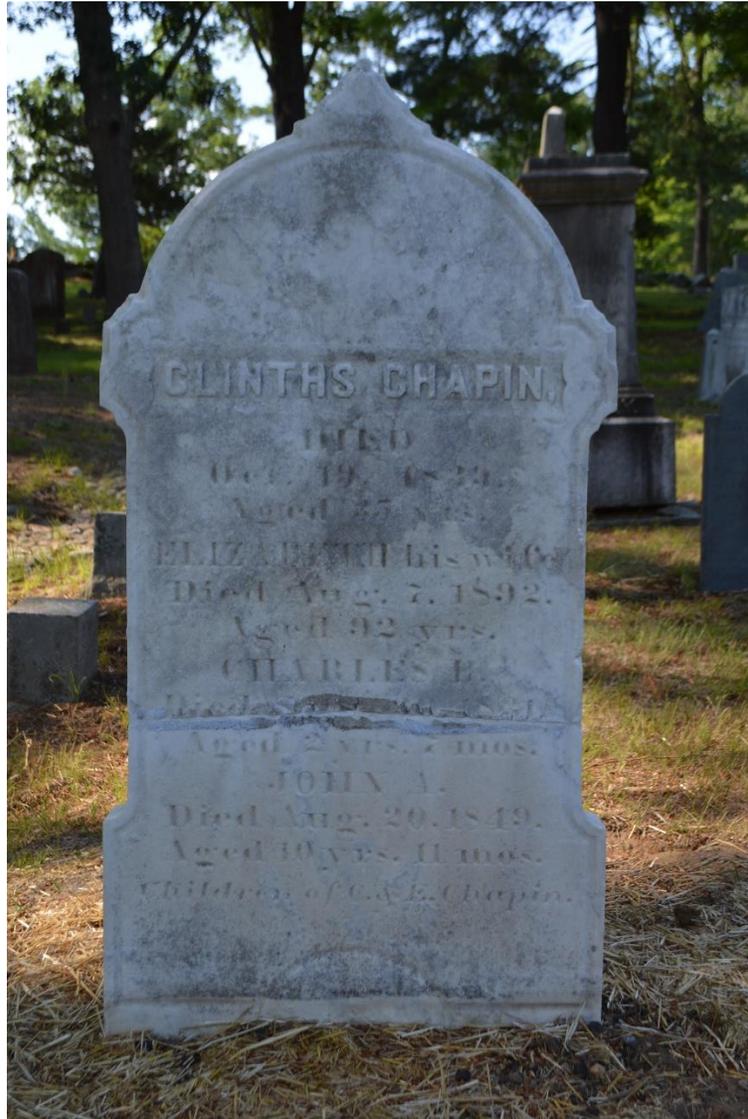
Name Chapin, Clinths, and Elizabeth, Charles & John
Date of Death Oct. 19, 1839

Material Marble
Marker Type tablet with base
Carving Condition 80% - 100% readable

Stone Condition Ambient dirt & biological growth
Broken, 2 fragments, fallen, base broken, caulk residue

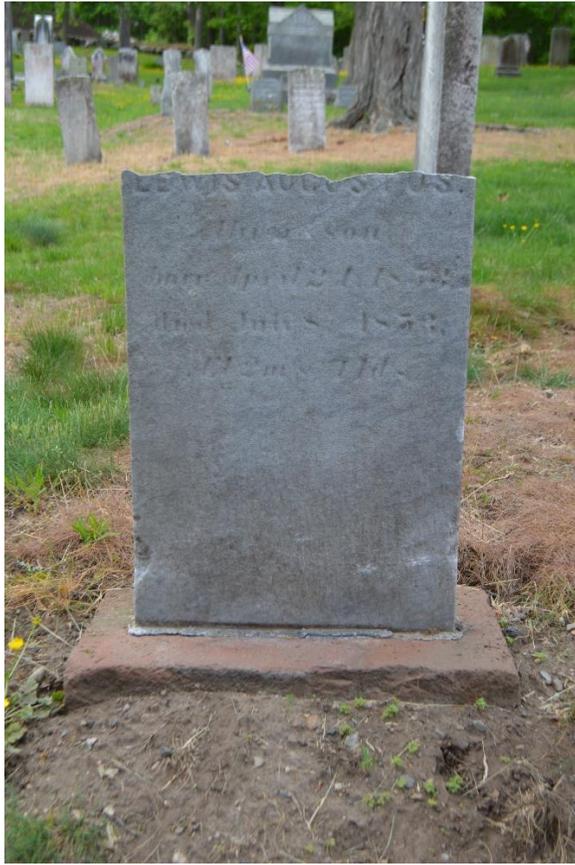
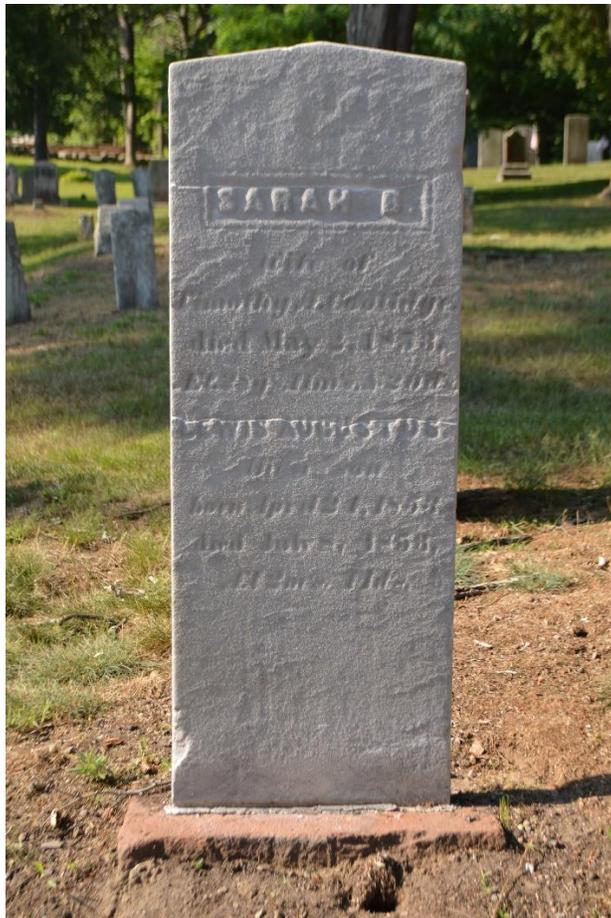
Name Coolidge, Sarah B.
Date of Death May 2, 1853

Material Marble
Marker Type tablet with base
Carving Condition 80% - 100% readable

Stone Condition Ambient dirt & biological growth
Broken, 3 fragments, two fragments stored in garage

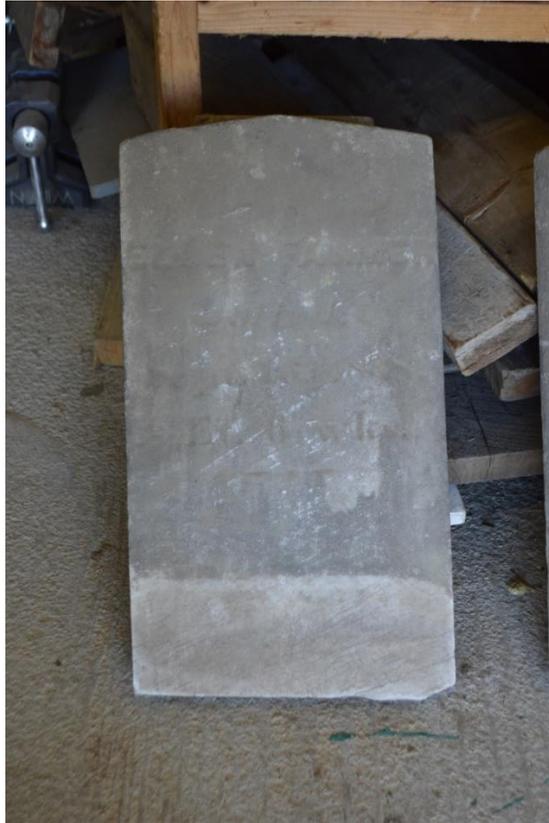
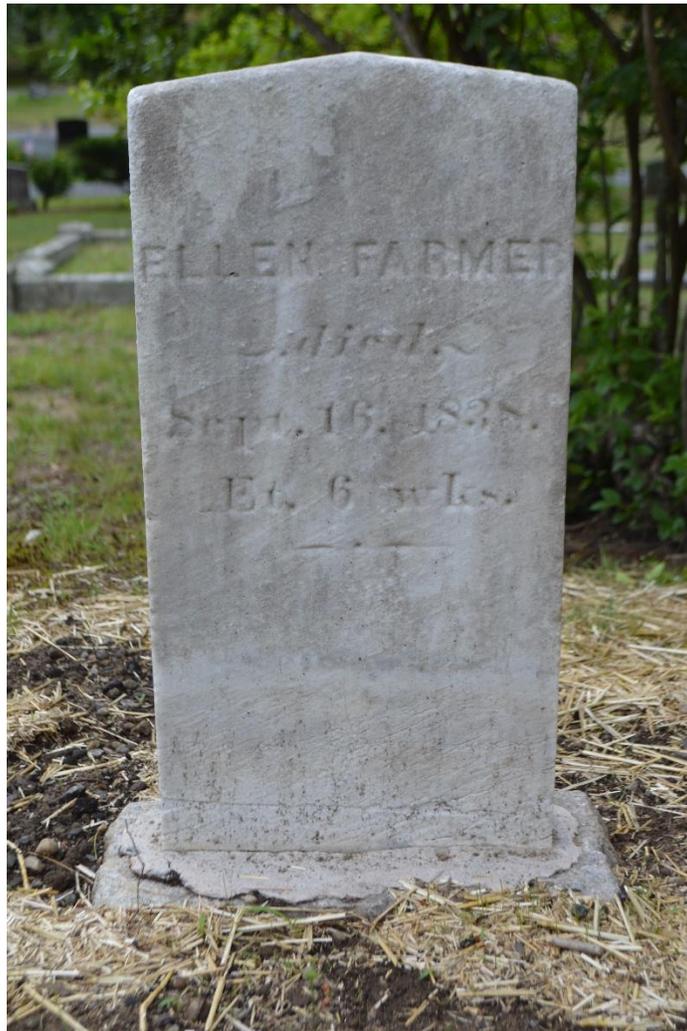
Name Farmer, Ellen
Date of Death Sept. 16, 1838

Material Marble
Marker Type tablet with base
Carving Condition 80% - 100% readable

Stone Condition Ambient dirt & biological growth
Broken, 2 fragments, stored in garage

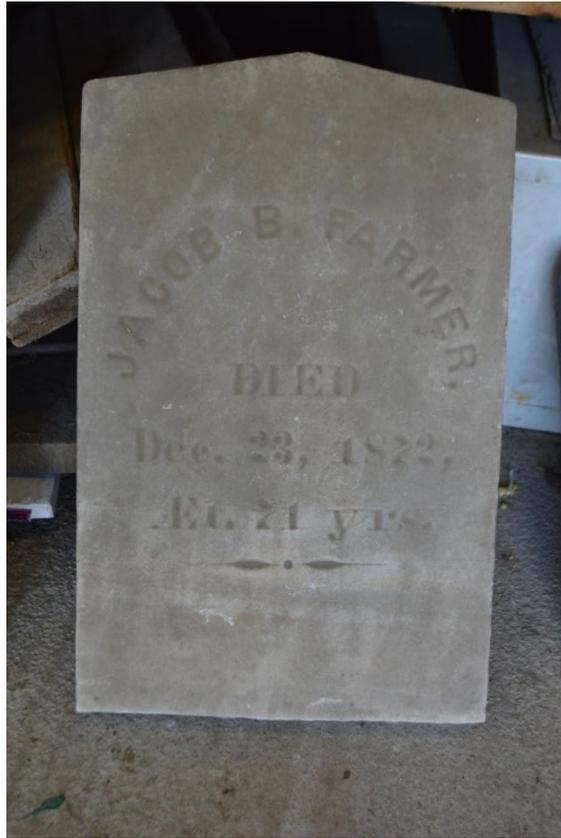
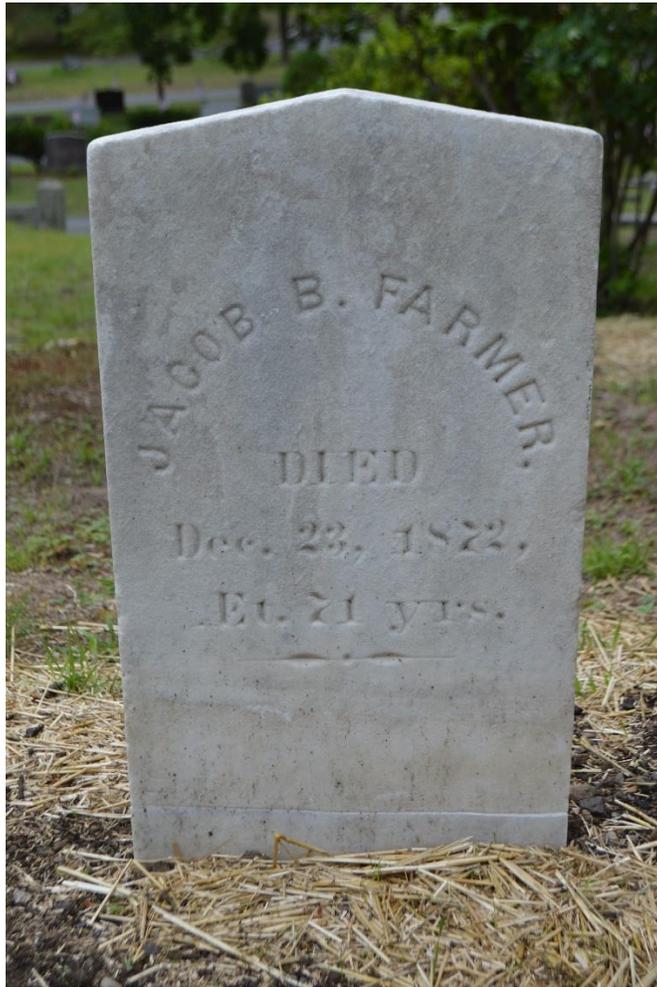
Name Farmer, Jacob B.
Date of Death Dec. 23, 1872

Material Marble
Marker Type tablet with base
Carving Condition 80% - 100% readable

Stone Condition Ambient dirt & biological growth
Broken, 2 fragments, stored in garage

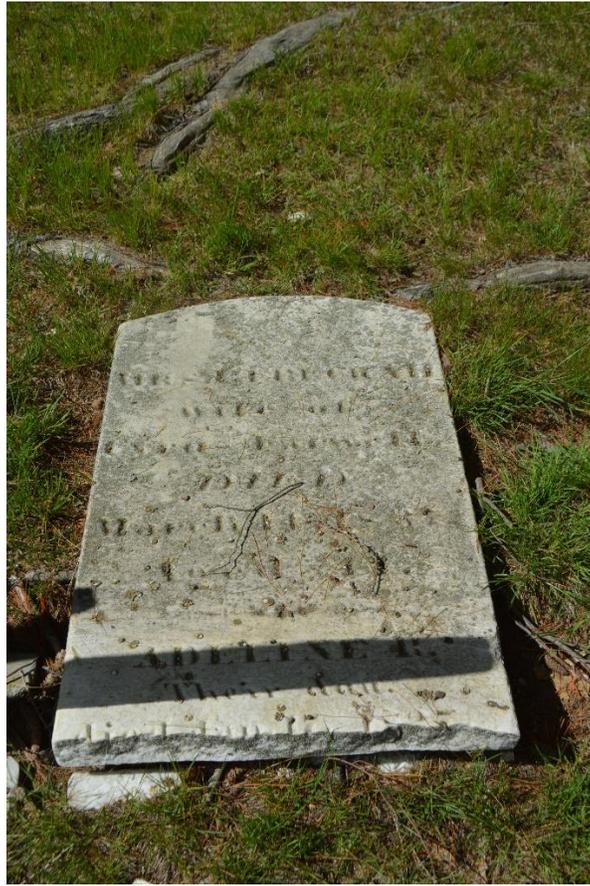
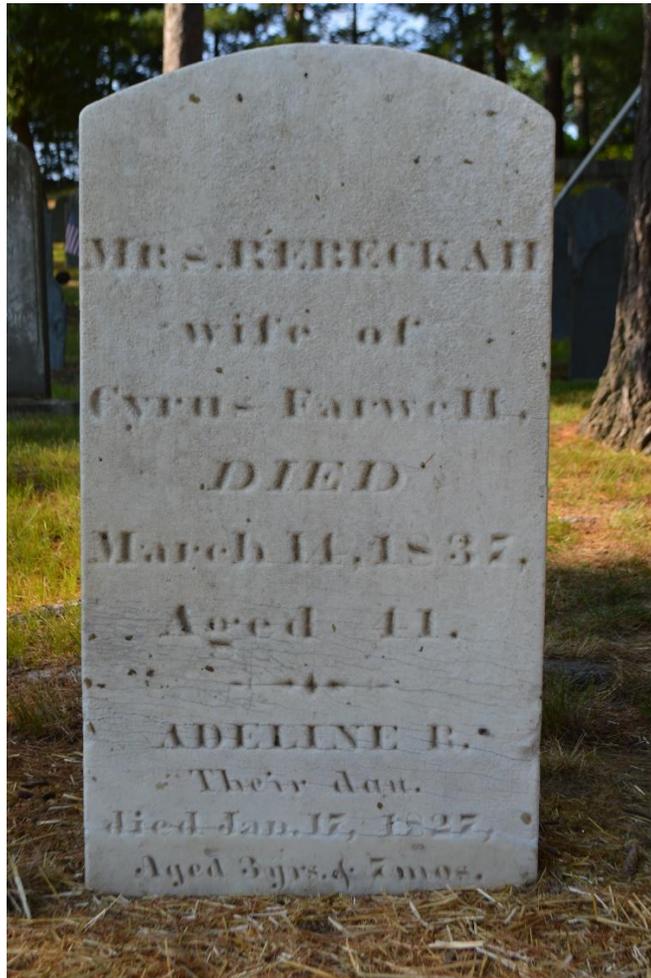
Name Farwell, Rebeckah, and Adeline R.
Date of Death March 11, 1837

Material Marble
Marker Type tablet
Carving Condition 80% - 100% readable

Stone Condition Ambient dirt & biological growth
Broken, 2 fragments, fallen

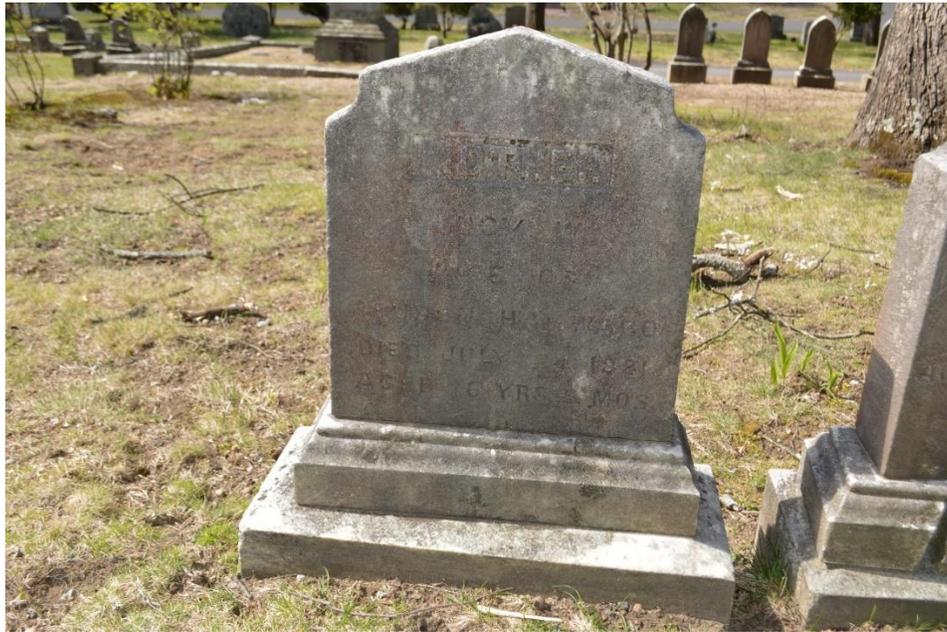
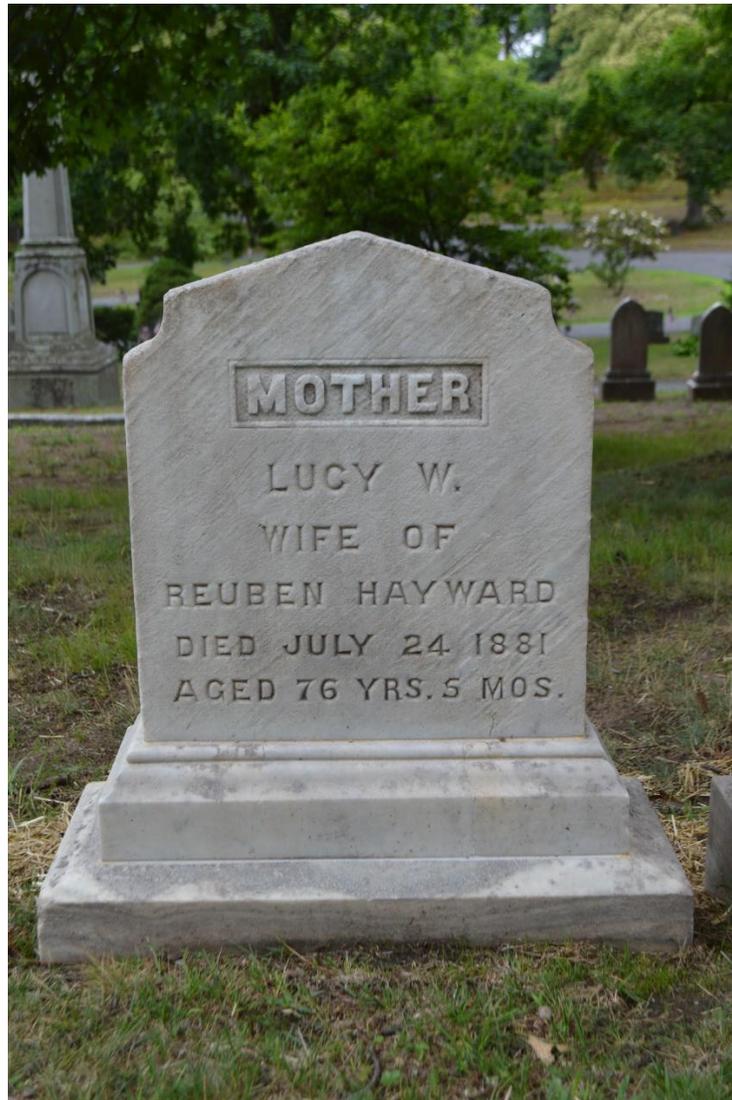
Name Hayward, Lucy W.
Date of Death July 24, 1881

Material Marble
Marker Type die with base
Carving Condition 80% - 100% readable

Stone Condition Ambient dirt & biological growth
Broken plinth, loose on base

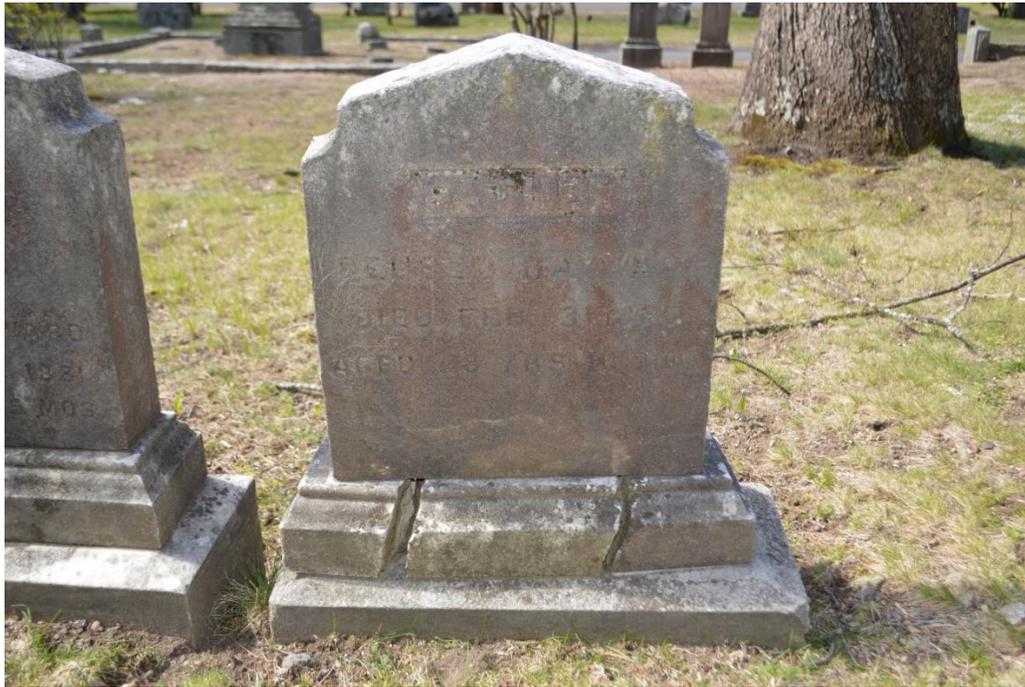
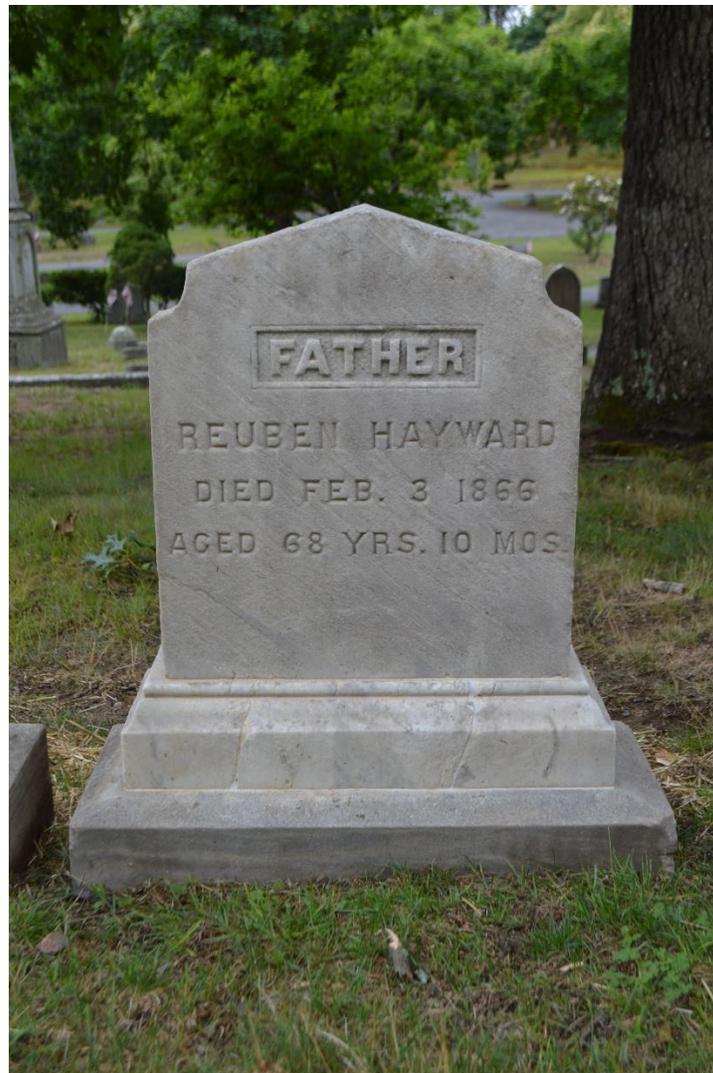
Name Hayward, Reuben
Date of Death Feb. 3, 1866

Material Marble
Marker Type die with base
Carving Condition 80% - 100% readable

Stone Condition Ambient dirt & biological growth
Broken plinth, 3 fragments, loose on base

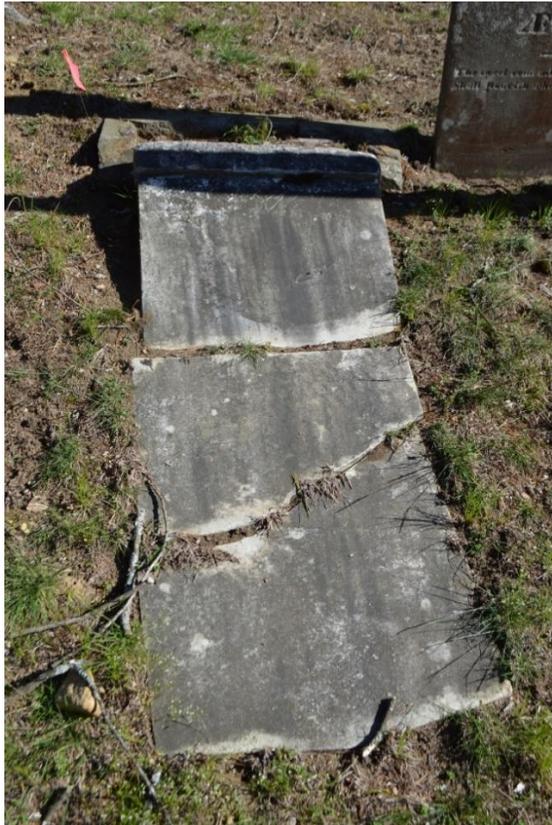
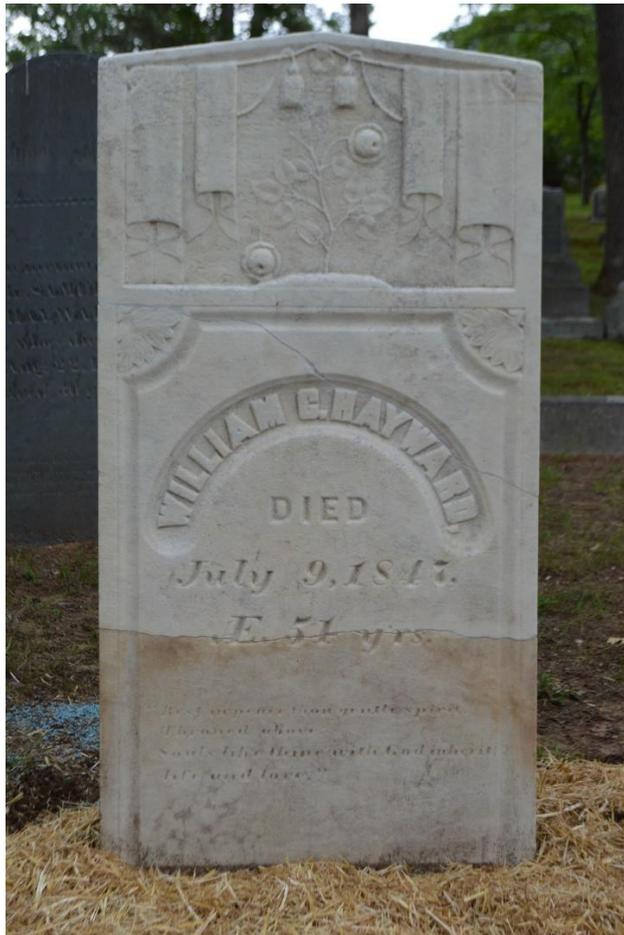
Name Hayward, William
Date of Death July 9, 1847

Material Marble
Marker Type tablet with base
Carving Condition 80% - 100% readable

Stone Condition Ambient dirt & biological growth
Broken, 4 fragments, fallen, broken base

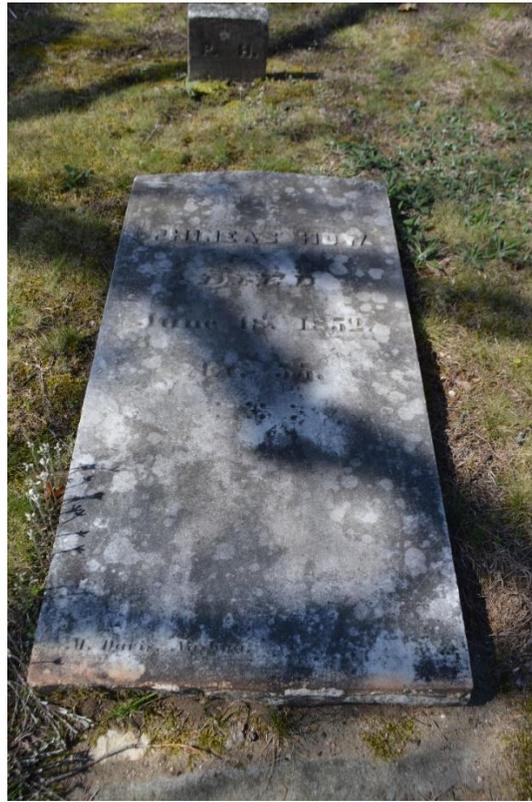
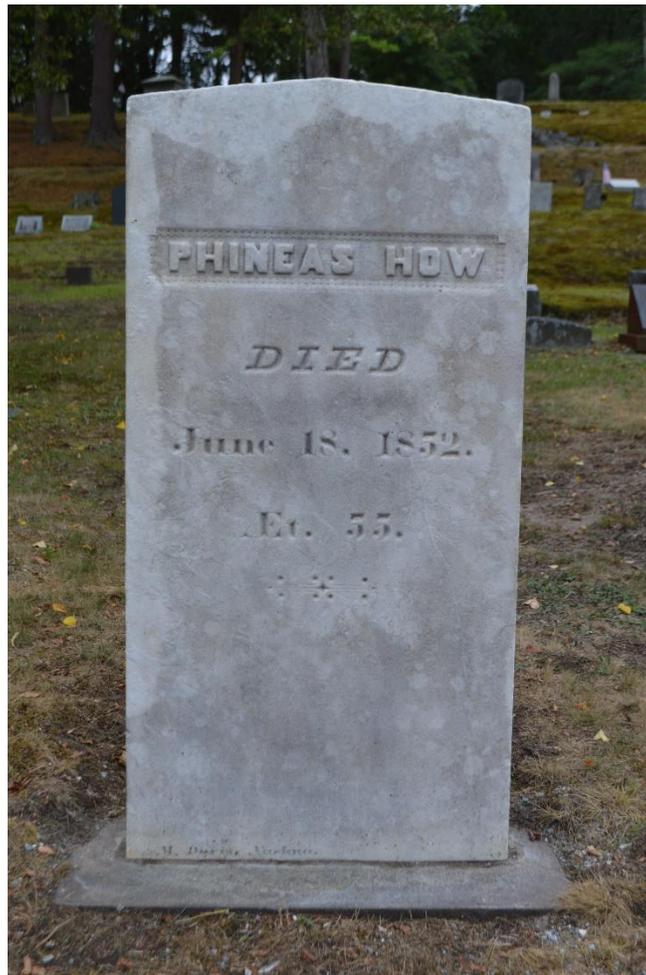
Name How, Phineas
Date of Death June 18, 1852

Material Marble
Marker Type tablet with base
Carving Condition 80% - 100% readable

Stone Condition Ambient dirt & biological growth
Leaning & sunken base, stone fallen

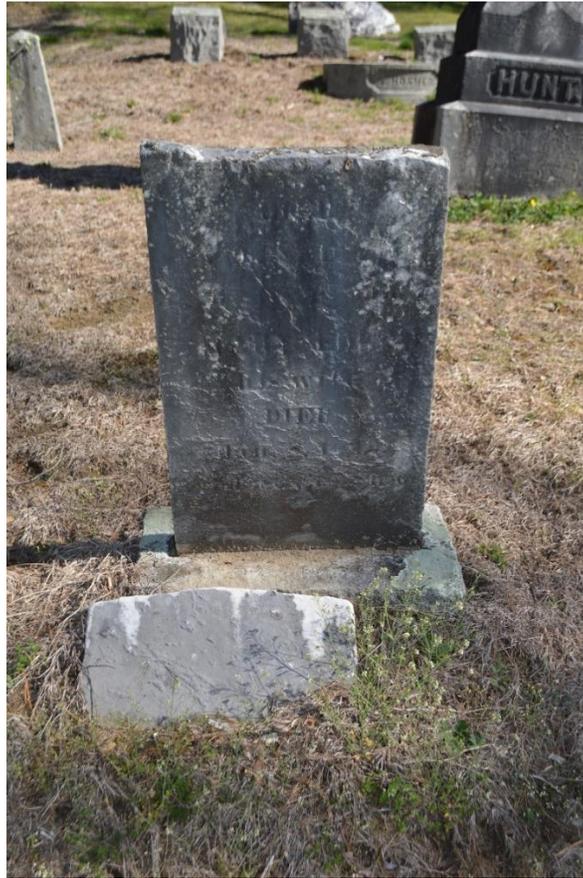
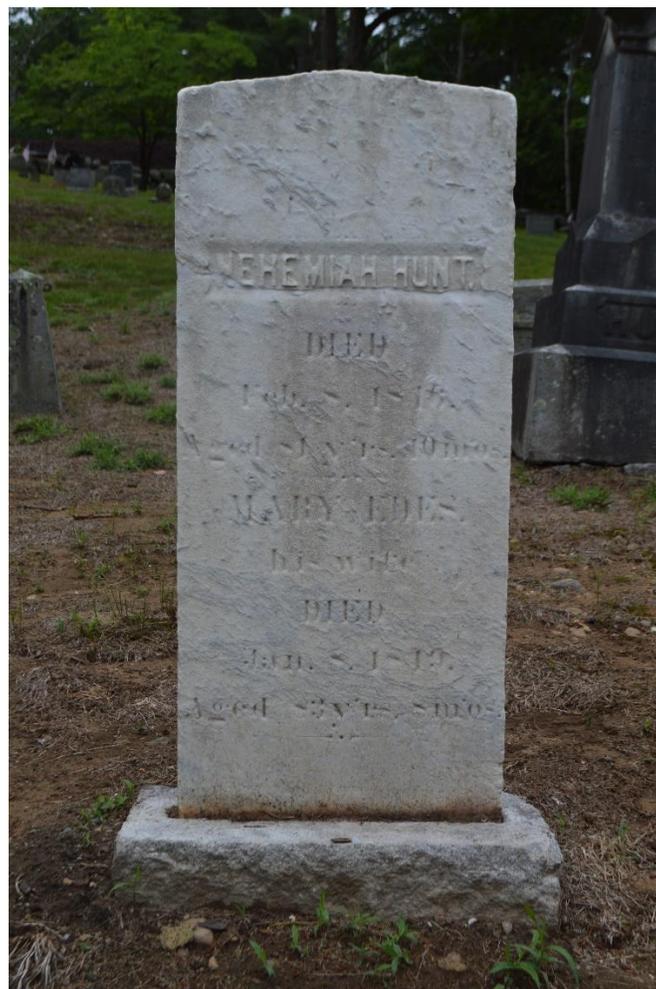
Material Marble
Marker Type tablet with base
Carving Condition 80% - 100% readable

Stone Condition Ambient dirt & biological growth
Broken, 2 fragments, fallen

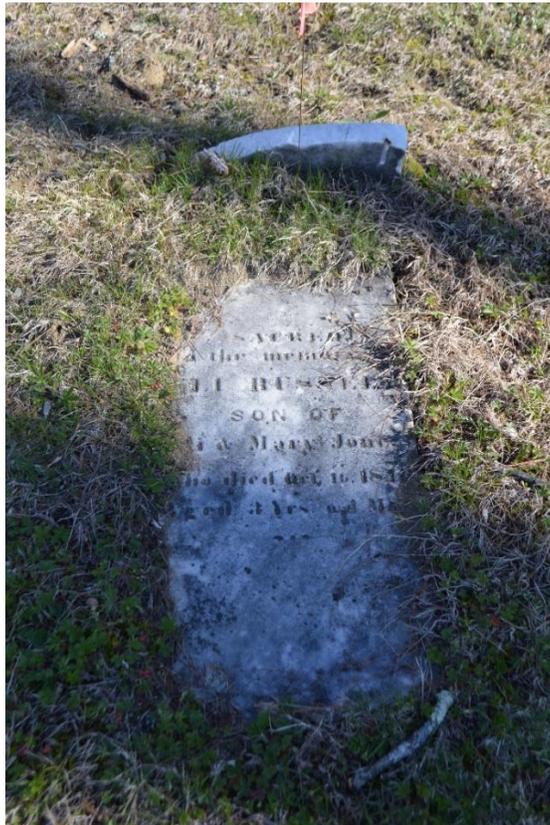
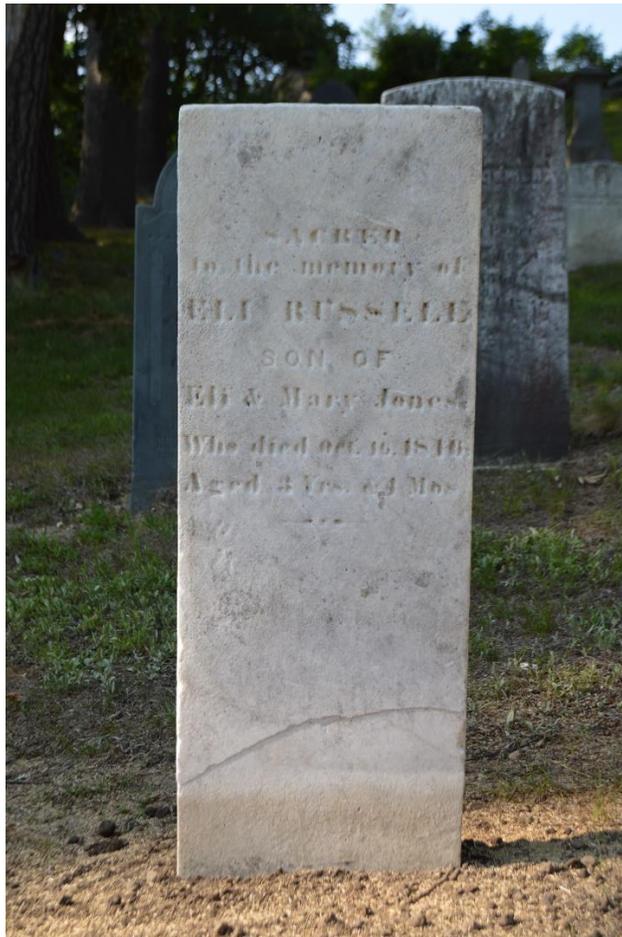
Name Jones, Eli Russell
Date of Death Oct. 16, 1810

Material Marble
Marker Type tablet
Carving Condition 80% readable

Stone Condition Ambient dirt & biological growth
Broken, 2 fragments, fallen

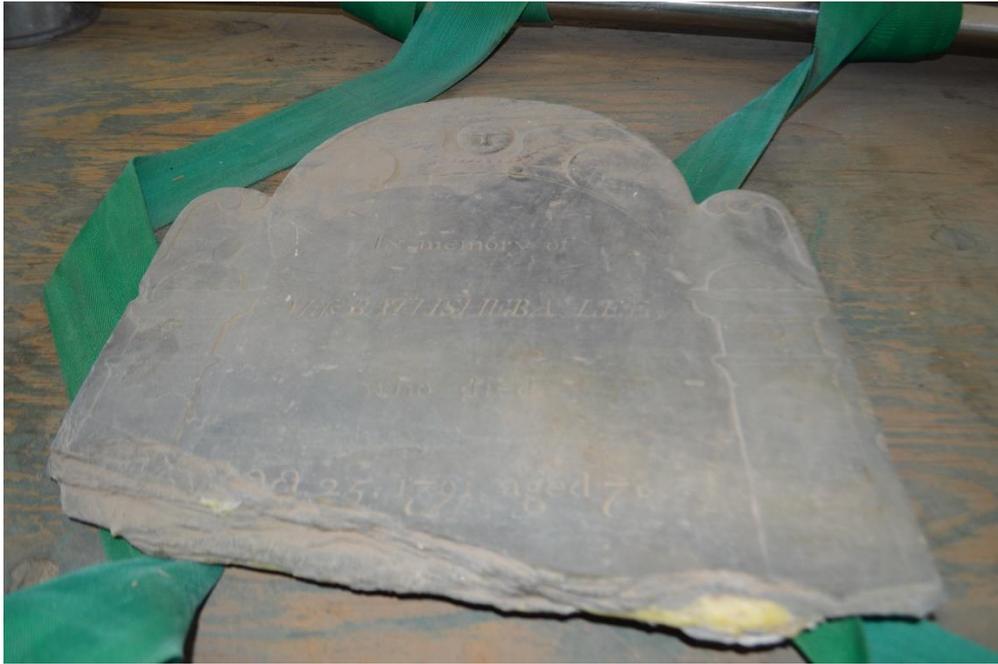
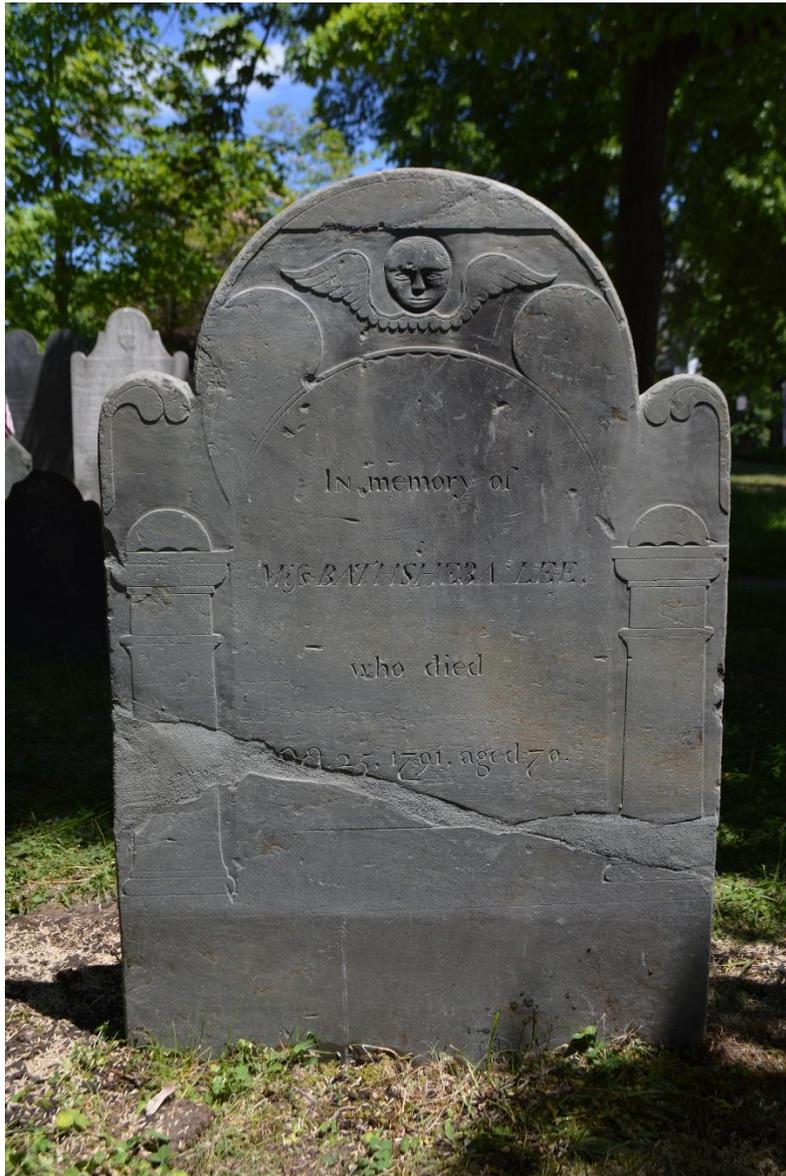
Material slate
Marker Type tablet
Carving Condition 80% - 100% readable

Stone Condition Ambient dirt & biological growth
sunken
Broken, 2 fragments

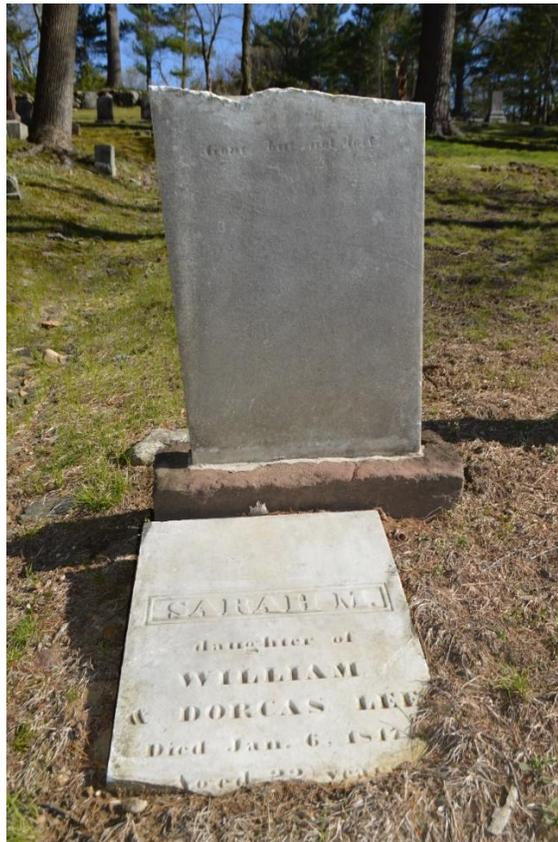
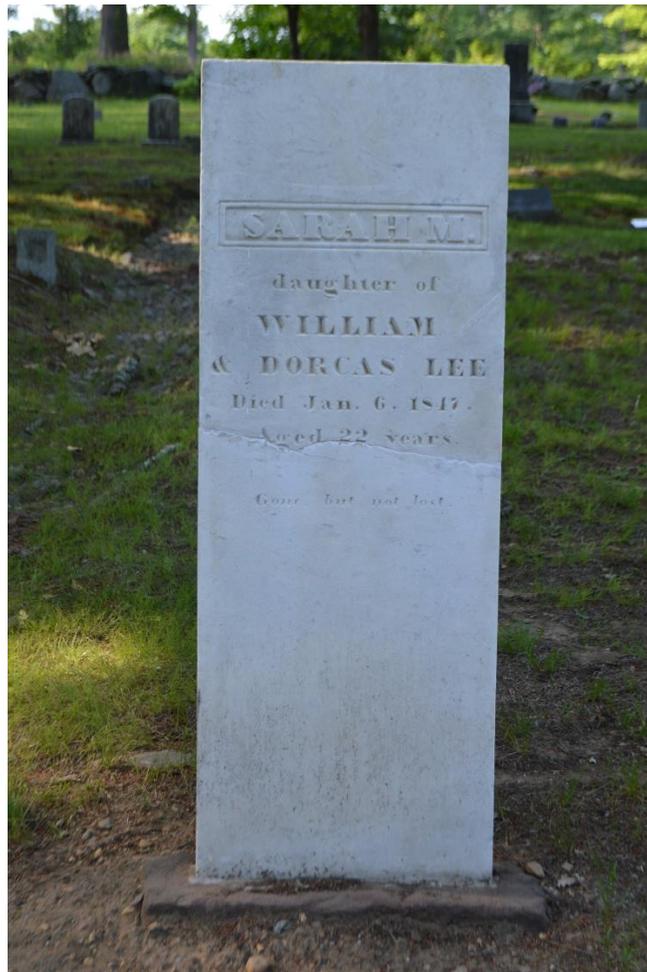
Material Marble
Marker Type tablet with base
Carving Condition 80% - 100% readable

Stone Condition Ambient dirt & biological growth
Broken, 2 fragments, fallen
