Sleepy Hollow Cemetery

Record Date June 2020
Cemetery Location Sleepy Hollow, Concord, MA

HISTORIC GRAVESTONE SERVICES *Conservation Form* TLC* 2020

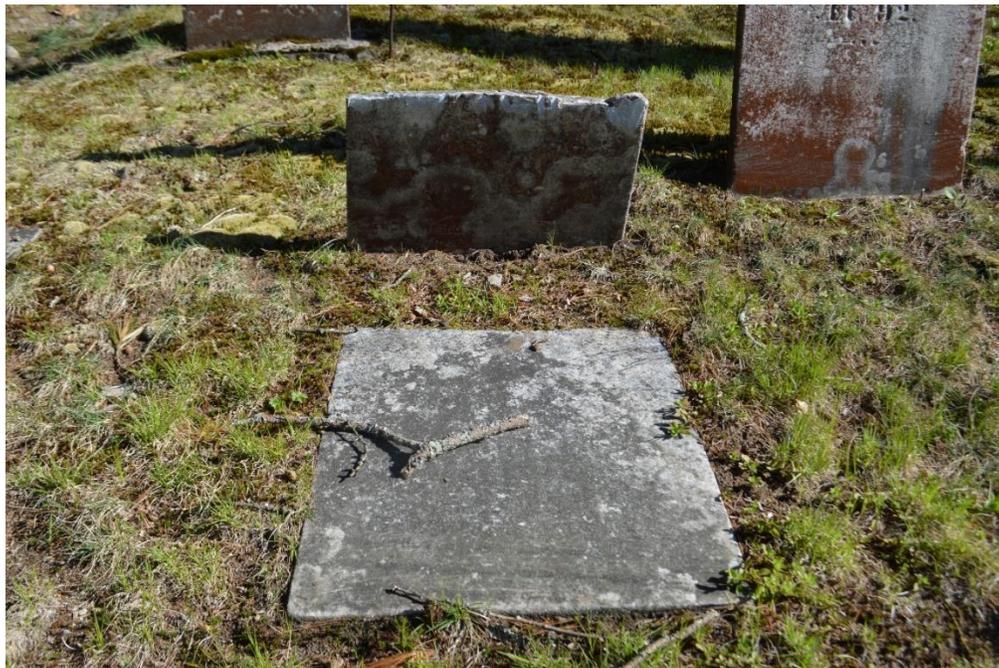
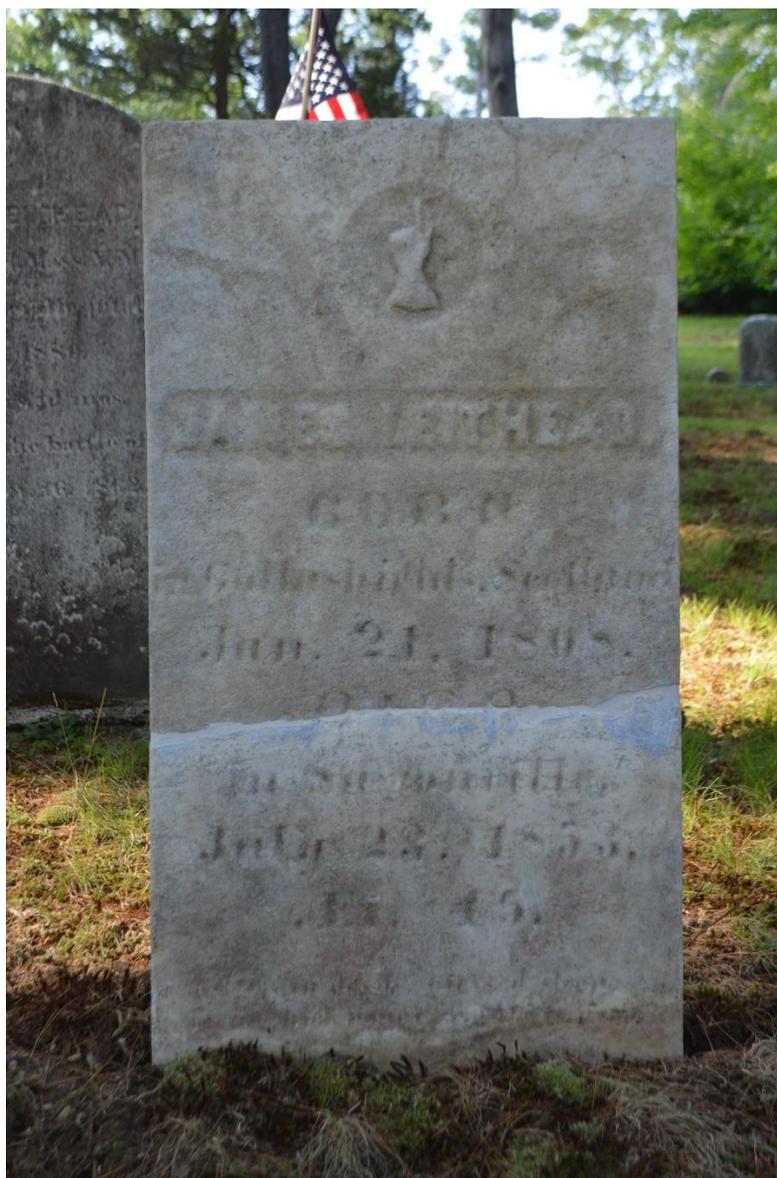
Name Leithead, James
Date of Death July 23, 1833

Material Marble
Marker Type tablet with base
Carving Condition 80% - 100% readable

Stone Condition Ambient dirt & biological growth
Broken, 2 fragments, fallen

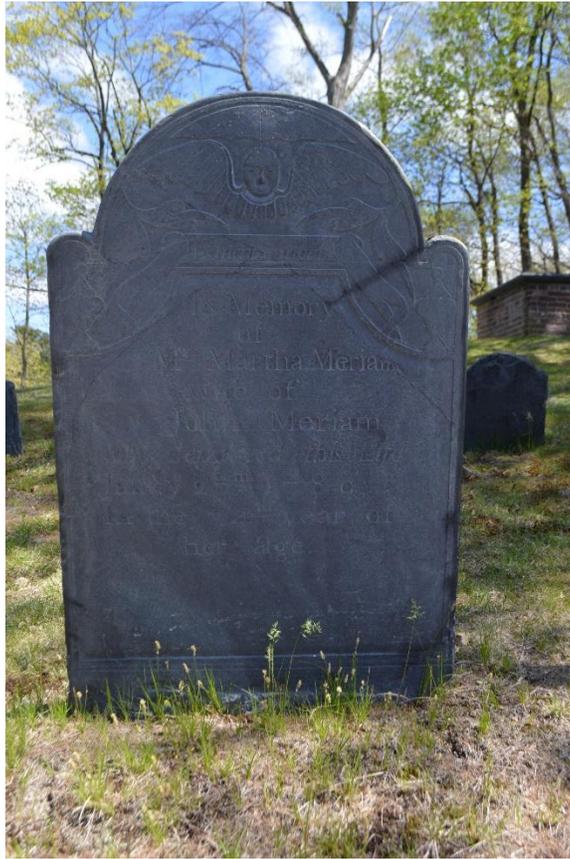
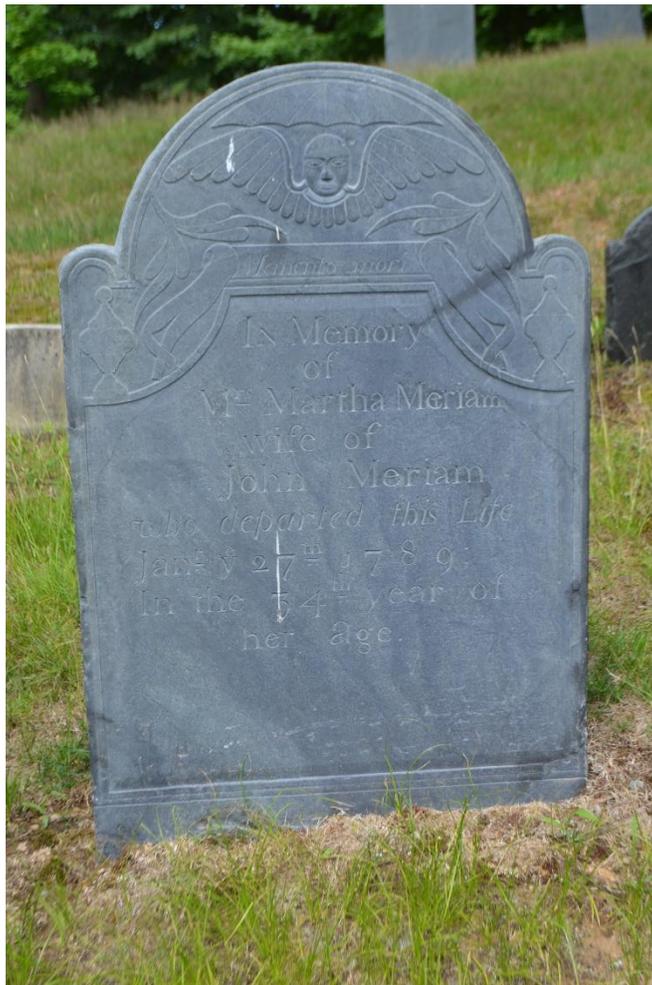
Name Meriam, Martha
Date of Death

Material Marble
Marker Type marker with base
Carving Condition 80% - 100% readable

Stone Condition Ambient dirt & biological growth
Leaning, delamination on cap, large crack

Treatment Clean & treat with D2 for biological growths
Reset stone plumb
Fill crack/delamination with Jahn M160

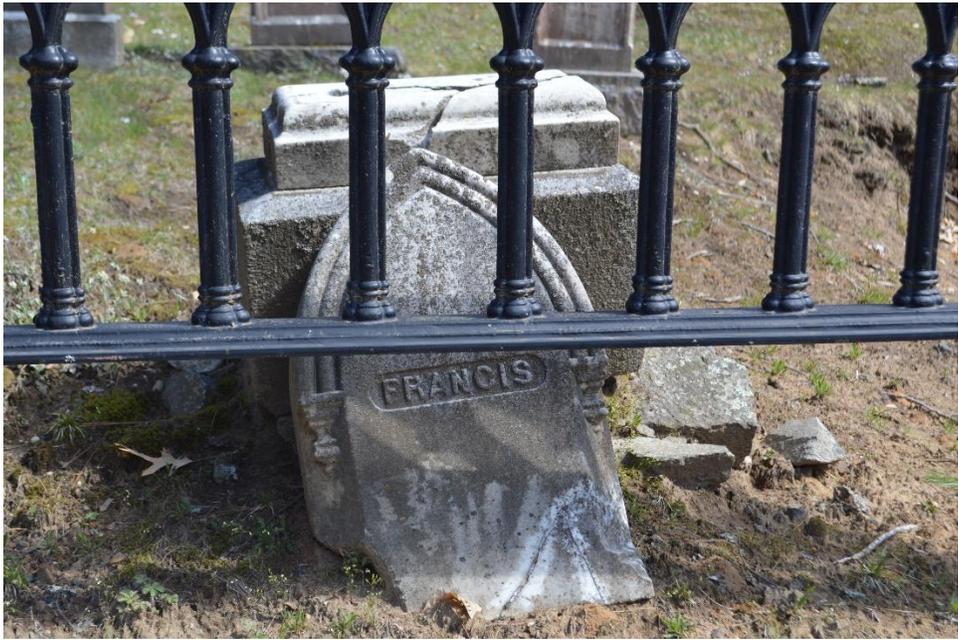
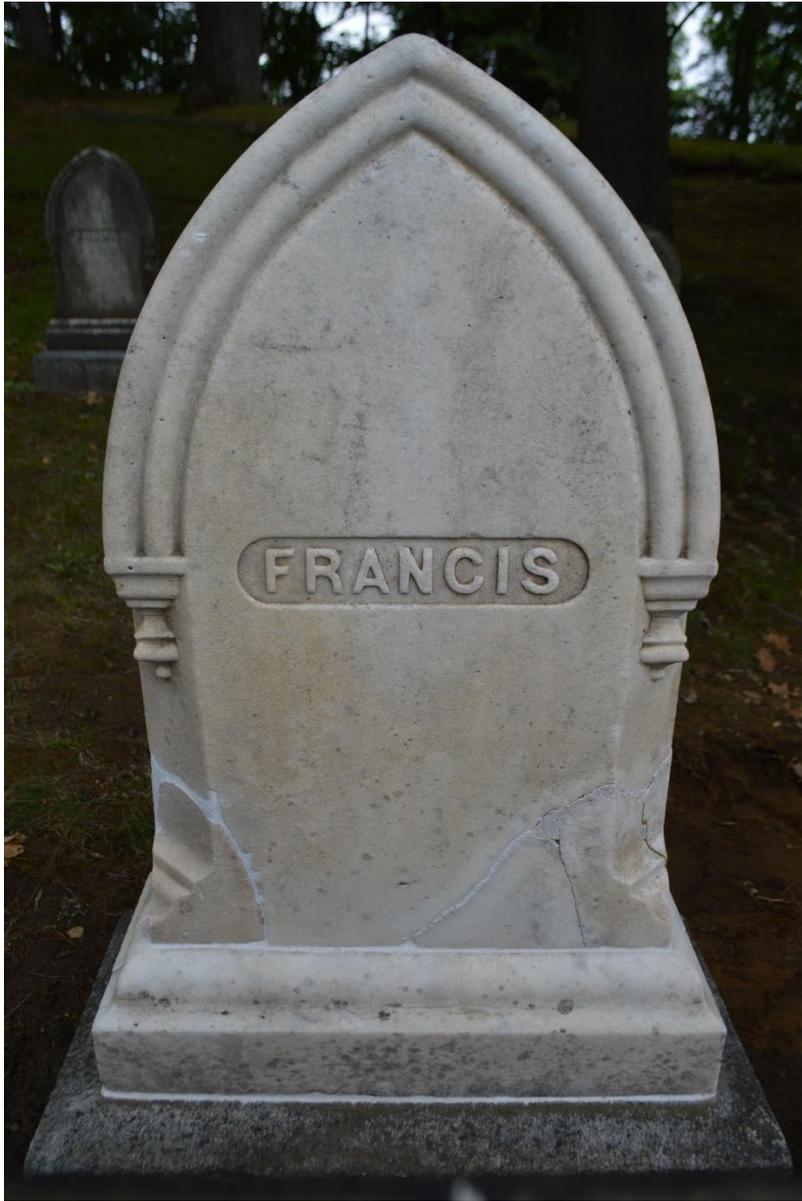
Material Marble
Marker Type die with base
Carving Condition 80% - 100% readable

Stone Condition Ambient dirt & biological growth
Broken, 2 fragments, missing material, fallen

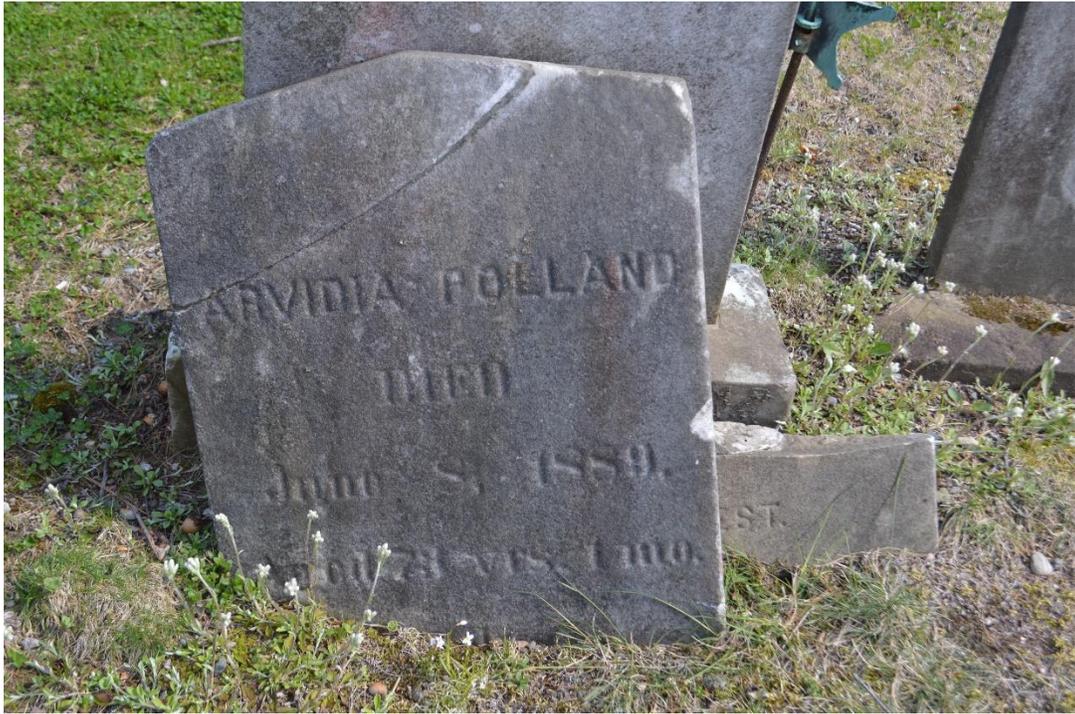
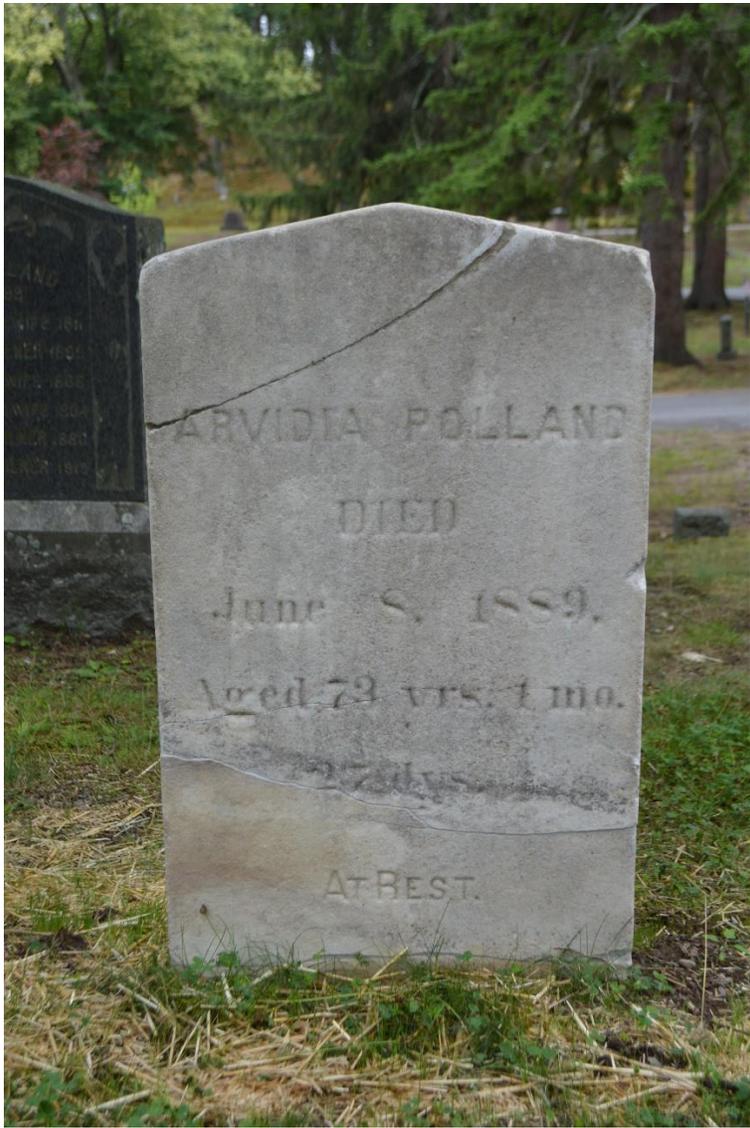
Name Polland, Arvidia
Date of Death

Material Marble
Marker Type tablet with base
Carving Condition 80% - 100% readable

Stone Condition Ambient dirt & biological growth
Broken, 2 fragments

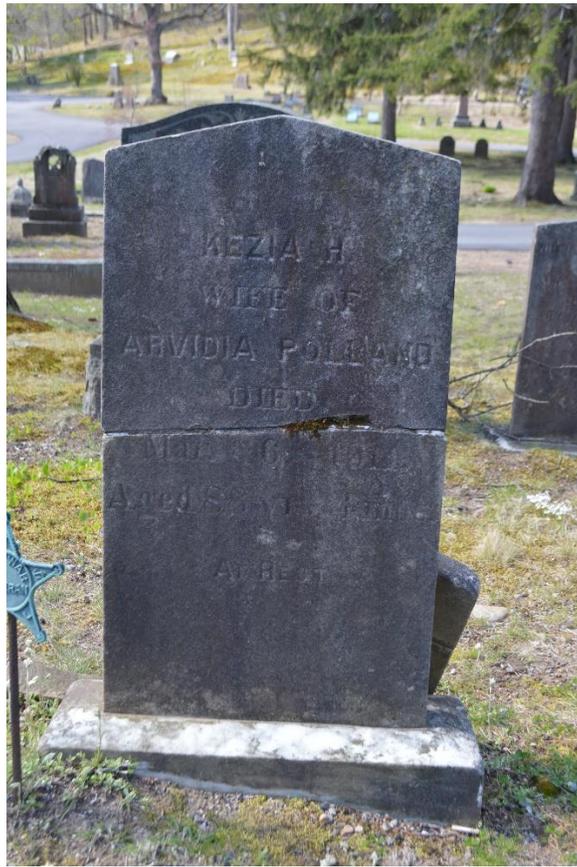
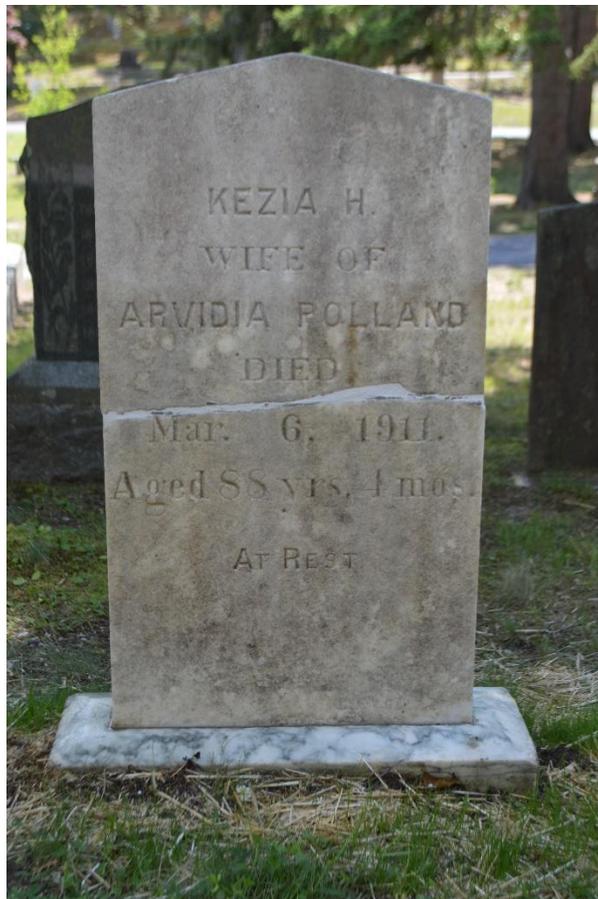
Name Polland, Kezia
Date of Death March 6, 1911

Material Marble
Marker Type tablet with base
Carving Condition 80% - 100% readable

Stone Condition Ambient dirt & biological growth
Leaning, old repair with epoxy, missing material

Treatment Clean & treat with D2 for biological growths
Reset stone with base plumb
Fill missing material with Jahn M120

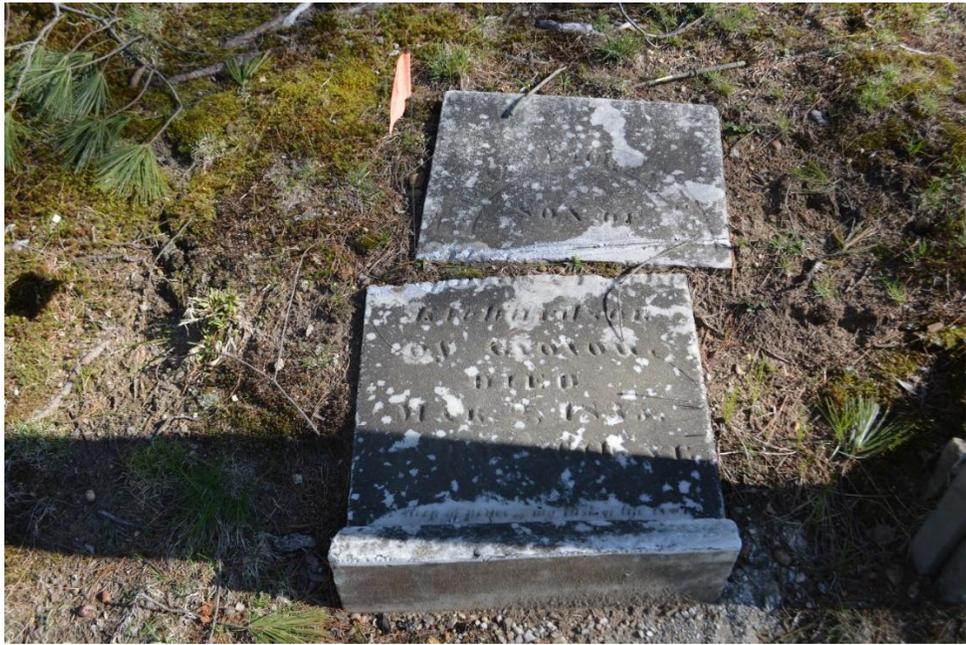
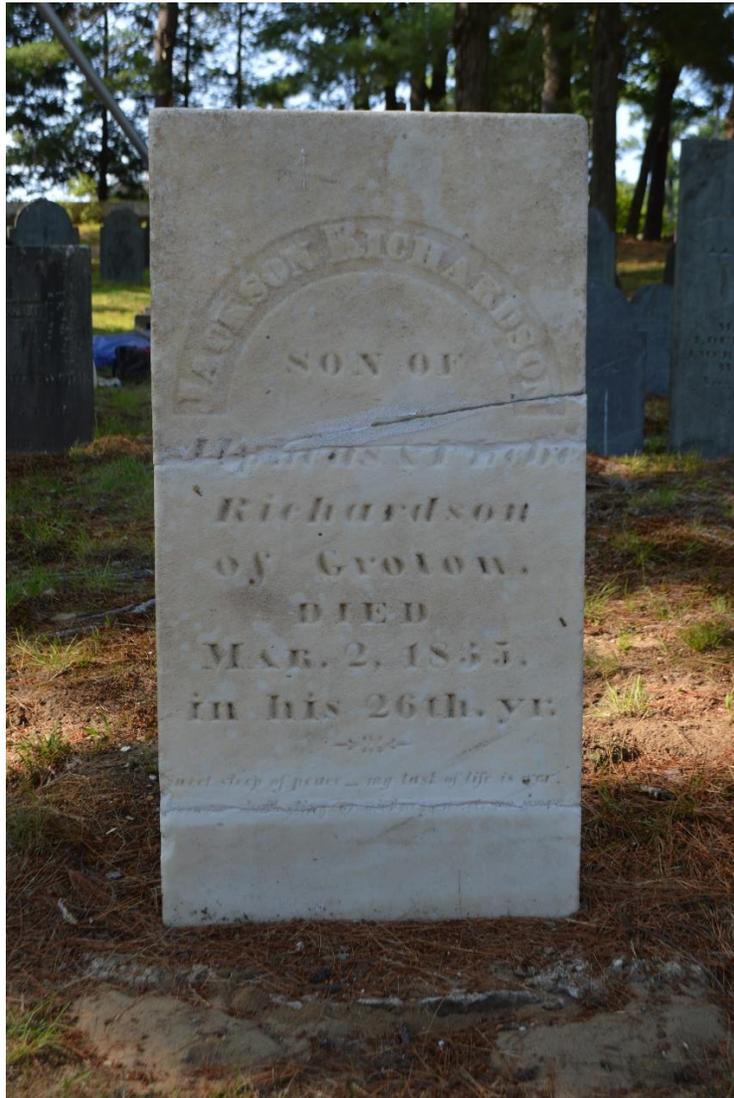
Material Marble
Marker Type tablet
Carving Condition 80% readable

Stone Condition Ambient dirt & biological growth
Broken, 3 fragments, fallen, old repair failure, caulk residue

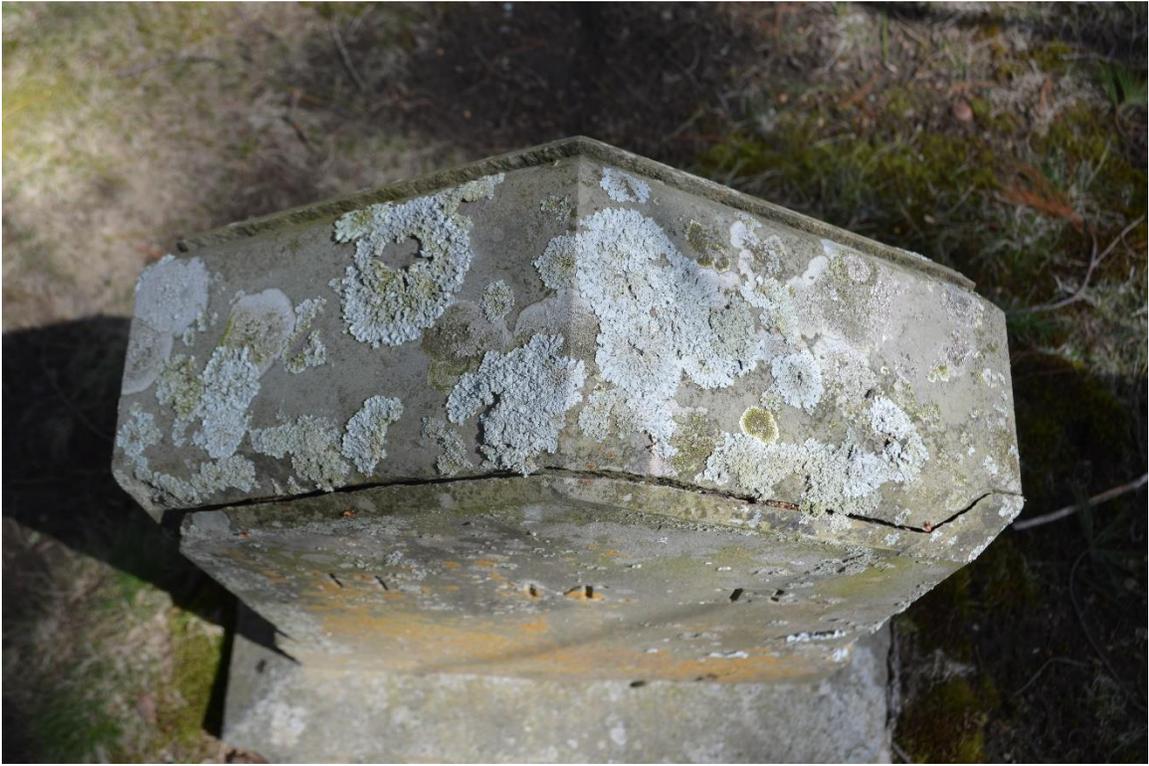
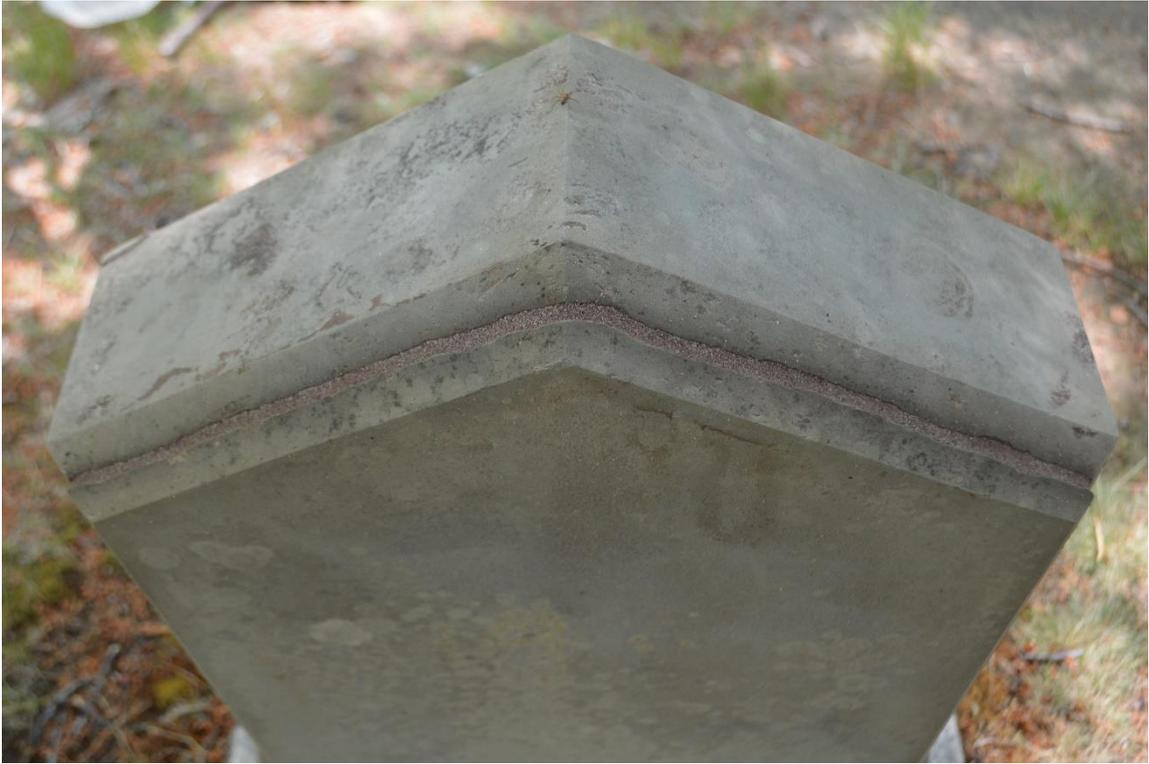
Material sandstone
Marker Type footstone
Carving Condition 80% - 100% readable

Stone Condition Ambient dirt & biological growth
Spalling on front and back at cap

Treatment Clean & treat with D2 for biological growths
Reattach fragments and fill cracks with Jahn M70

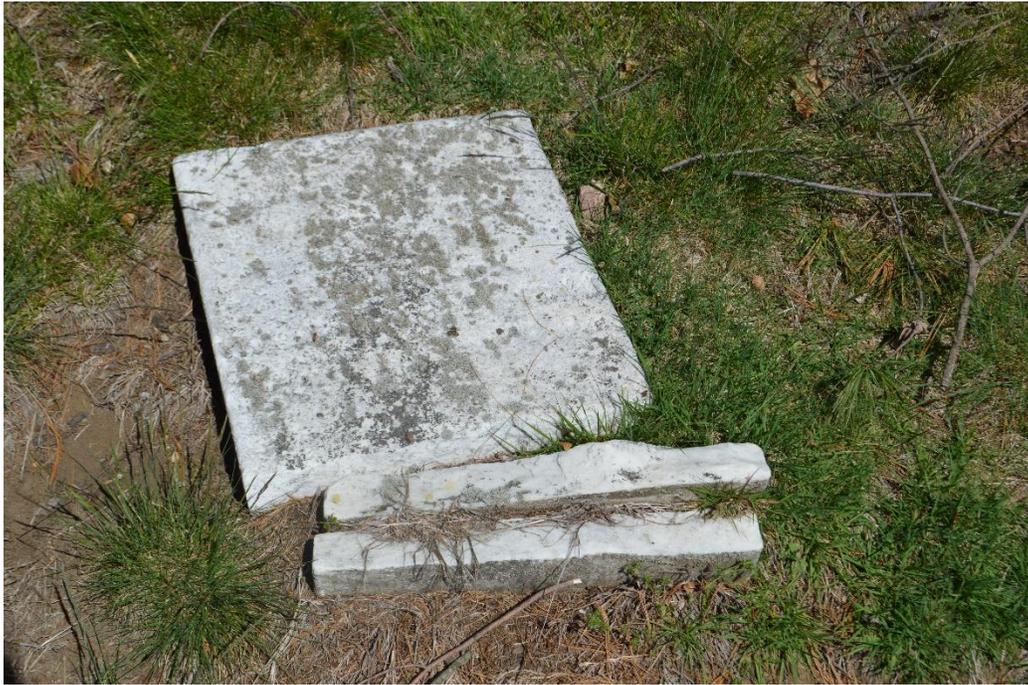
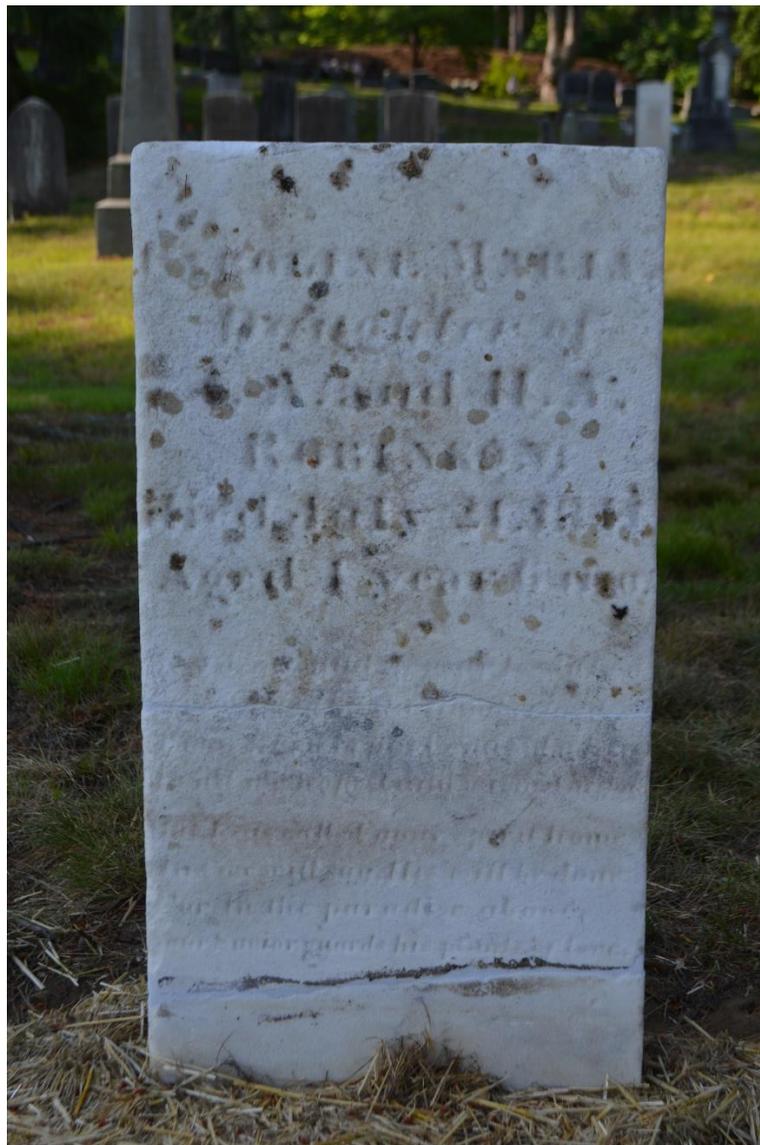
Material Marble
Marker Type tablet
Carving Condition 30% readable

Stone Condition Ambient dirt & biological growth
Broken, 3 fragments, old repair failure, epoxy residue

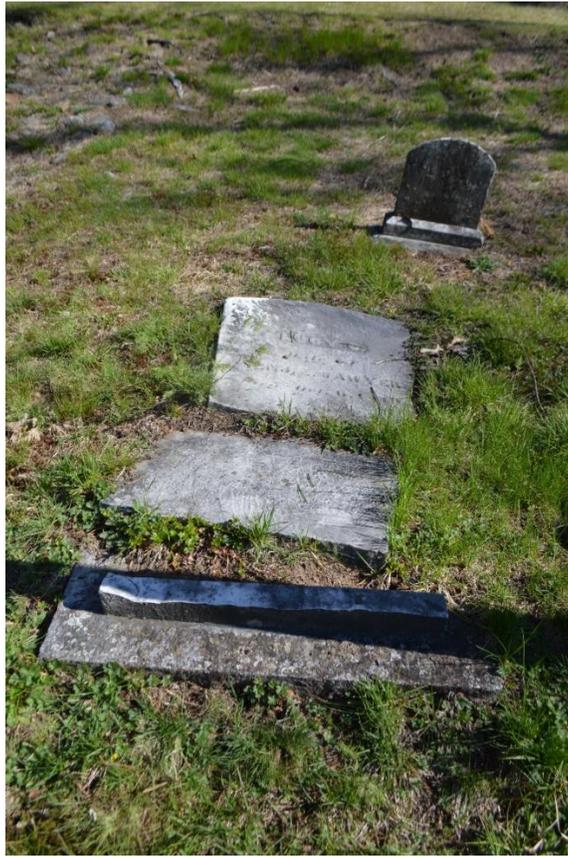
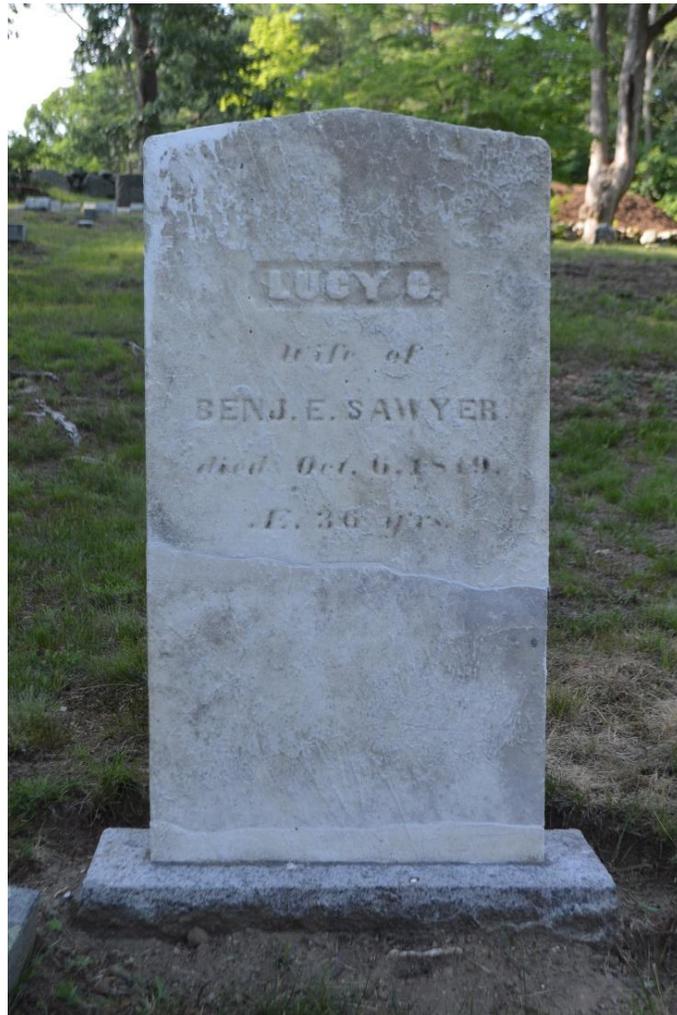
Name Sawyer, Lucy C.
Date of Death Oct. 6, 1819

Material Marble
Marker Type tablet with base
Carving Condition 80% - 100% readable

Stone Condition Ambient dirt & biological growth
Broken, 3 fragments, fallen

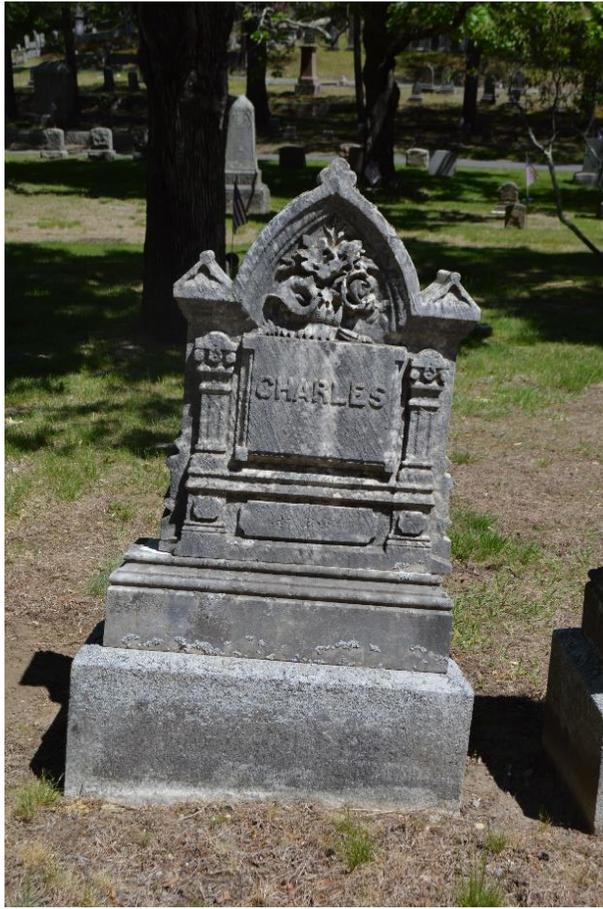
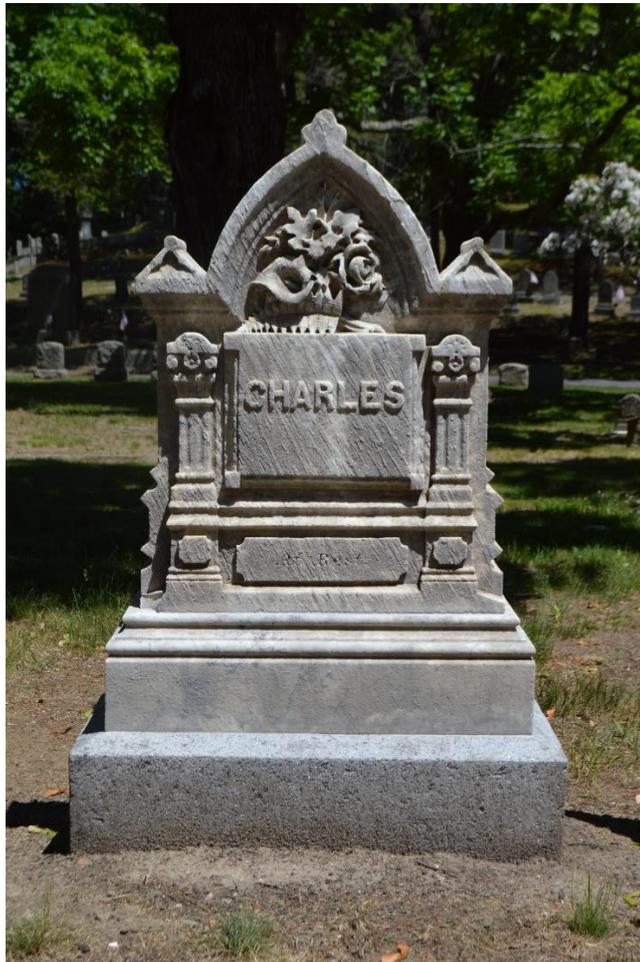
Name Stearns, Charles
Date of Death April 5, 1885

Material Marble
Marker Type die with base
Carving Condition 80% - 100% readable

Stone Condition Ambient dirt & biological growth
Leaning & sunken base, loose on base

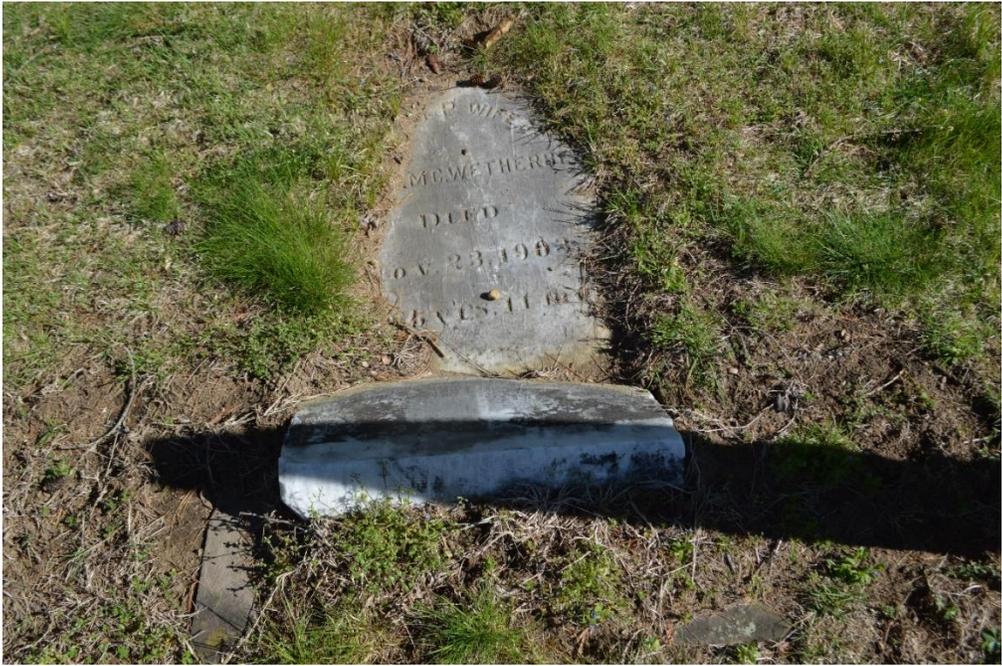
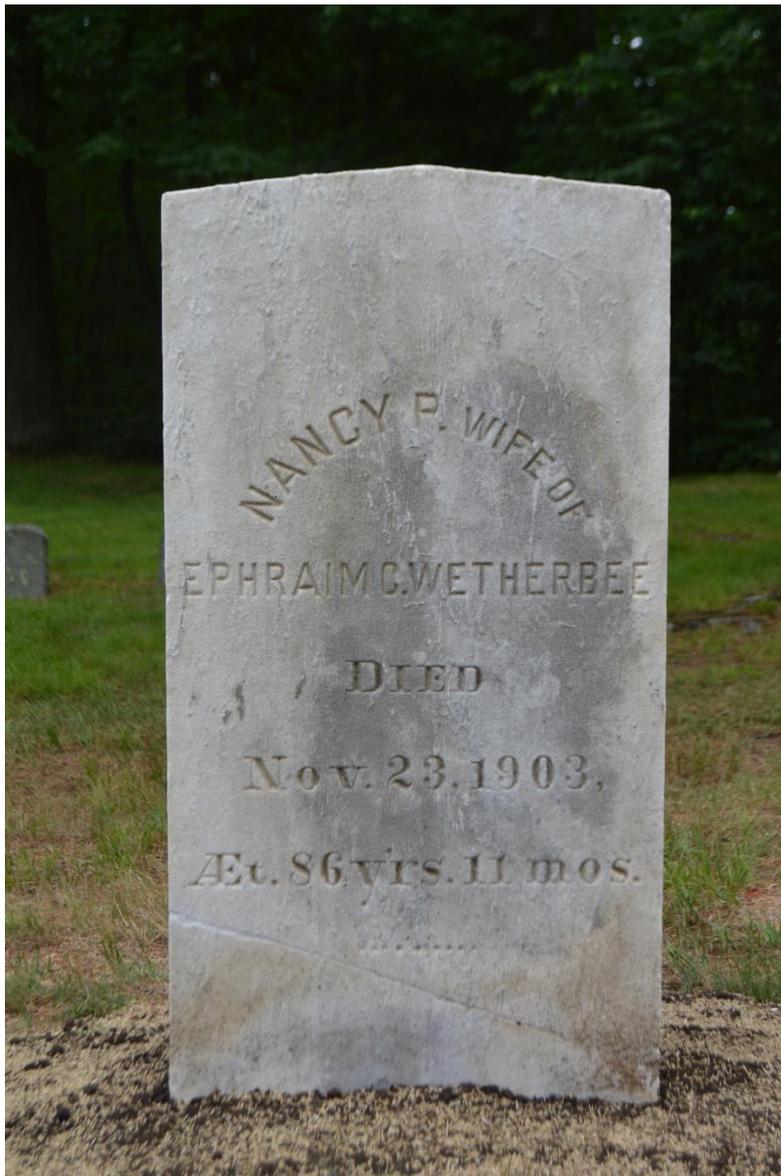
Name Wetherbee, Nancy P.
Date of Death Nov. 23, 1903

Material Marble
Marker Type tablet with base
Carving Condition 80% - 100% readable

Stone Condition Ambient dirt & biological growth
Broken, 2 fragments, fallen, broken base

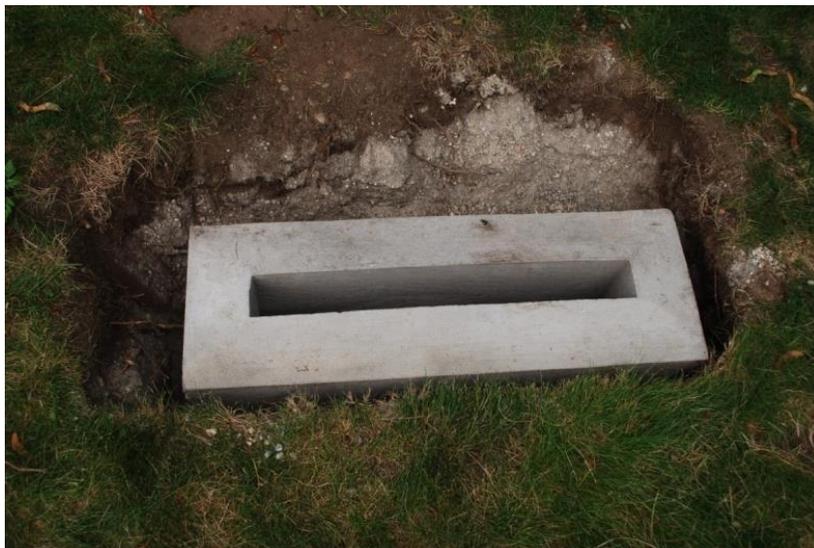
There are several situations where a new cast base will be required. Usually tablets which are broken near grade level or have been cut years earlier and set into bases that have failed are typical examples of when a new base is needed. Bases can be set above grade or below depending on the stone, aesthetics or other factors. Bases can be cast on site or pre-cast and set in place on a level bed of gravel and sand.

Cast concrete bases are typically made with a slot that is ½” wider and thicker than the stone and is recessed 3”-4”. Depending on the size of the stone the base is usually 8”-12” deep, 8”-12” greater thickness and 6”-8” wider than the stone. Drainage holes in the cast base are required in order to remove moisture from the mortar pocket. This method is fine when resetting stones with a square bottom.
