Warner's Pond Management Plan Summary

**Re: Project Completion Report for Nuisance Aquatic Plant Management Program at
Warner's Pond - 2004**

2004 Invasive Aquatic Plant Management Program – photodocumentation

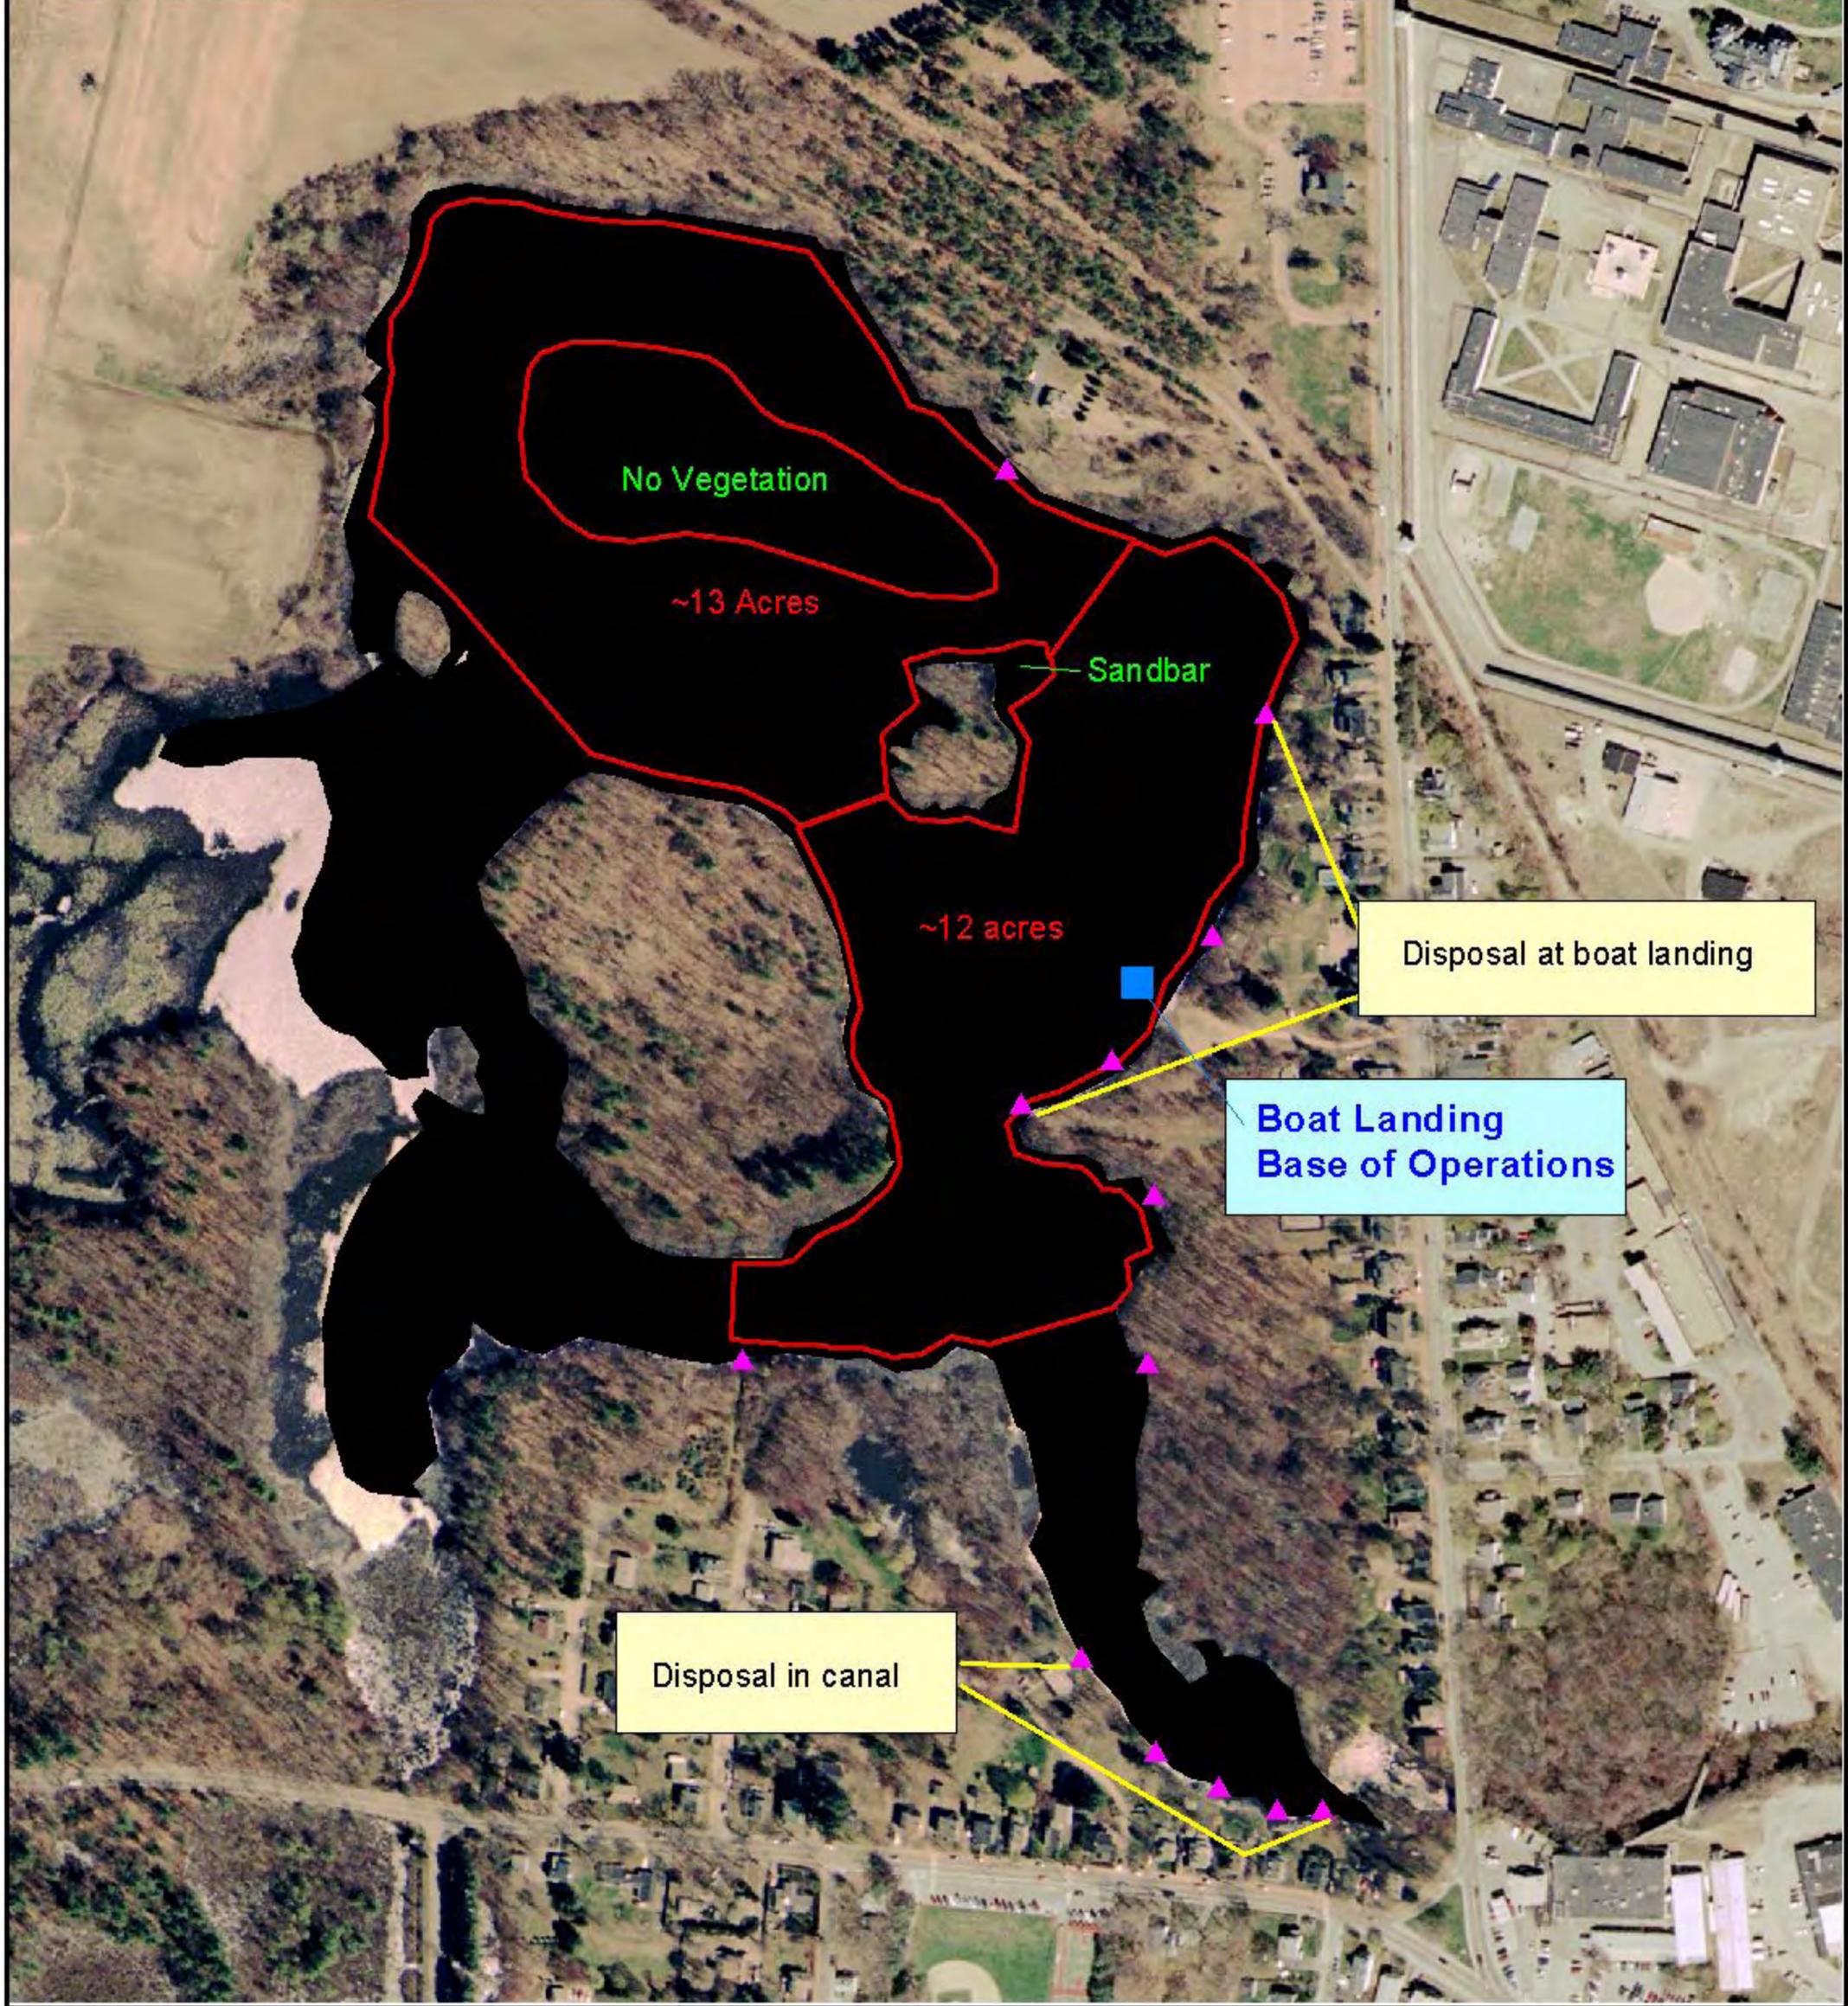
FIGURE	SURVEY DATE	MAP DATE
1	6/11/04	7/8/04

**2004 Harvesting and
Hydro-Raking Plan**

- Recommended harvest areas
Total Area ~ 25 acres
- ▲ Potential shoreline hydro-rake locations

The early season survey took place on 6/11/04 and was conducted by Marc Bellaud. The primary goal of the survey was to establish priority harvesting areas for the upcoming summer and identify potential hydro-rake sites along shore. To establish these areas, the entire pond was inspected and areas were prioritized for harvesting based on the severity of the fanwort problem and access for harvesting equipment. Depth, bottom composition, and vegetation assemblages were recorded at 11 of the previously established (during the 1999 and 2003 surveys) data point locations (see Figure 2) around the pond to help monitor the success of the current management plan. In addition, shoreline access points for the abutting properties were inspected to determine which sites were the highest priorities for a demonstration hydro-raking effort (see Figure 1).

Although much of the 44 acre open water area of the lake has been severely impacted by the presence of Fanwort, 25 acres in the eastern half of the pond were identified as the priority harvest area and 13 access points were noted as potential shoreline hydro-rake locations (see Figure 1).

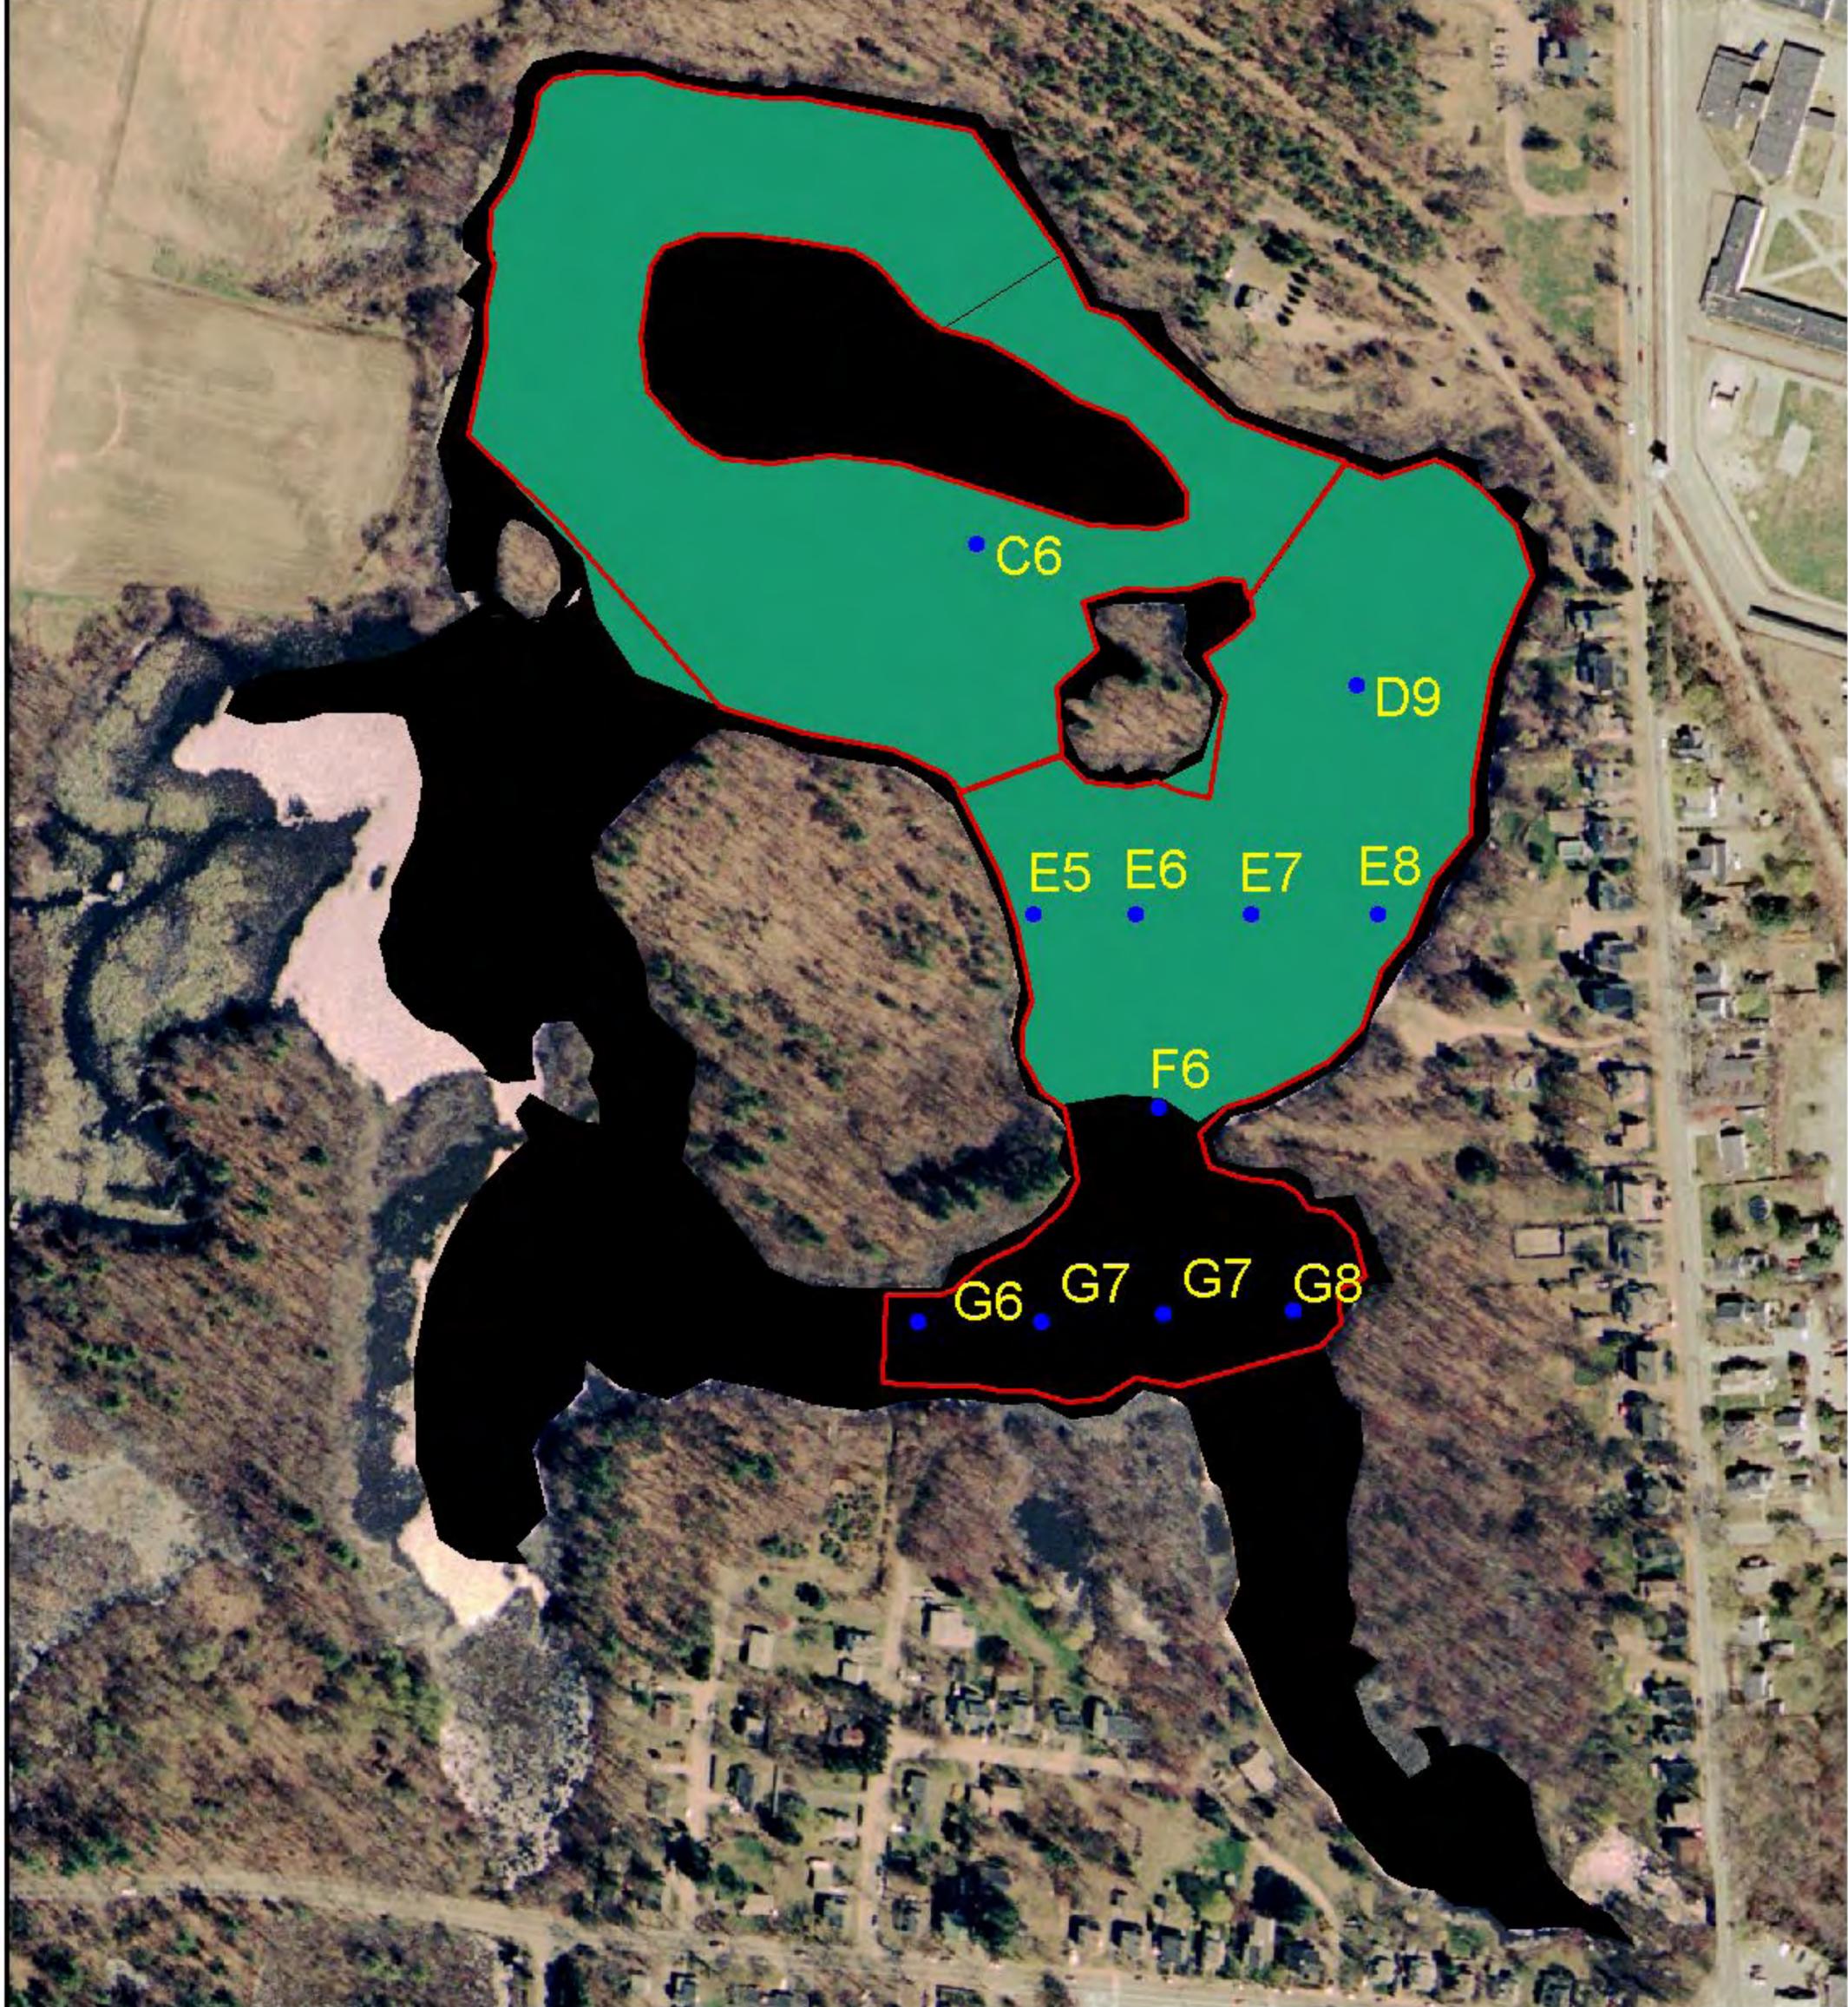
FIGURE	SURVEY DATE	MAP DATE
2	9/29/04	1/6/05

Areas Harvested in 2004

- Recommended harvest areas
Total Area ~ 25 acres
- Actual harvested area as reported by the Town of Concord ~21 acres
- Data points surveyed in 2003 & 2004

The harvesting operation at Warners Pond began on 7/9/04 and continued until 7/22/04. The harvesting was done with a USF&W aquatic weed harvester, on loan from the USF&W to the Town of Concord. Of the 13 days which the Town had the harvester, 9 days of varying lengths were spent harvesting, totaling 45 harvesting hours. Within this amount of time the harvester was able to cut approximately 21 acres, (see Figure 2) and generate 23 truckloads of organic debris.

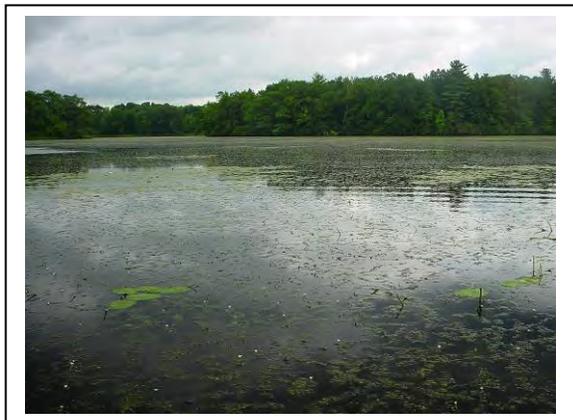
Before 2003

9/2/03 – Looking northwest from boat launch - fanwort (*Cabomba caroliniana*) flowers breaking the surface, dense cover

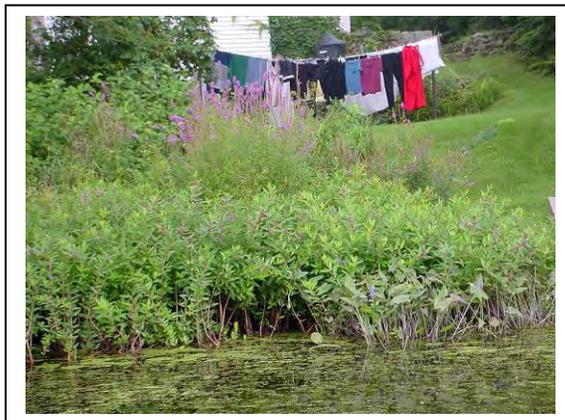
Before 2003

9/2/03 – Representative shoreline growth of invasive emergent vegetation

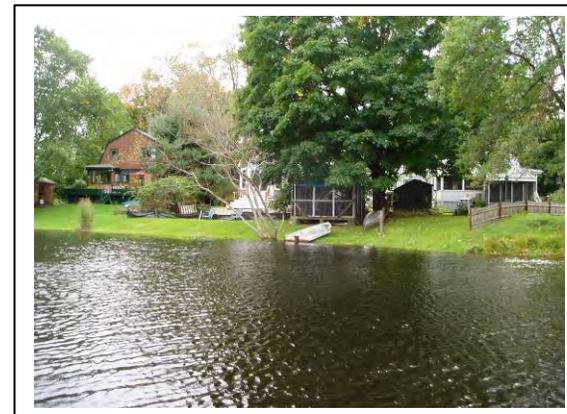
9/29/04 – Post hydro-raking, cleared shoreline in southern outlet canal

The individual shorefronts that were hydro-raked in the outlet canal remained clear of nuisance emergent vegetation. The hydro-rake was able to remove most of the overgrown emergent vegetation and the accumulated leaf litter and sediment deposits. The property owners were left with clear access to the pond. This strategy appears to be an effective way to reclaim shoreline access points that have become overgrown with invasive vegetation.

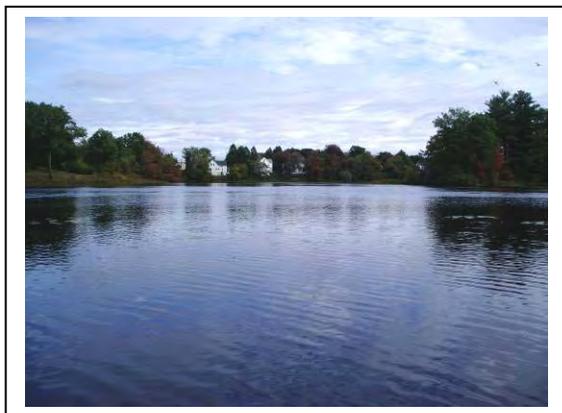
After 2004

9/29/04 – Looking south from boat launch – area supported dense fanwort cover in Sept. 2003

At the time of the September 2003 survey the fanwort in Warners Pond had reached the surface in almost all infested areas. When the pond was inspected in late September 2004, fanwort was still present at most locations, but its biomass was reduced and the plants were on average 2 feet below the surface. The reduction in plant cover and biomass between the two survey years is a direct result of the harvesting program, and it highlights the success of the harvesting campaign.

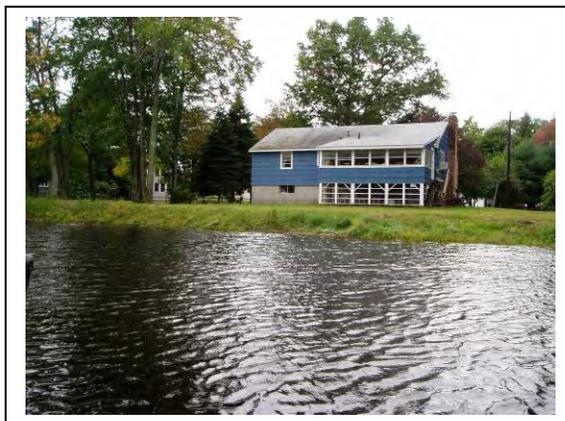
After 2004

9/29/04 – Post hydro-raking, cleared shoreline in southern outlet canal

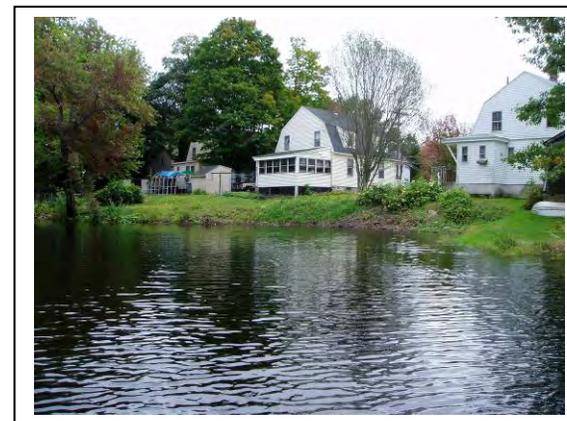
After 2004

9/29/04 – Post hydro-raking, cleared shoreline in southern outlet canal
